FINAL STRUCTURAL REPORT

Lantana Oceanfront Condominiums
Building 3 - 1811 Florida A1A
Indian Harbour Beach, Florida 32937

Engineer's Project # 20-0184
May 29, 2020

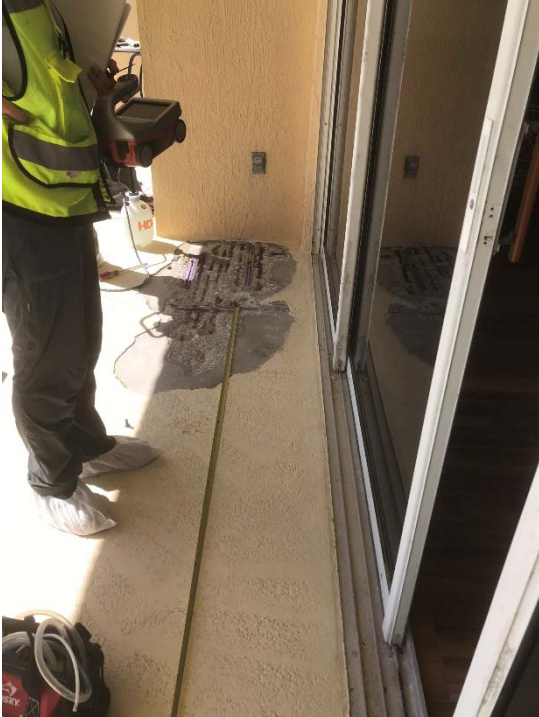
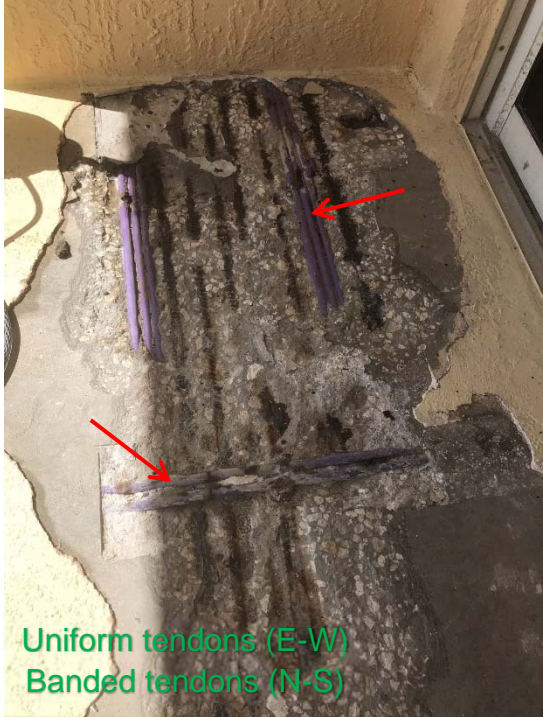
- **Unit 3201**
 - Evident concrete slab spalling with exposed corroded rebar and PT tendons in both the banded and uniform directions. Column grid line A and 5 thru 7.
 - Several evident slab concrete spall and hollow sounding floor area locations including the north side slab edge are aligned over the 1st group of banded tendons. Column grid line A.

Picture No.: 1, 2	DESCRIPTION: Unit 3201: Concrete slab spalling with exposed rebar and post tension tendons (Banded tendons N-S orientation; Uniform tendons E-W orientation)

- Depending on the actual anchorage proximity within the Six (6) tendons of the 1st group of banded tendons along the column grid line A, it is very likely that all of the tendons in the group will require de-tensioning / re-tensioning to allow the slab repairs. Also, there are “mirror” damages noted in the south unit balcony 3206. This means that the entire length of these banded tendons will require de-tensioning (from the building north and south end) thus requiring the full continuous safe shoring, to the ground floor, of all the 2nd floor balconies.

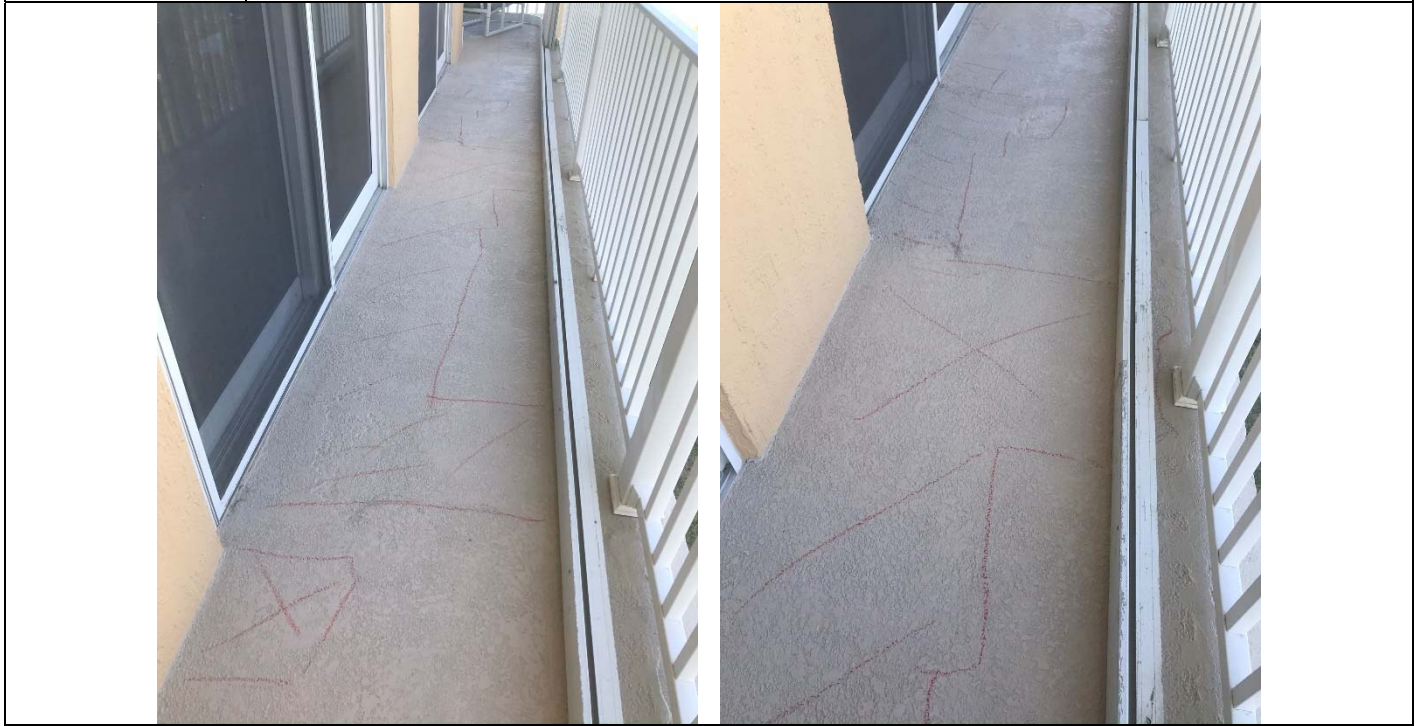
- For more information see attached finding drawings.
 - **Unit 3206:**
 - As noted for unit 3201, a number of possible slab spalling locations are found along the 1st group of banded tendons along column grid line A. This means that the entire length of these banded tendons will be de-tensioned (from the building north end to the building south end) thus requiring the full continuous safe shoring, to the ground floor, of all the 2nd floor balconies.

- Similar to unit 3201, apparent extensive slab concrete spalls in front of the 12x24 concrete column along grid line B will likely impact the banded group of eight (8) tendons along grid line B.

Picture No.: 10,11 DESCRIPTION: Unit 3206: Concrete slab hollow sounding locations.

- There are 2 options to proceed with the repairs located along column grid line B, one involves the full length de-tensioning / re-tensioning of the banded tendon group (from the north end of the building to the south end of the building) with full safe shoring (to the ground floor) along the impacted 2nd floor areas in all the units to allow the simultaneous repairs in both of the end units. The other option is to de-tension / re-tension only one end unit at a time with the temporary tendon lock-off being placed inside that unit and only shoring that unit. Then proceed to the de-tensioning / re-tensioning of the same banded group of tendons at the opposite end unit with the temporary lock-off inside that unit.

- A number of uniform tendons may be impacted (and will require de-tensioning / re-tensioning to allow the slab concrete repairs) if located directly over the possible slab spalling/repair areas. Some of these uniform direction tendons (E-W direction) will require their temporary lock-offs inside the units.

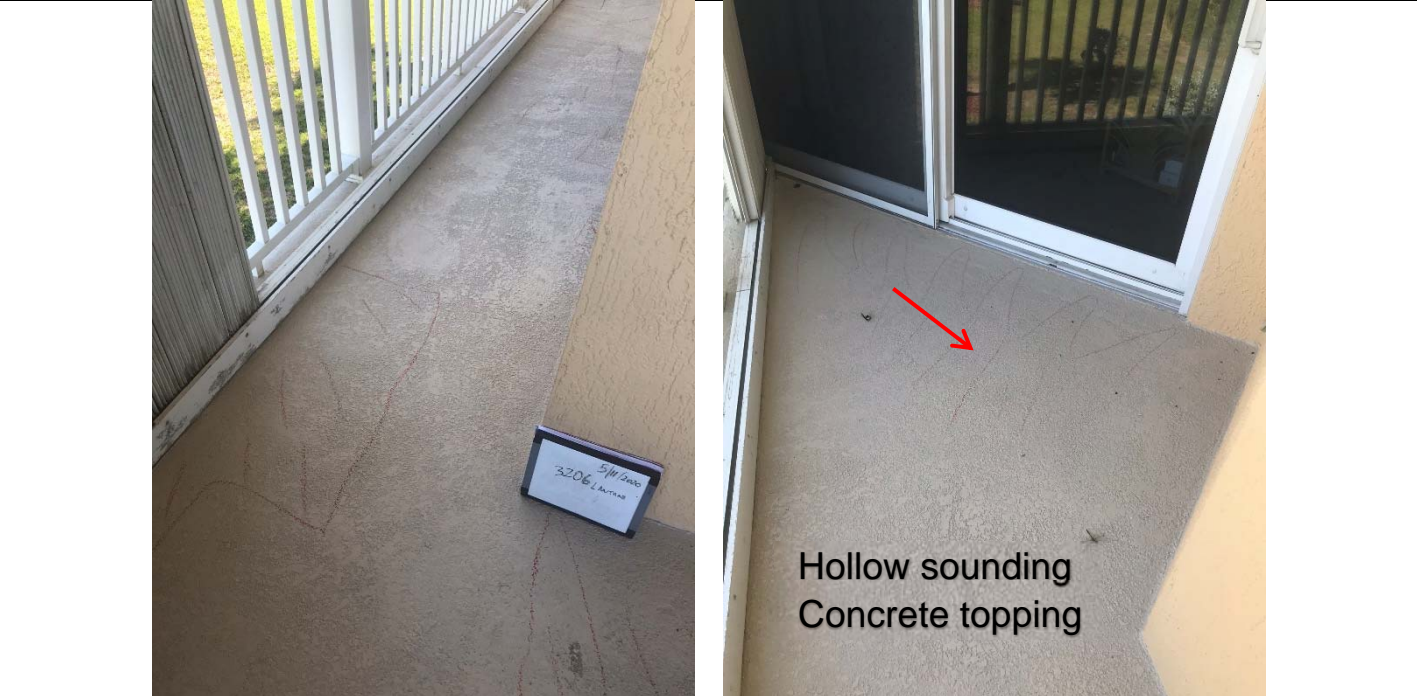
Picture No.: 12,13 DESCRIPTION: Unit 3206: Concrete slab hollow sounding locations.

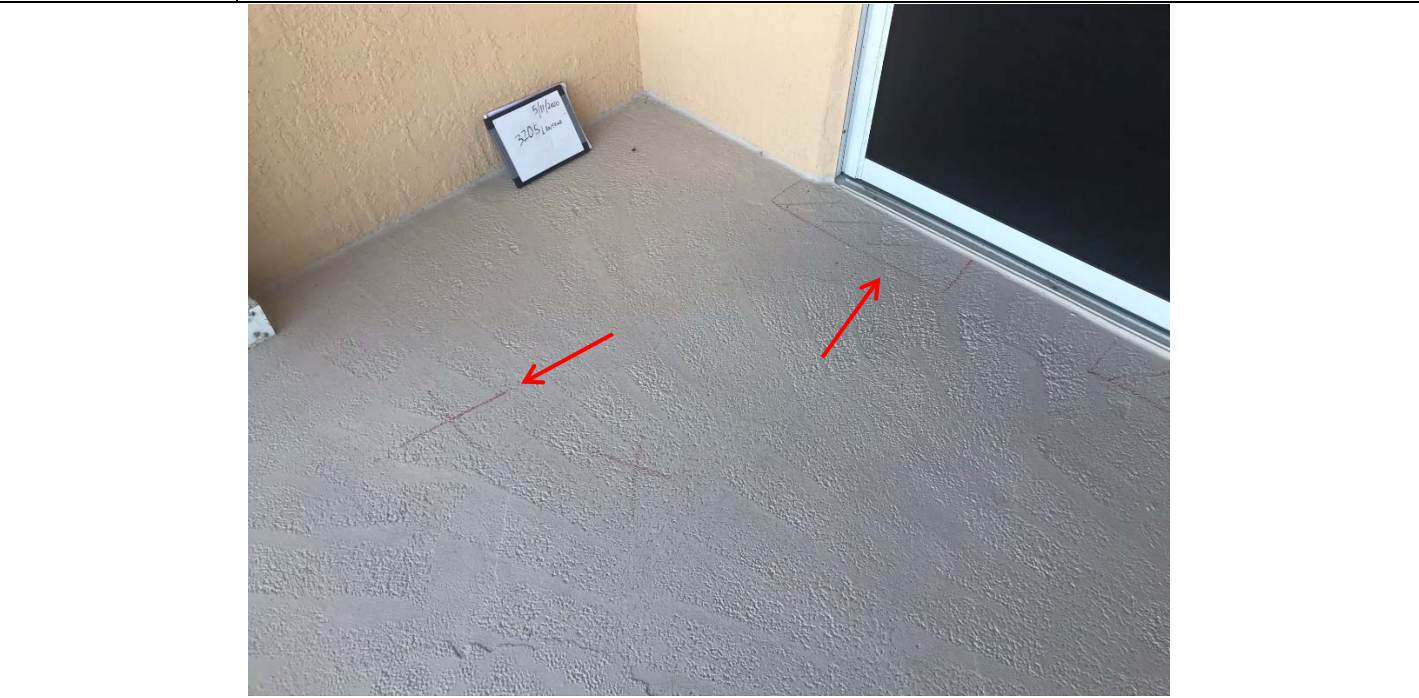
- **Unit 3205:**
 - Observed nine (9) slab hollow sounding locations. The majority of these areas are directly aligned with the banded group of tendons along column grid line A.

Picture No.: 16	DESCRIPTION: Unit 3205: Concrete slab hollow sounding locations.
-----------------	--

- A number of uniform tendons may be impacted (and will require de-tensioning / re-tensioning to allow the slab concrete repairs) if located directly over the possible slab spalling/repair areas. It is possible that some of these uniform direction tendons (E-W direction) will require their temporary lock-offs inside the units.

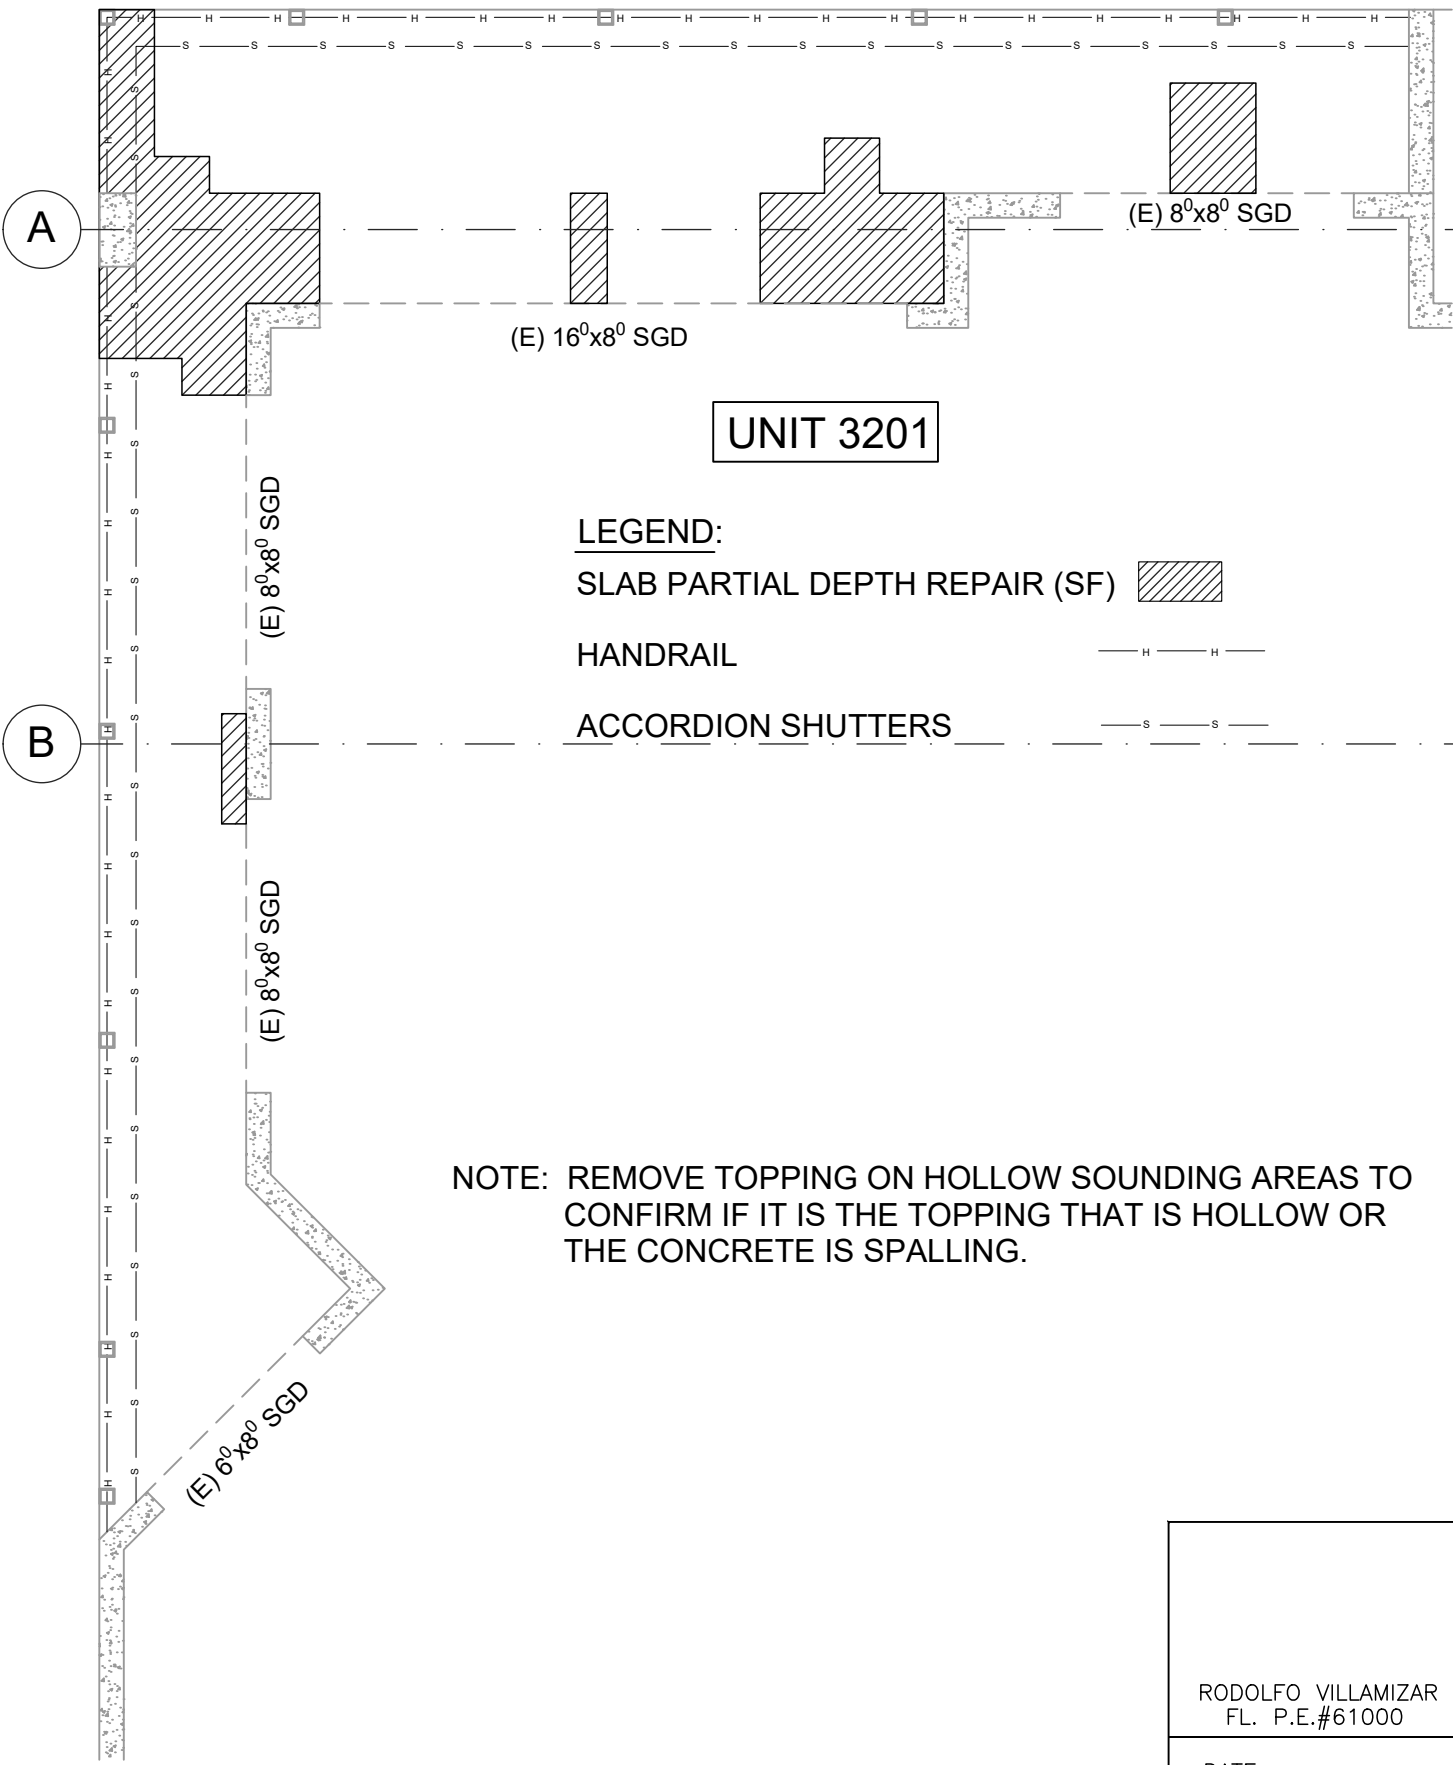
UNIT 3201

- An apparent slab concrete spall in front of the 12x24 concrete column along grid line B will likely impact the banded group of eight (8) tendons along grid line B. Also, there are “mirror” and extensive slab spalling in the south end unit balcony 3206 along the same grid line B.

- There are 2 options to proceed with the repairs located along column grid line B, one involves the full length de-tensioning / re-tensioning of the banded tendon group (from the north end of the building to the south end of the building) with full safe shoring (to the ground floor) along the impacted 2nd floor areas in all the units to allow the simultaneous repairs in both of the end units. The other option is to de-tension / re-tension only one end unit at a time with the temporary tendon lock-off being placed inside that unit and only shoring that unit. Then proceed to the de-tensioning / re-tensioning of the same banded group of tendons at the opposite end unit with the temporary lock-off inside that unit.

- A number of uniform tendons may be impacted along the balcony slab (and will require de-tensioning / re-tensioning to allow the slab concrete repairs) if located directly over the possible slab spalling/repair areas. Some of these uniform direction tendons (E-W direction) will require their temporary lock-offs inside the units.
