## **LANTANA CONDOMINIUMS INDIAN HARBOUR BEACH, FLORIDA POST-TENSIONING TESTING**

VCS Project Number – F20028FL

June 5, 2020

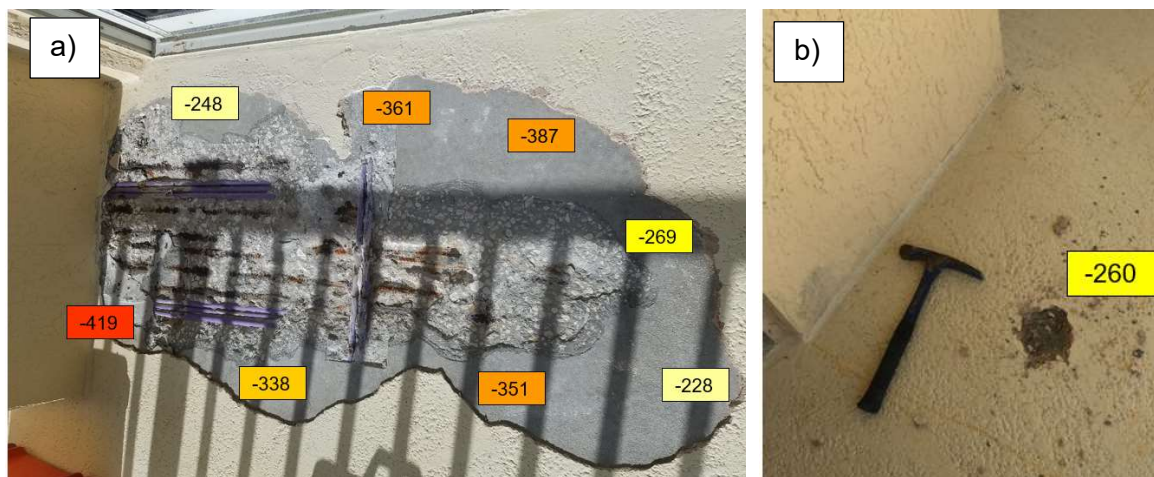
All corrosion potential measurements collected on the unit 3201 balcony (Figure 3) were either at the 90% probability of active corrosion or in the uncertain range. This is not surprising given the condition of the spall area. When the stucco was removed in a delaminated area in front of the northeast column in unit 3201, cracks were observed in the concrete, indicating that this delamination was caused by concrete deterioration rather than debonding of the stucco. Although it was only possible to take one corrosion potential measurement in this area, it indicates that concrete deterioration is likely due to rebar corrosion.

Figure 3: Corrosion Potential Measurements in Unit 3201 Balcony: a) Spall in Front of the Balcony Doors, b) Delamination in Front of the Northeast Column

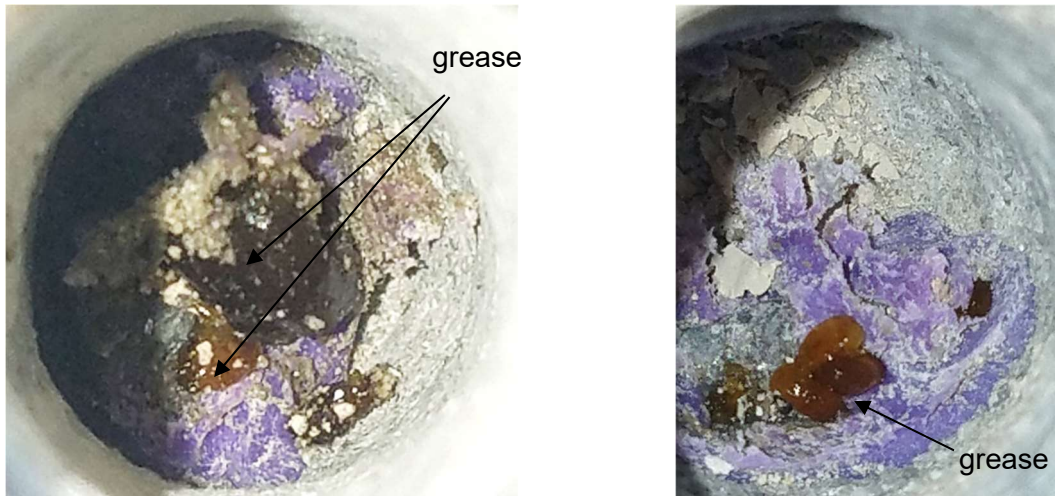
Table 5 shows the locations of all the PTCE tests carried out on the Building #3 balconies. Out of the 6 exposed tendons, no air flow was measured at the “OUT” port in 4 of the tendons. Although no air flow was achieved in 67% of the tested tendons, grease was visible at the “OUT” port locations in all instances as shown in Figure 4. Presence of large amounts of grease in the sheathing around the tendons can also prevent air flow through the tendons during the PTCE testing. This indicates that the tendons are well protected by the grease and the risk of corrosion is low. Air was able to flow along two tendons. In one tendon (test 5) a “dry” condition was indicated, while a “wet” condition was indicated in the other tendon (test 7) (Figure 5).

Figure 4: Drops of grease at the "OUT" port location after moisture testing (typical)

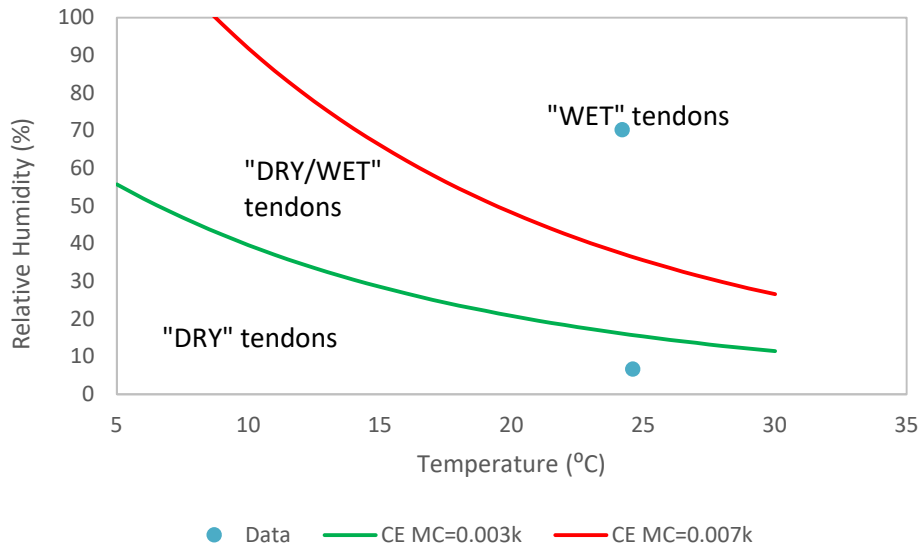
Figure 5: PTCE Moisture Testing Results for Tests 5 and 7

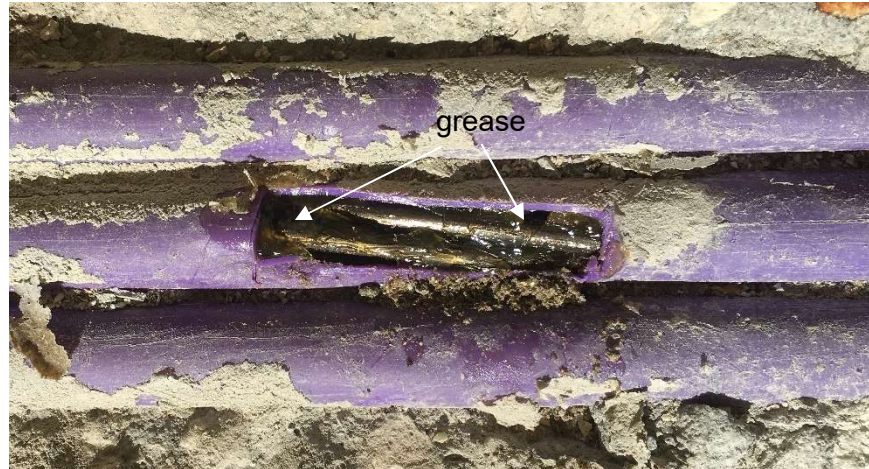
In addition to moisture testing, VCS visually inspected the condition of the tendons in the spall area where tendon sheathing has been cut. Ample amounts of grease were visible in the sheathing (Figure 6). The tendons were free of corrosion and appeared to be under tension. Tension was checked by attempting to drive a screwdriver between the individual strands of the tendon. If the tendon is under tension then the screwdriver should not be able to fit between the strands. If tension is lost then the screwdriver will be able to fit between the strands. The screwdriver was unable to fit between the stands indicating that tendon is under tension. The screwdriver test was also performed in the openings made for PTCE testing. In all cases, it was not possible to fit the screwdriver between the wires of the tendons and the tendons appeared to be under tension.

Figure 6: Opening in the Tendon Sheathing
