# STRUCTURAL REPORT

## Lantana Oceanfront Condominiums Building 1 - 1791 Florida A1A Indian Harbour Beach, Florida 32937

Engineer's Project # 21-0530  
January 28, 2022

## 1. Executive Summary

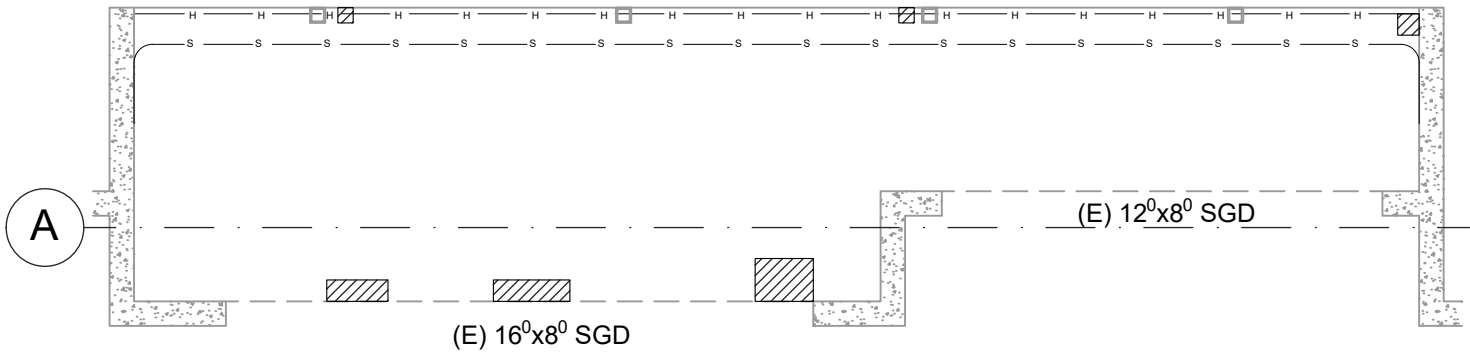
**UNIT 1202**

- **Unit 1202:**
  - Identified several evident hollow sounding floor overlay / topping area locations. The existing floor finishes directly over the identified hollow sounding floor surfaces should be removed to further verify and rule out the possibility of being actual concrete slab spalling.
  - For more information see attached findings drawings.

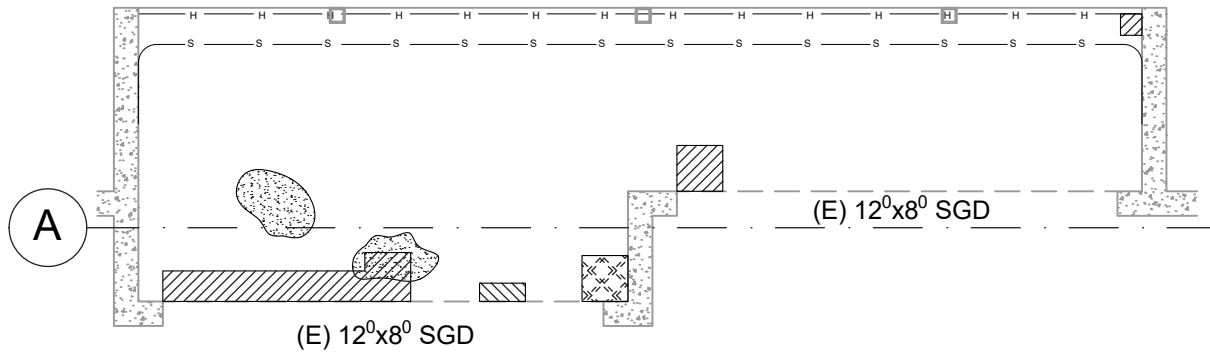
**UNIT 1203**

- **Unit 1203:**
  - Possible concrete spall located by the south interior corner in front of the living room. This area is directly aligned with the band group of tendons (N-S orientation) along column grid line A. Both banded tendons and uniform tendons (E-W orientation) may be impacted if located directly over the possible slab spalling/repair areas, and may require de-tensioning / re-tensioning to allow the slab concrete repairs.

- Identified several evident hollow sounding floor overlay / topping area locations. The existing floor finishes directly over the identified hollow sounding floor surfaces should be removed to further verify and rule out the possibility of being actual concrete slab spalling.

- Observed water ponding locations. A slab pitch correction to these locations is recommended to ensure the proper draining away of water.
  - For more information see attached findings drawings.

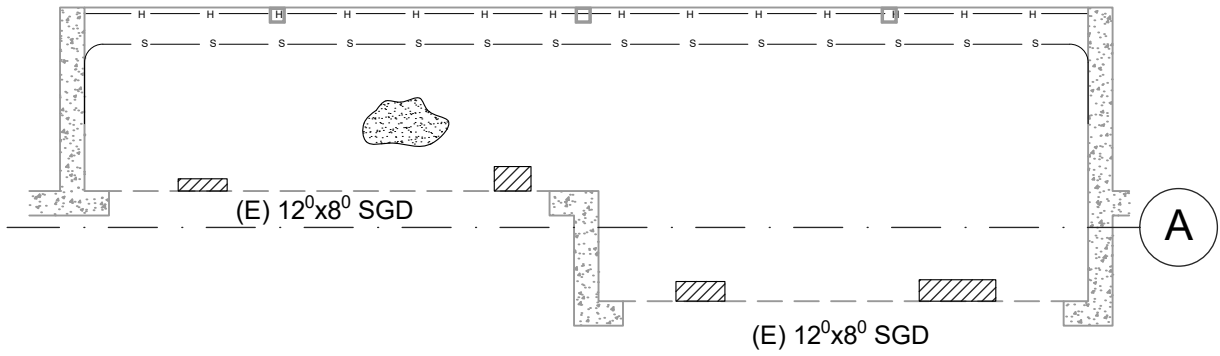
**UNIT 1204**

- **Unit 1204:**
  - Identified a few evident hollow sounding floor overlay / topping area locations. The existing floor finishes directly over the identified hollow sounding floor surfaces should be removed to further verify and rule out the possibility of being actual concrete slab spalling.
  - Observed water ponding locations. A slab pitch correction to these locations is recommended to ensure the proper draining away of water.
  - For more information see attached findings drawings.

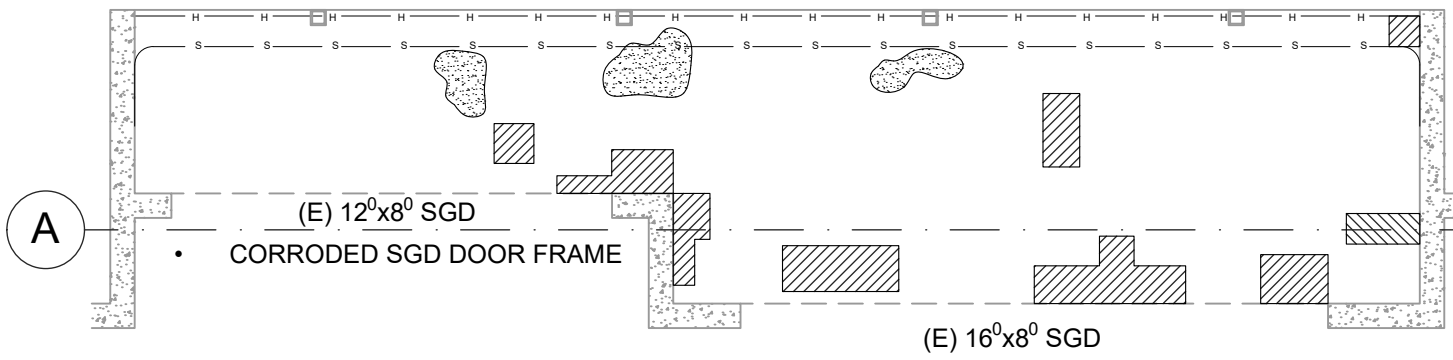
**UNIT 1205**

- **Unit 1205:**
  - Identified several evident hollow sounding floor overlay / topping area locations. The existing floor finishes directly over the identified hollow sounding floor surfaces should be removed to further verify and rule out the possibility of being actual concrete slab spalling.
  - Observed water ponding locations. A slab pitch correction to these locations is recommended to ensure the proper draining away of water.
  - For more information see attached findings drawings.

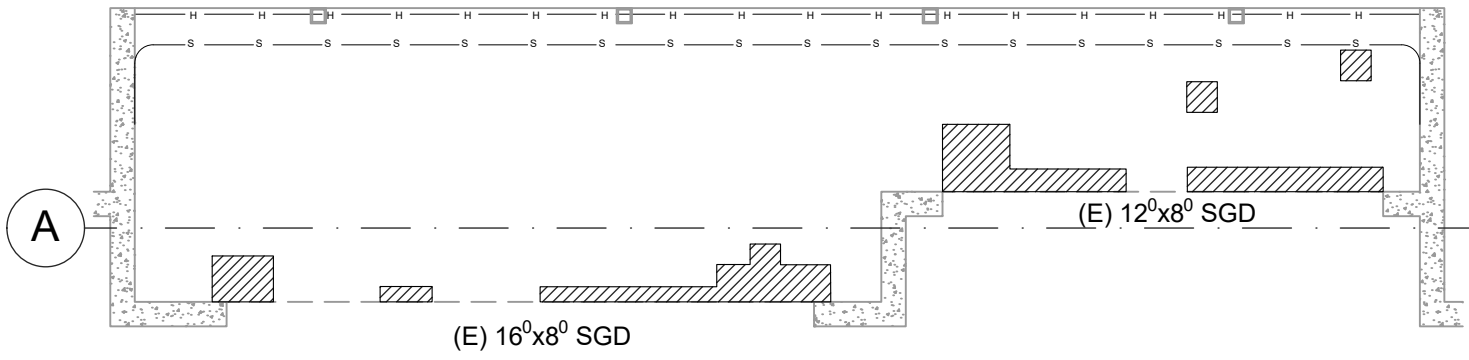
**UNIT 1302**

- **Unit 1302:**
  - Identified several evident hollow sounding floor overlay / topping area locations. The existing floor finishes directly over the identified hollow sounding floor surfaces should be removed to further verify and rule out the possibility of being actual concrete slab spalling.
  - For more information see attached findings drawings.

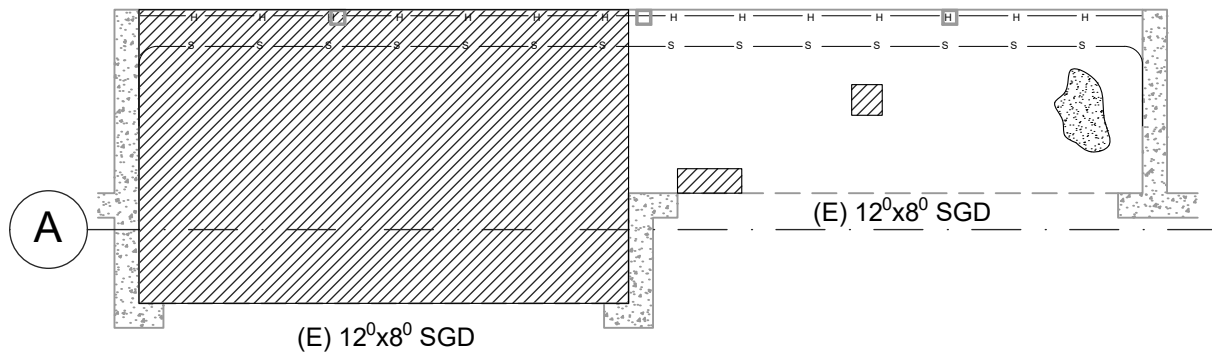
**UNIT 1303**

- **Unit 1303:**
  - The majority of the existing cementitious floor topping on the north half of the balcony is delaminated from the concrete substrate.
  - The existing floor finishes directly over the identified hollow sounding floor surfaces should be removed to further verify and rule out the possibility of being actual concrete slab spalling.
  - A slab pitch verification and correction to these locations is recommended to ensure the proper draining away of water.
  - For more information see attached findings drawings.

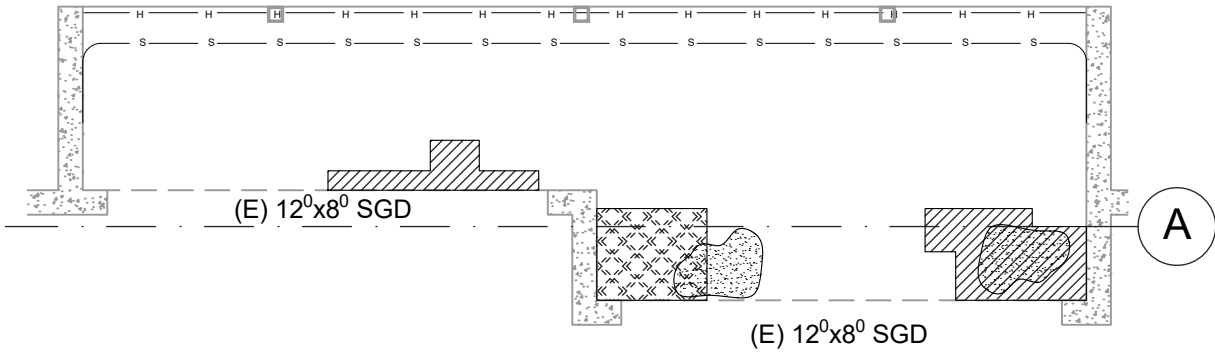
**UNIT 1304**

- **Unit 1304:**
  - Possible concrete spall located by the north interior corner in front of the living room. This area is directly aligned with the band group of tendons (N-S orientation) along column grid line A. Both banded tendons and uniform tendons (E-W orientation) may be impacted if located directly over the possible slab spalling/repair areas, and may require de-tensioning / re-tensioning to allow the slab concrete repairs.

- Identified a few other evident hollow sounding floor overlay / topping area locations. The existing floor finishes directly over the identified hollow sounding floor surfaces should be removed to further verify and rule out the possibility of being actual concrete slab spalling.

- Observed water ponding locations. A slab pitch correction to these locations is recommended to ensure the proper draining away of water.
  - For more information see attached findings drawings.

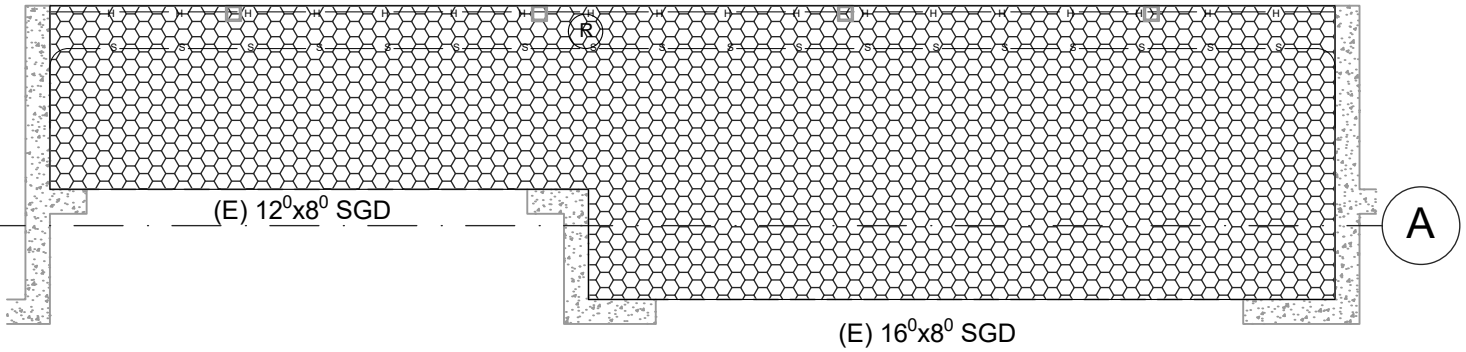
**UNIT 1305**

- **Unit 1305:**
  - The entire balcony floor has tile flooring finishes. The majority of the installed tile flooring is hollow sounding / delaminated from its substrate. Complete removal of the tile flooring is recommended to verify the condition and integrity of the substrate.
  - A slab pitch verification and correction is recommended to ensure the proper draining away of water.
  - For more information see attached findings drawings.

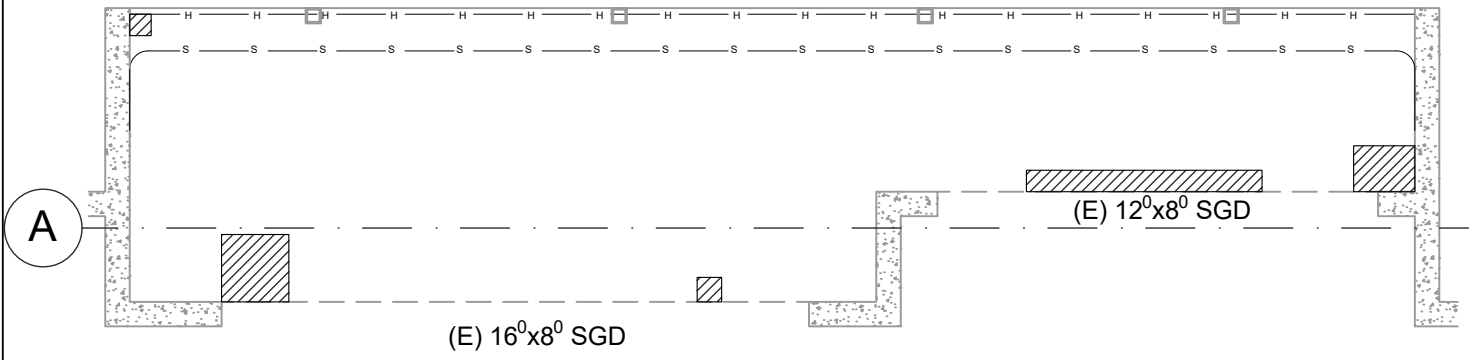
**UNIT 1402**

- **Unit 1402:**
  - Identified several evident hollow sounding floor overlay / topping area locations. The existing floor finishes directly over the identified hollow sounding floor surfaces should be removed to further verify and rule out the possibility of being actual concrete slab spalling.
  - Observed numerous rust spot (stains) locations on the cementitious floor topping.
  - For more information see attached findings drawings.

- NUMEROUS RUST SPOTS ON DECK

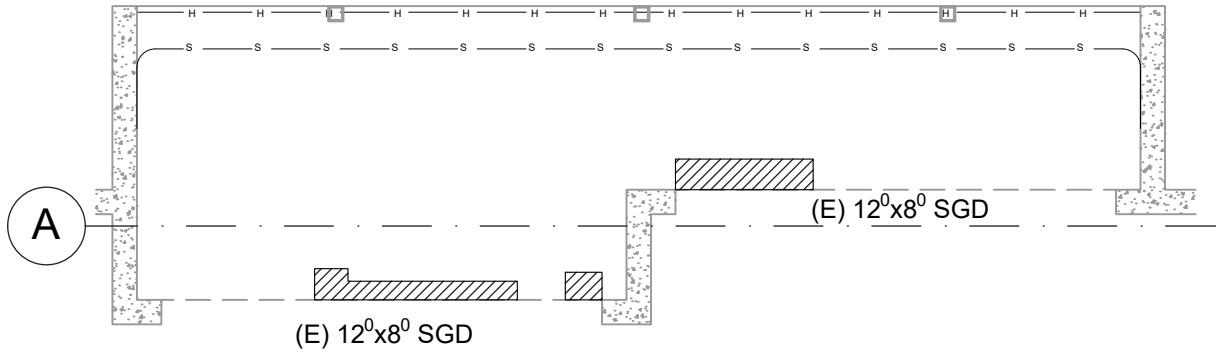
**UNIT 1403**

- **Unit 1403:**
  - Identified several evident hollow sounding floor overlay / topping area locations. The existing floor finishes directly over the identified hollow sounding floor surfaces should be removed to further verify and rule out the possibility of being actual concrete slab spalling.
  - For more information see attached findings drawings.

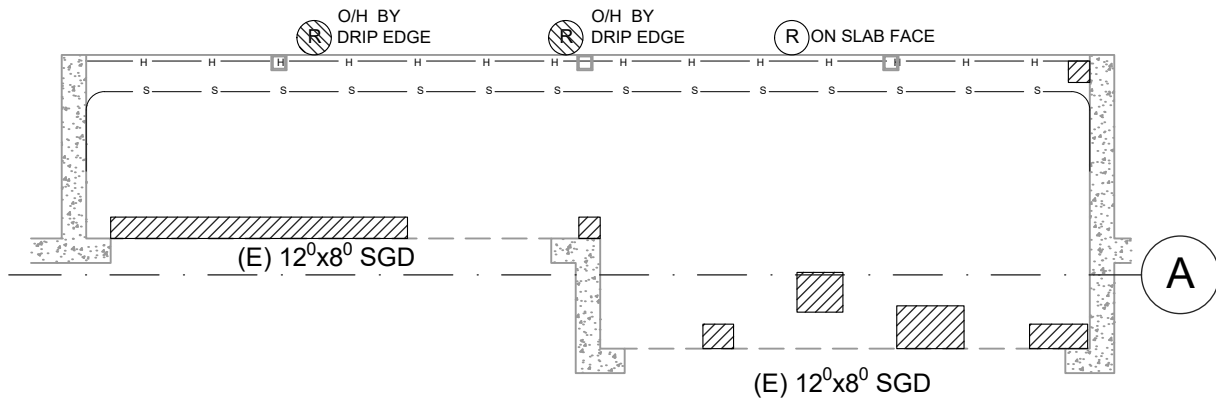
**UNIT 1404**

- **Unit 1404:**
  - Identified several evident hollow sounding floor overlay / topping area locations. The existing floor finishes directly over the identified hollow sounding floor surfaces should be removed to further verify and rule out the possibility of being actual concrete slab spalling.
  - For more information see attached findings drawings.

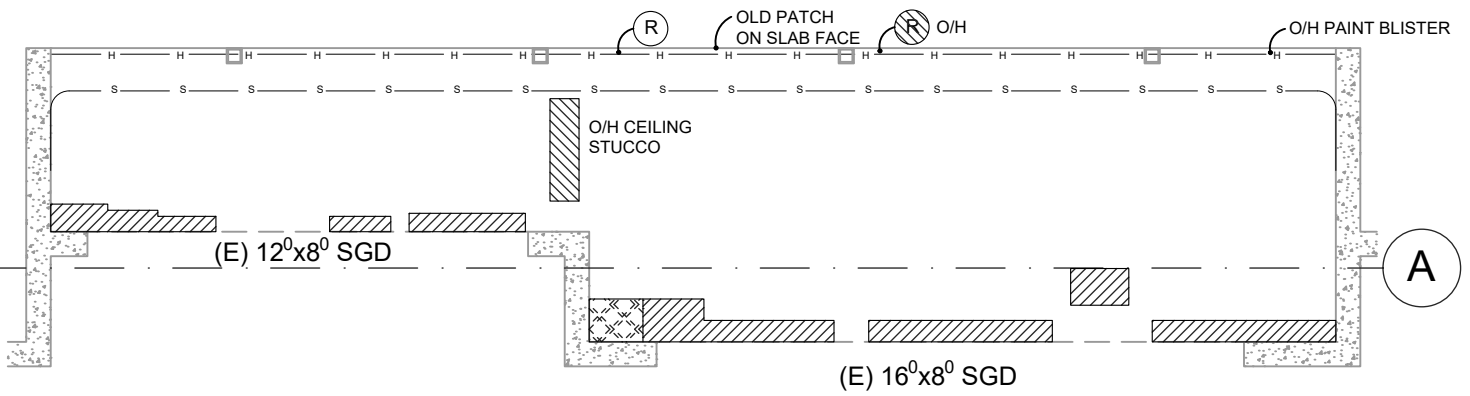
**UNIT 1405**

- **Unit 1405:**
  - Possible concrete spall located by the north interior corner in front of the living room. This area is directly aligned with the band group of tendons (N-S orientation) along column grid line A. Both banded tendons and uniform tendons (E-W orientation) may be impacted if located directly over the possible slab spalling/repair areas, and may require de-tensioning / re-tensioning to allow the slab concrete repairs.
  - Identified several evident hollow sounding floor overlay / topping area locations. The existing floor finishes directly over the identified hollow sounding floor surfaces should be removed to further verify and rule out the possibility of being actual concrete slab spalling.
  - For more information see attached findings drawings.
