# STRUCTURAL REPORT

## Lantana Oceanfront Condominiums Building 2 - 1811 Florida A1A Indian Harbour Beach, Florida 32937

Engineer's Project # 21-0530  
January 26, 2022

### 1. Executive Summary

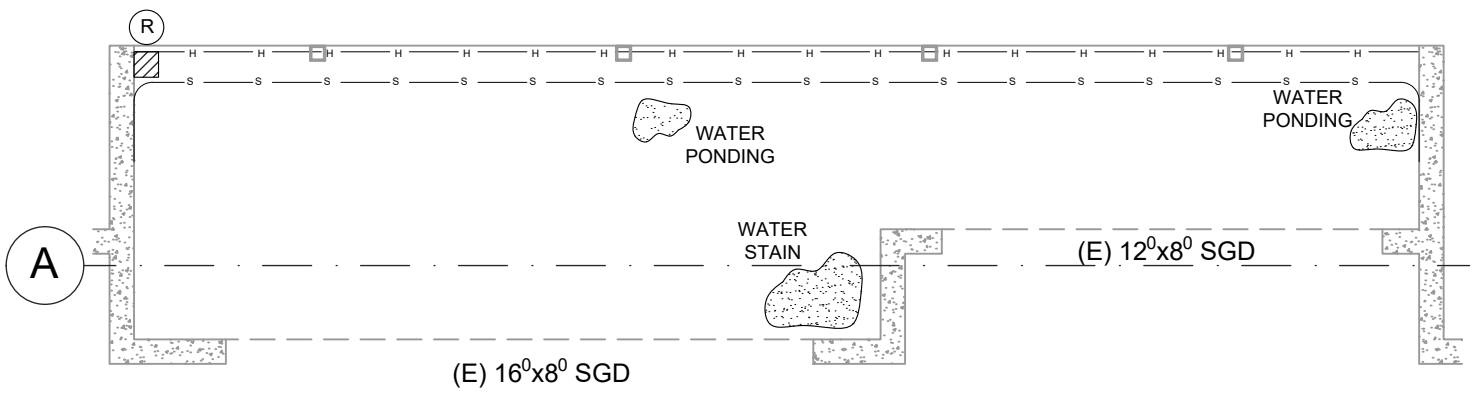
**UNIT 2202**

- **Unit 2202:**
  - Observed water ponding locations. A slab pitch correction to these locations is recommended to ensure the proper draining away of water.
  - For more information see attached findings drawings.

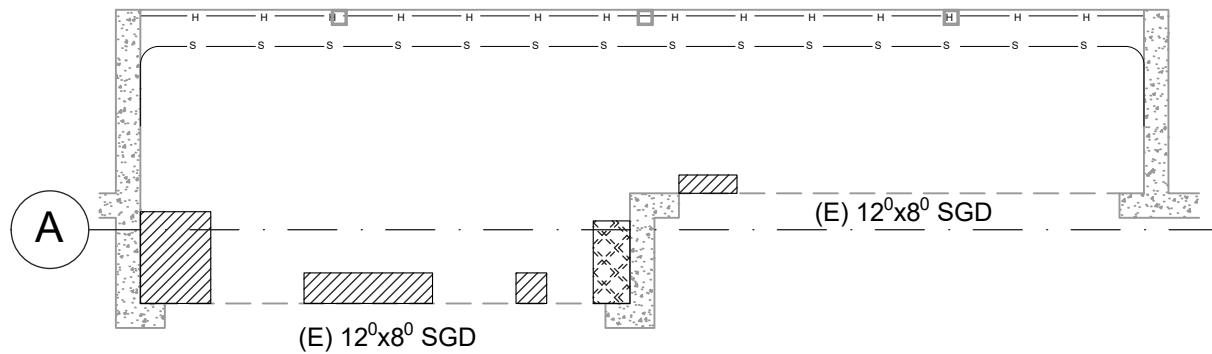
**UNIT 2203**

- **Unit 2203:**
  - Possible concrete spall located by the south interior corner in front of the living room. This area is directly aligned with the band group of tendons (N-S orientation) along column grid line A. Both banded tendons and uniform tendons (E-W orientation) may be impacted if located directly over the possible slab spalling/repair areas, and may require de-tensioning / re-tensioning to allow the slab concrete repairs.
  - Identified several evident hollow sounding floor overlay / topping area locations. The existing floor finishes directly over the identified hollow sounding floor surfaces should be removed to further verify and rule out the possibility of being actual concrete slab spalling.
  - For more information see attached findings drawings.

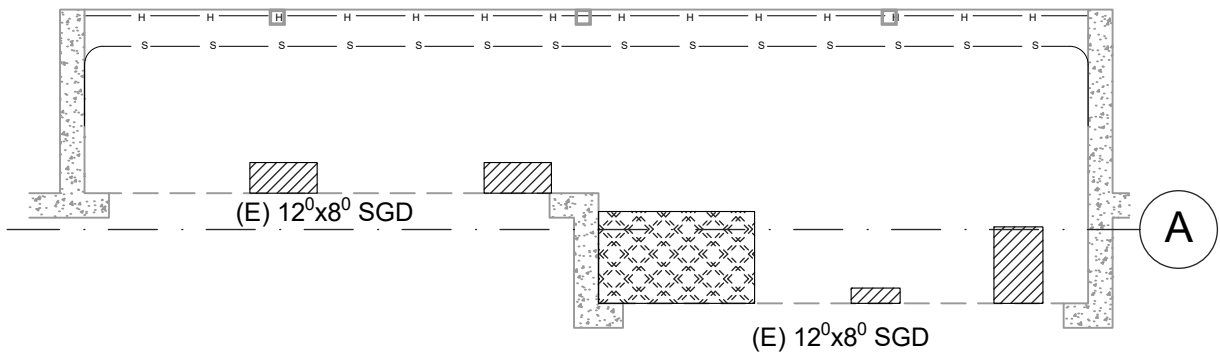
**UNIT 2204**

- **Unit 2204:**
  - Possible concrete spall located by the north interior corner in front of the living room. This area is directly aligned with the band group of tendons (N-S orientation) along column grid line A. Both banded tendons and uniform tendons (E-W orientation) may be impacted if located directly over the possible slab spalling/repair areas, and may require de-tensioning / re-tensioning to allow the slab concrete repairs.
  - Identified several evident hollow sounding floor overlay / topping area locations. The existing floor finishes directly over the identified hollow sounding floor surfaces should be removed to further verify and rule out the possibility of being actual concrete slab spalling.
  - For more information see attached findings drawings.

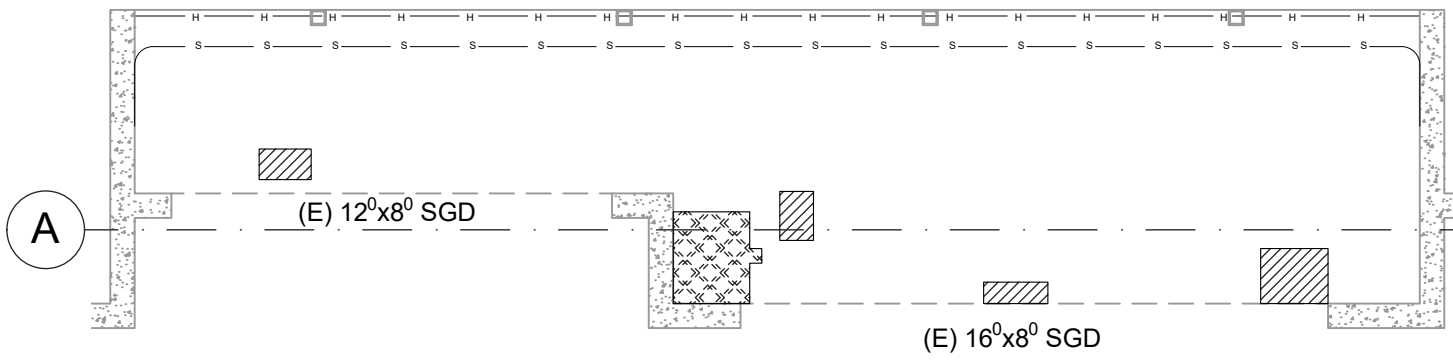
**UNIT 2205**

- **Unit 2205:**
  - Possible concrete spall located by the north interior corner in front of the living room. This area is directly aligned with the band group of tendons (N-S orientation) along column grid line A. Both banded tendons and uniform tendons (E-W orientation) may be impacted if located directly over the possible slab spalling/repair areas, and may require de-tensioning / re-tensioning to allow the slab concrete repairs.
  - Identified several evident hollow sounding floor overlay / topping area locations. The existing floor finishes directly over the identified hollow sounding floor surfaces should be removed to further verify and rule out the possibility of being actual concrete slab spalling.
  - For more information see attached findings drawings.

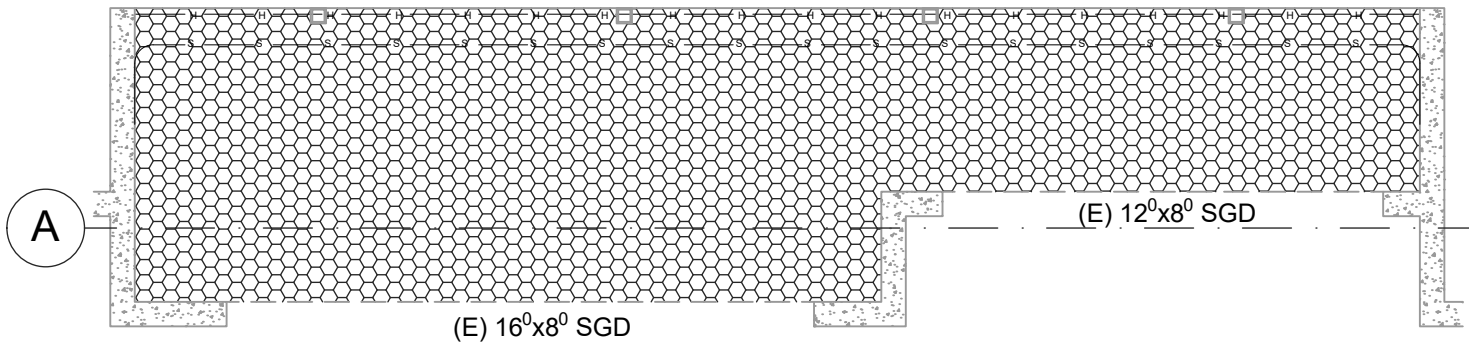
**UNIT 2302**

- **Unit 2302:**
  - The entire balcony floor has tile flooring finishes. The majority of the installed tile flooring is hollow sounding / delaminated from its substrate. Complete removal of the tile flooring is recommended to verify the condition and integrity of the substrate.

- TILE FLOORING
- DELAMINATED TILE
- SHUTTERS INSTALLED OVER TILE
- SGD MISSING SCREWS

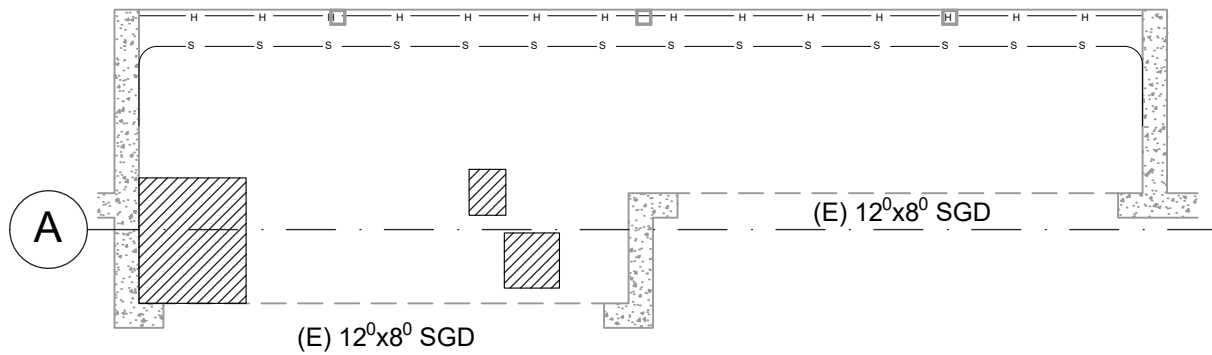
**UNIT 2303**

- For more information see attached findings drawings.
- **Unit 2303:**
  - Identified several evident hollow sounding floor overlay / topping area locations. The existing floor finishes directly over the identified hollow sounding floor surfaces should be removed to further verify and rule out the possibility of being actual concrete slab spalling.

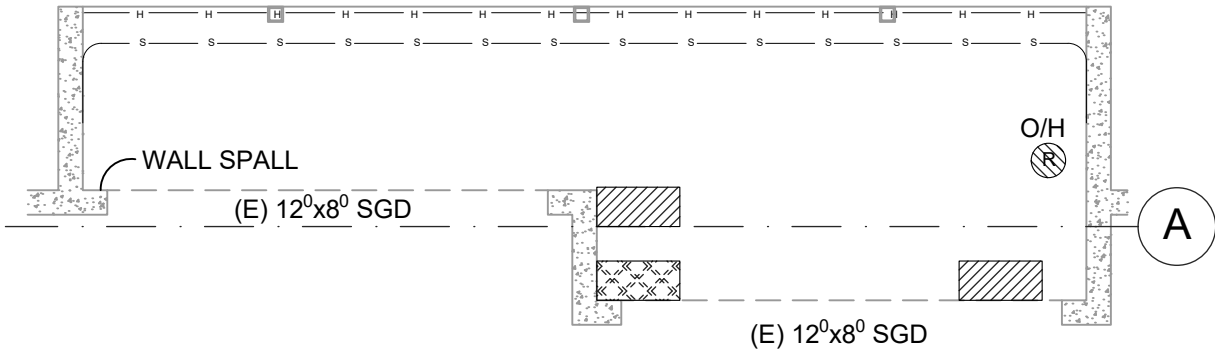
**UNIT 2304**

- For more information see attached findings drawings.
- **Unit 2304:**
  - Possible concrete spall located by the north interior corner in front of the living room. This area is directly aligned with the band group of tendons (N-S orientation) along column grid line A. Both banded tendons and uniform tendons (E-W orientation) may be impacted if located directly over the possible slab spalling/repair areas, and may require de-tensioning / re-tensioning to allow the slab concrete repairs.

- Identified a few other evident hollow sounding floor overlay / topping area locations. The existing floor finishes directly over the identified hollow sounding floor surfaces should be removed to further verify and rule out the possibility of being actual concrete slab spalling.

- TOPPING SLAB PAINT PEELING
- WALL SPALL
- O/H = OVERHEAD

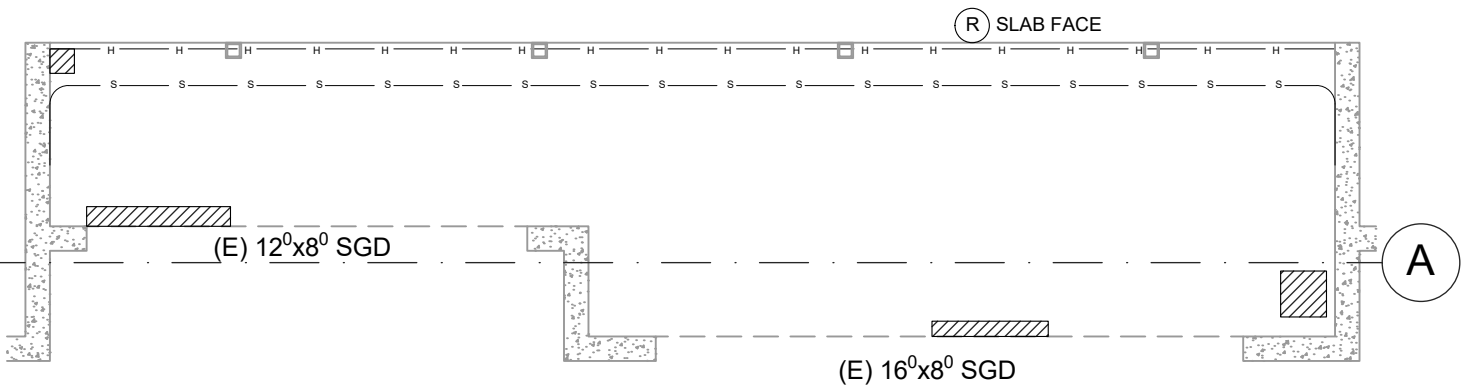
**UNIT 2305**

- For more information see attached findings drawings.
- **Unit 2305:**
  - Identified a few evident hollow sounding floor overlay / topping area locations. The existing floor finishes directly over the identified hollow sounding floor surfaces should be removed to further verify and rule out the possibility of being actual concrete slab spalling.

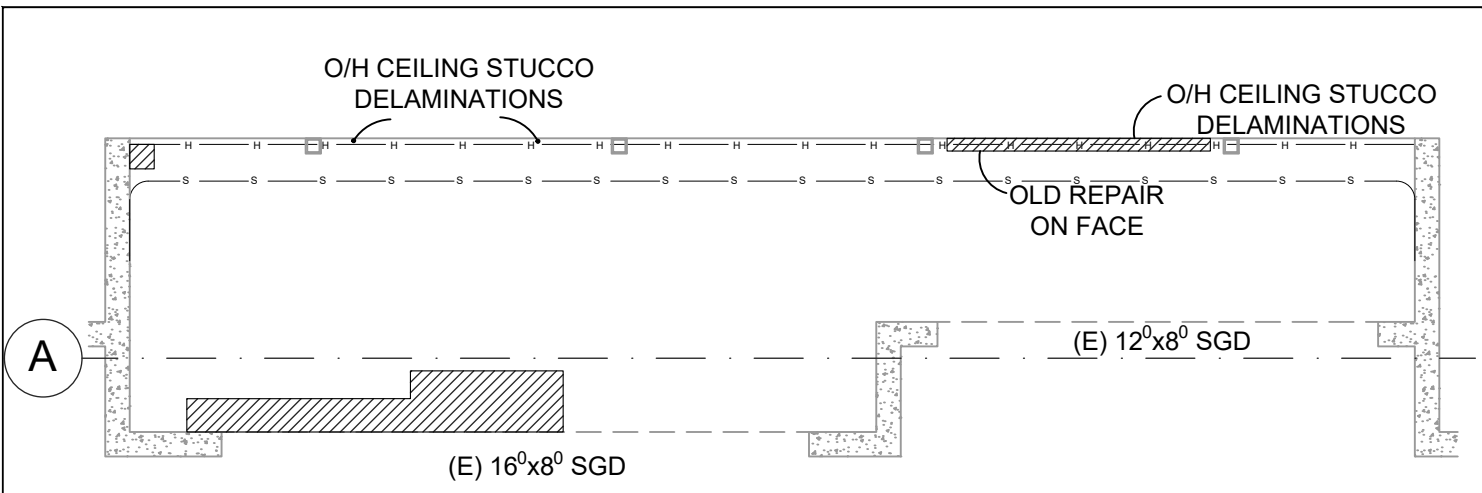
**UNIT 2402**

- For more information see attached findings drawings.
- **Unit 2402:**
  - Identified a few evident hollow sounding floor overlay / topping area locations. The existing floor finishes directly over the identified hollow sounding floor surfaces should be removed to further verify and rule out the possibility of being actual concrete slab spalling.

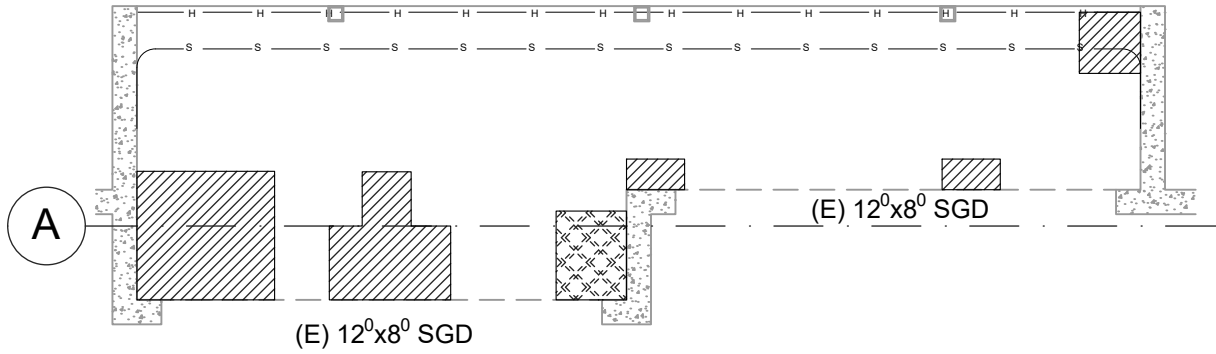
**UNIT 2403**

- **Unit 2403:**
  - Possible concrete spall located by the south interior corner in front of the living room. This area is directly aligned with the band group of tendons (N-S orientation) along column grid line A. Both banded tendons and uniform tendons (E-W orientation) may be impacted if located directly over the possible slab spalling/repair areas, and may require de-tensioning / re-tensioning to allow the slab concrete repairs.

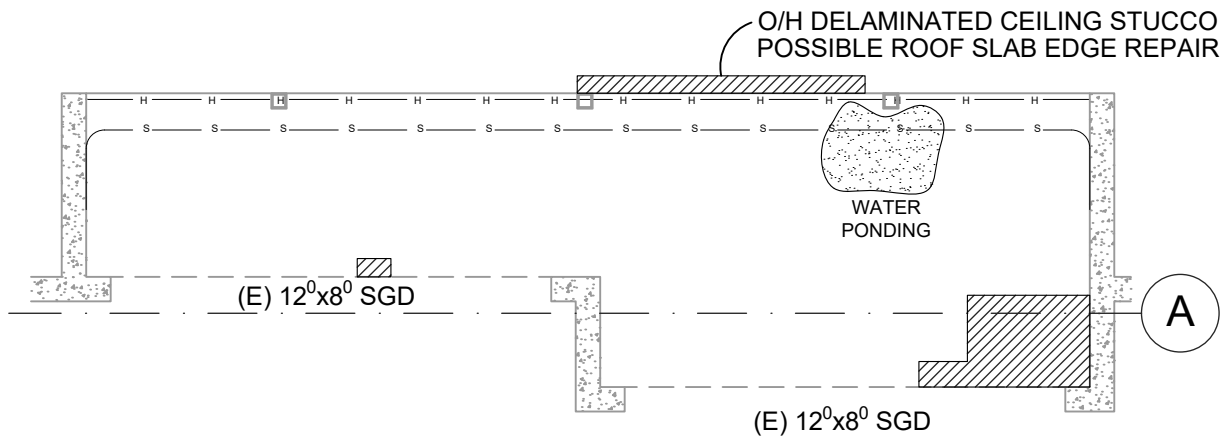
**UNIT 2404**

- **Unit 2404:**
  - Identified a few evident hollow sounding floor overlay / topping area locations. The existing floor finishes directly over the identified hollow sounding floor surfaces should be removed to further verify and rule out the possibility of being actual concrete slab spalling.

- Identified a large location of hollow sounding overhead ceiling plaster near the drip edge. Possibility of it being an actual roof concrete slab edge damage / repair. Remove and install new stucco / plaster.

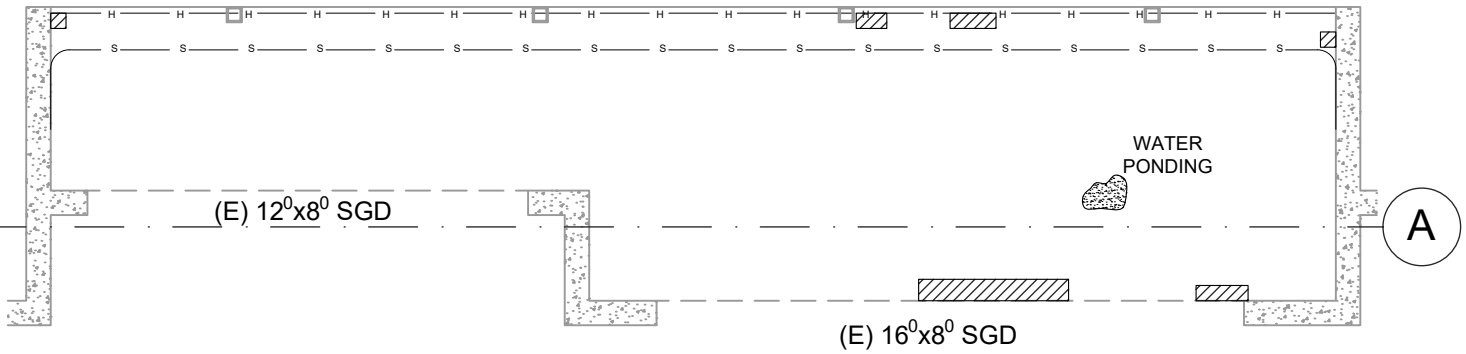
**UNIT 2405**

- For more information see attached findings drawings.
- **Unit 2405:**
  - Identified a few evident hollow sounding floor overlay / topping area locations. The existing floor finishes directly over the identified hollow sounding floor surfaces should be removed to further verify and rule out the possibility of being actual concrete slab spalling.
