STRUCTURAL REPORT

Lantana Oceanfront Condominiums Building 3 - 1831 Florida A1A Indian Harbour Beach, Florida 32937

Engineer's Project # 21-0530
January 26, 2022

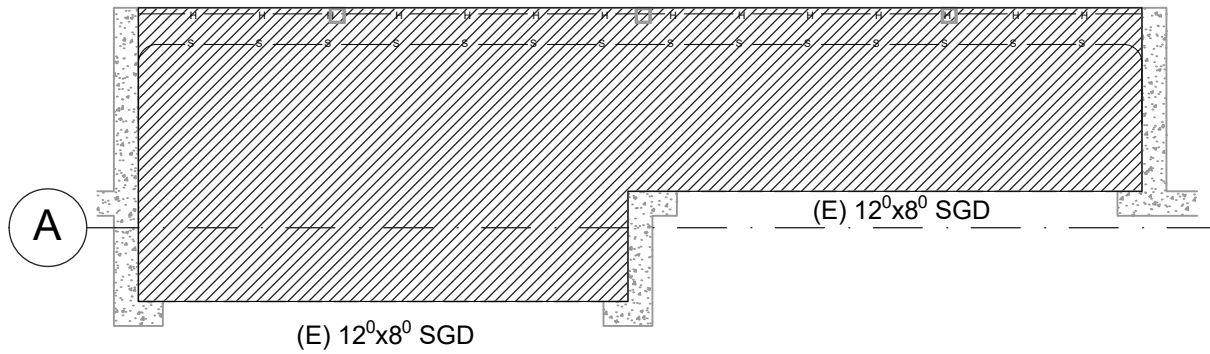
UNIT 3203

- **Unit 3203:**
 - The majority of the balcony floor cementitious topping was identified to be hollow sounding / delaminated from the substrate. A complete removal of the topping is recommended to verify the condition and integrity of the concrete substrate.
 - The slab pitch should be verified and corrected with the new topping to ensure the proper draining away of water.
 - For more information see attached findings drawings.

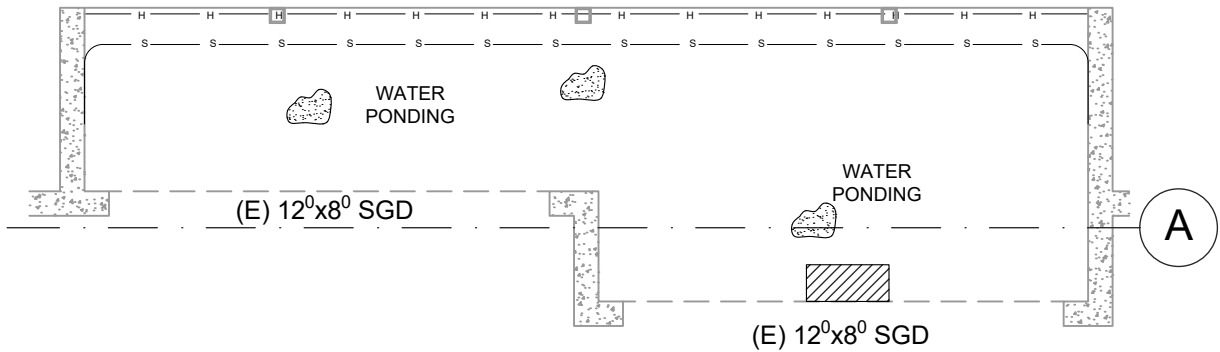
UNIT 3204

- **Unit 3204:**
 - Identified a few evident hollow sounding floor overlay / topping area locations. The existing floor finishes directly over the identified hollow sounding floor surfaces should be removed to further verify and rule out the possibility of being actual concrete slab spalling.
 - Observed water ponding locations. A slab pitch correction to these locations is recommended to ensure the proper draining away of water.
 - For more information see attached findings drawings.

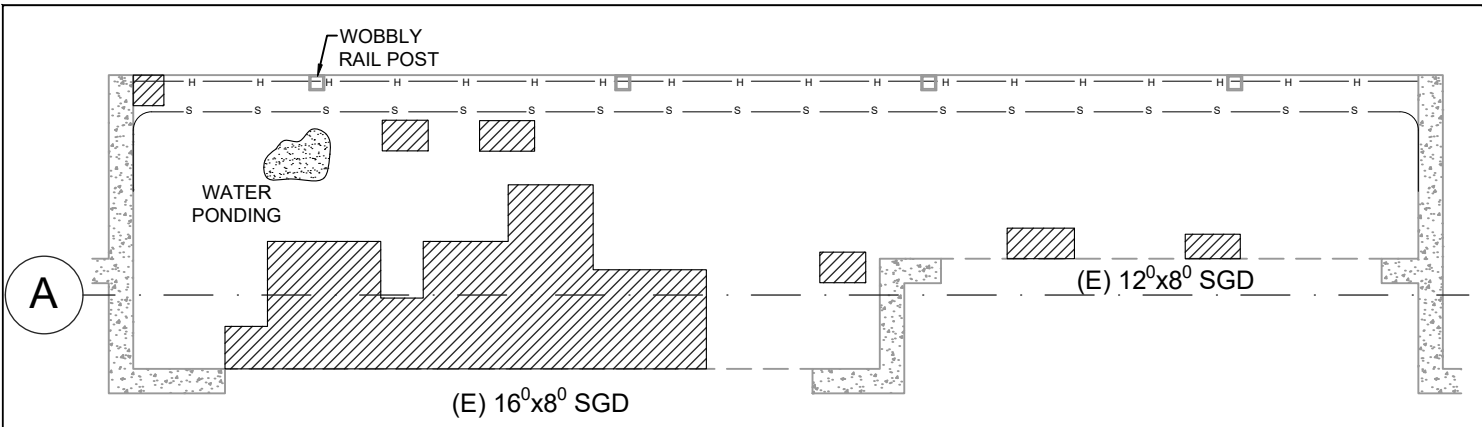
UNIT 3302

- **Unit 3302:**
 - Identified several evident hollow sounding floor overlay / topping area locations. The existing floor finishes directly over the identified hollow sounding floor surfaces should be removed to further verify and rule out the possibility of being actual concrete slab spalling.
 - A slab pitch verification / correction to the above locations is recommended to ensure the proper draining away of water.
 - For more information see attached findings drawings.

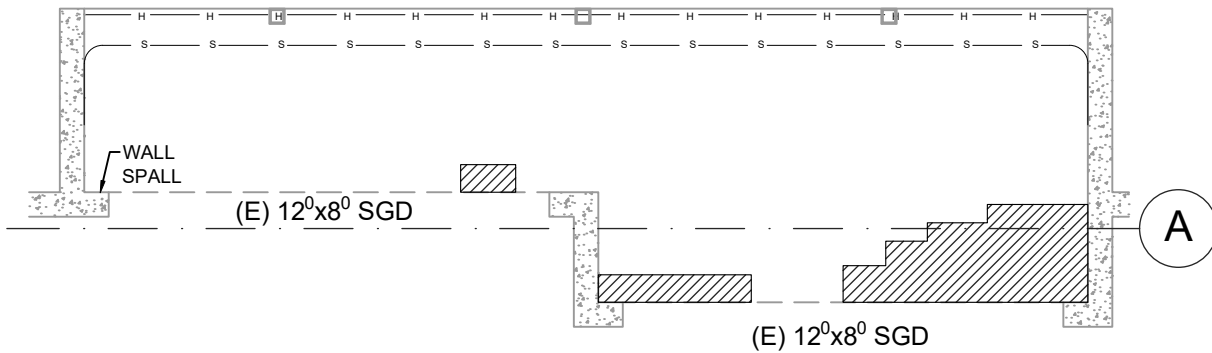
UNIT 3304

- **Unit 3304:**
 - Identified several evident hollow sounding floor overlay / topping area locations. The existing floor finishes directly over the identified hollow sounding floor surfaces should be removed to further verify and rule out the possibility of being actual concrete slab spalling.
 - For more information see attached findings drawings.

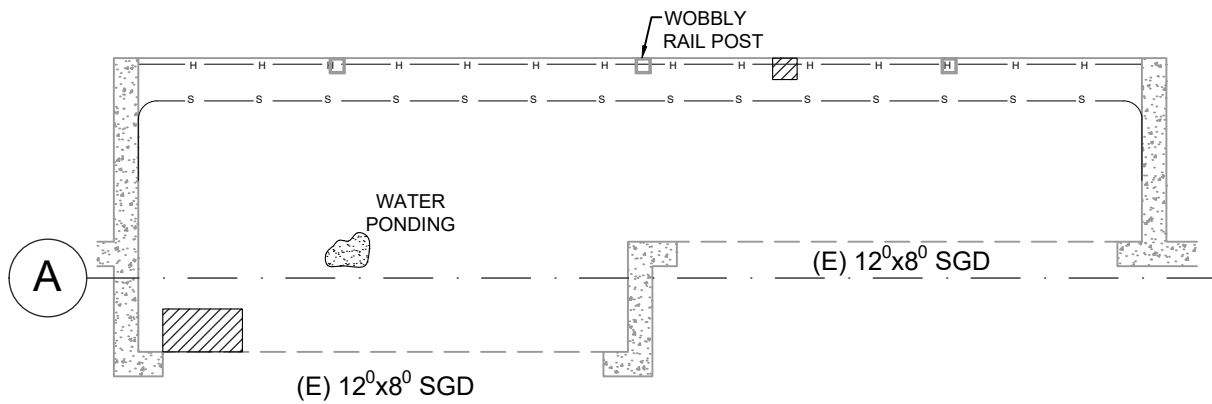
UNIT 3403

- **Unit 3403:**
 - Identified a few evident hollow sounding floor overlay / topping area locations. The existing floor finishes directly over the identified hollow sounding floor surfaces should be removed to further verify and rule out the possibility of being actual concrete slab spalling.
 - For more information see attached findings drawings.

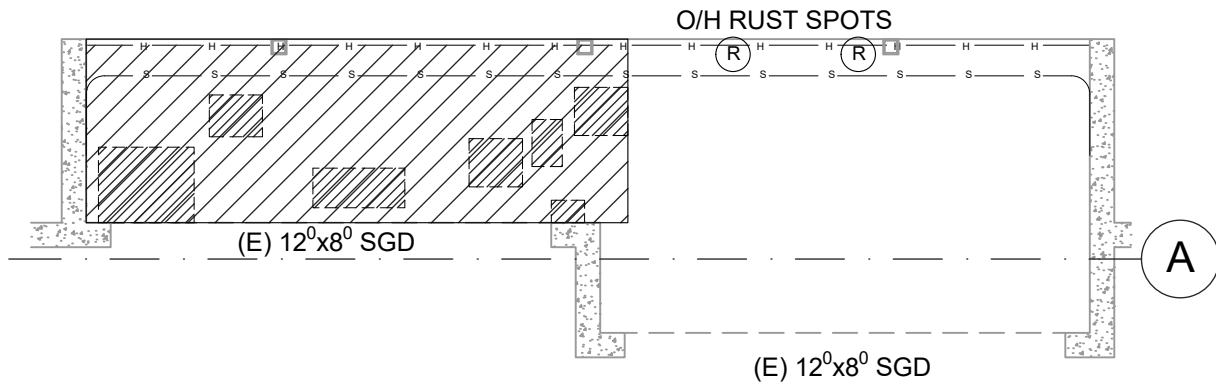
UNIT 3404

- **Unit 3404:**
 - Identified several evident hollow sounding floor overlay / topping area locations. The existing floor finishes directly over the identified hollow sounding floor surfaces should be removed to further verify and rule out the possibility of being actual concrete slab spalling.

- A slab pitch verification / correction to the above locations is recommended to ensure the proper draining away of water.
- For more information see attached findings drawings.

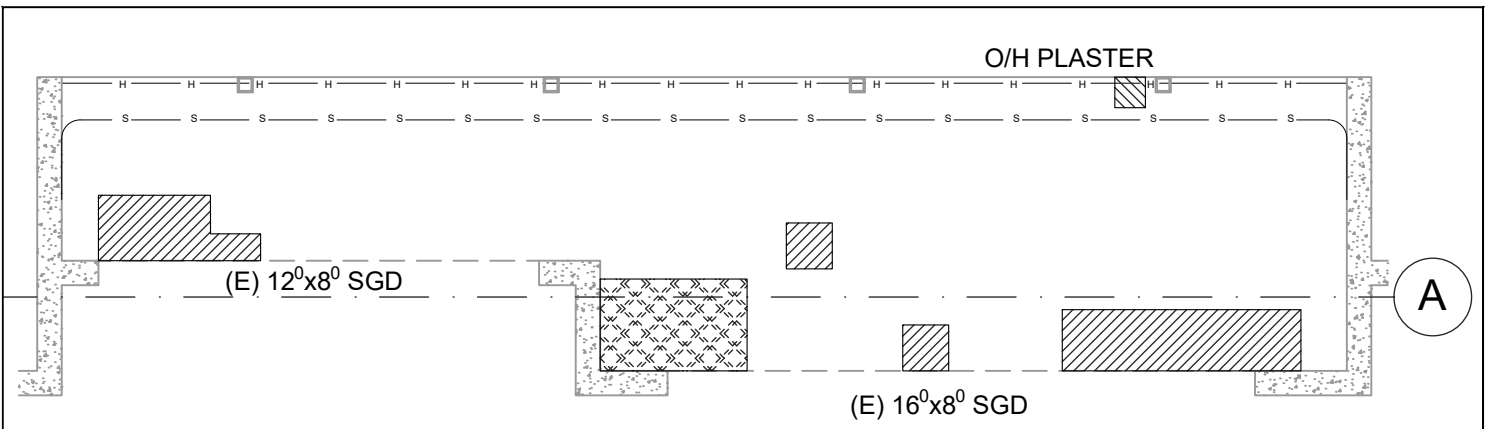
UNIT 3405

- **Unit 3405:**
 - Possible concrete spall located by the north interior corner in front of the living room. This area is directly aligned with the band group of tendons (N-S orientation) along column grid line A. Both banded tendons and uniform tendons (E-W orientation) may be impacted if located directly over the possible slab spalling/repair areas, and may require de-tensioning / re-tensioning to allow the slab concrete repairs.

- Identified several evident hollow sounding floor overlay / topping area locations. The existing floor finishes directly over the identified hollow sounding floor surfaces should be removed to further verify and rule out the possibility of being actual concrete slab spalling.
