# STRUCTURAL REPORT

## Lantana Oceanfront Condominiums Building 4 - 1851 Florida A1A Indian Harbour Beach, Florida 32937

Engineer's Project # 21-0530  
January 6, 2022

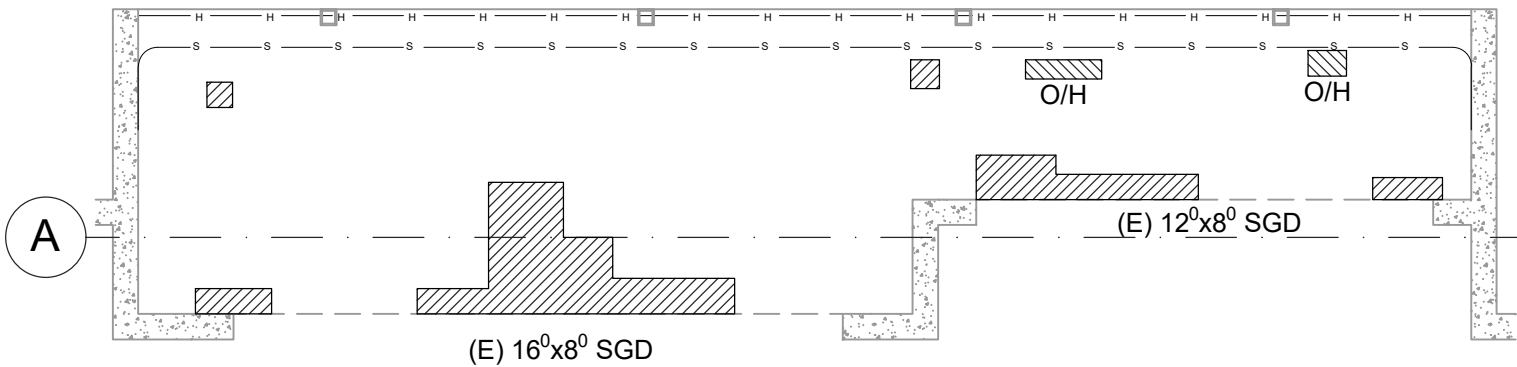
**UNIT 4202**

- **Unit 4202**
  - Identified several evident hollow sounding floor overlay / topping area locations. The existing floor finishes directly over the identified hollow sounding floor surfaces should be removed to further verify and rule out the possibility of being actual concrete slab spalling.
  - Found a couple small area locations of hollow sounding overhead ceiling plaster near the top shutter track. Remove and install new stucco / plaster.
  - For more information see attached finding drawings.

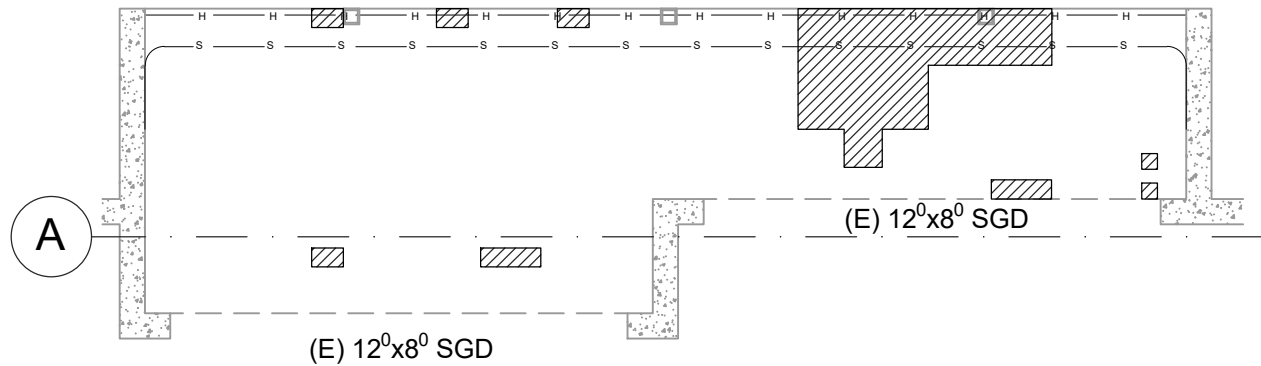
**UNIT 4203**

- **Unit 4203:**
  - Identified several evident hollow sounding floor overlay / topping area locations. The existing floor finishes directly over the identified hollow sounding floor surfaces should be removed to further verify and rule out the possibility of being actual concrete slab spalling.
  - For more information see attached finding drawings.

- REMOVABLE COMPOSITE TILE.
- BRAND NEW SHUTTERS.

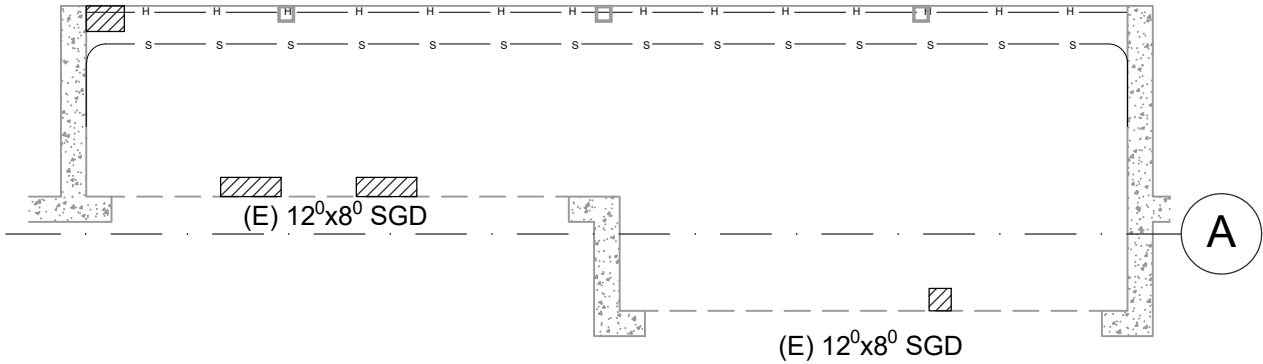
**UNIT 4204**

- **Unit 4204:**
  - Identified a few evident hollow sounding floor overlay / topping area locations. The existing floor finishes directly over the identified hollow sounding floor surfaces should be removed to further verify and rule out the possibility of being actual concrete slab spalling.
  - For more information see attached finding drawings.

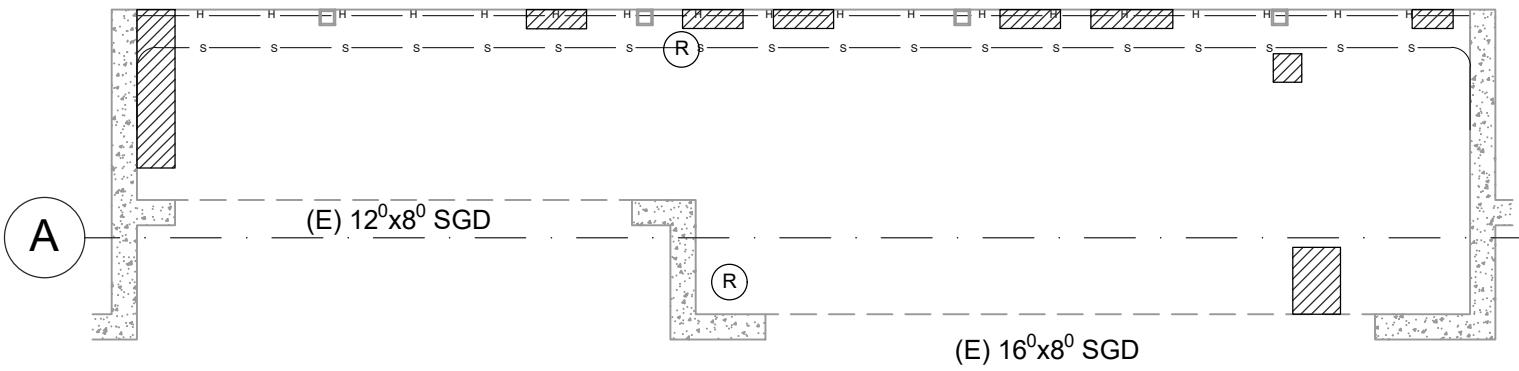
**UNIT 4205**

- **Unit 4205:**
  - Identified several evident hollow sounding floor overlay / topping area locations. The existing floor finishes directly over the identified hollow sounding floor surfaces should be removed to further verify and rule out the possibility of being actual concrete slab spalling.
  - For more information see attached finding drawings.

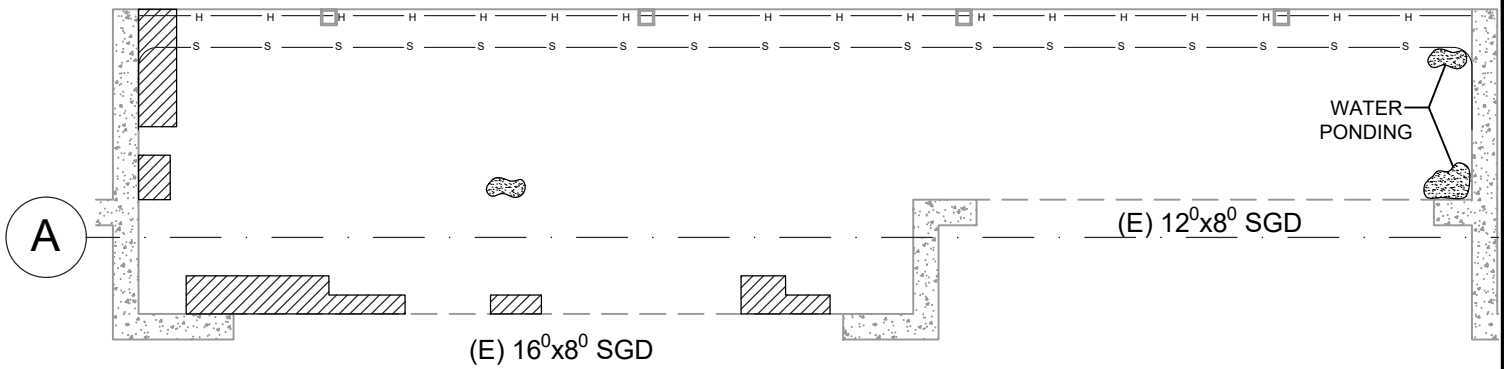
**UNIT 4302**

- **Unit 4302:**
  - Identified a slab concrete spall in the north end of the balcony under the shutter bottom track.
  - Identified several evident hollow sounding floor overlay / topping area locations. The existing floor finishes directly over the identified hollow sounding floor surfaces should be removed to further verify and rule out the possibility of being actual concrete slab spalling.
  - Observed water ponding locations. A pitch correction to these locations is recommended to ensure the proper draining away of water.
  - For more information see attached finding drawings.

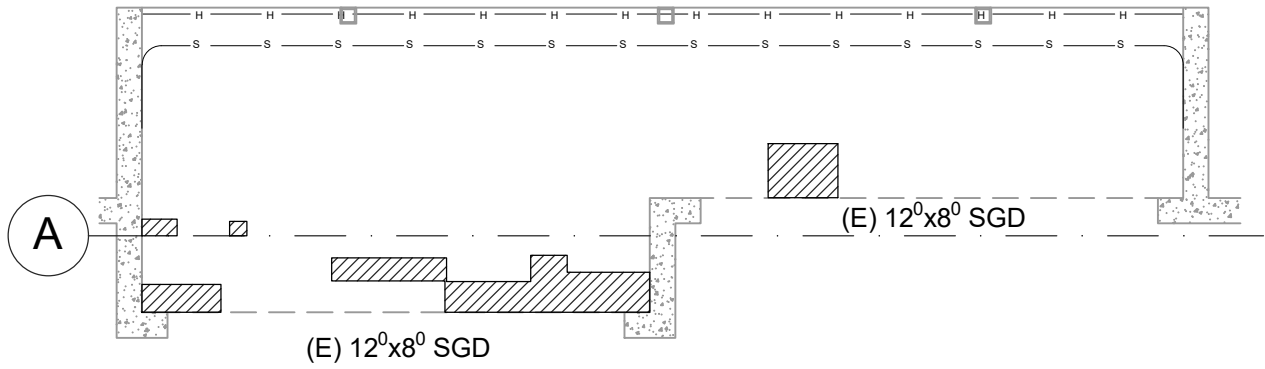
**UNIT 4303**

- **Unit 4303:**
  - Possible concrete spall located by the south interior corner in front of the living room. This area is directly aligned with the band group of tendons (N-S orientation) along column grid line A. Both banded tendons and uniform tendons (E-W orientation) may be impacted (and may require de-tensioning / re-tensioning to allow the slab concrete repairs) if located directly over the possible slab spalling/repair areas.
  - Identified several evident hollow sounding floor overlay / topping area locations. The existing floor finishes directly over the identified hollow sounding floor surfaces should be removed to further verify and rule out the possibility of being actual concrete slab spalling.
  - For more information see attached finding drawings.

- PAINT DECK PEELING/BLISTER.
- ABANDONED WALL SCREWS OH.

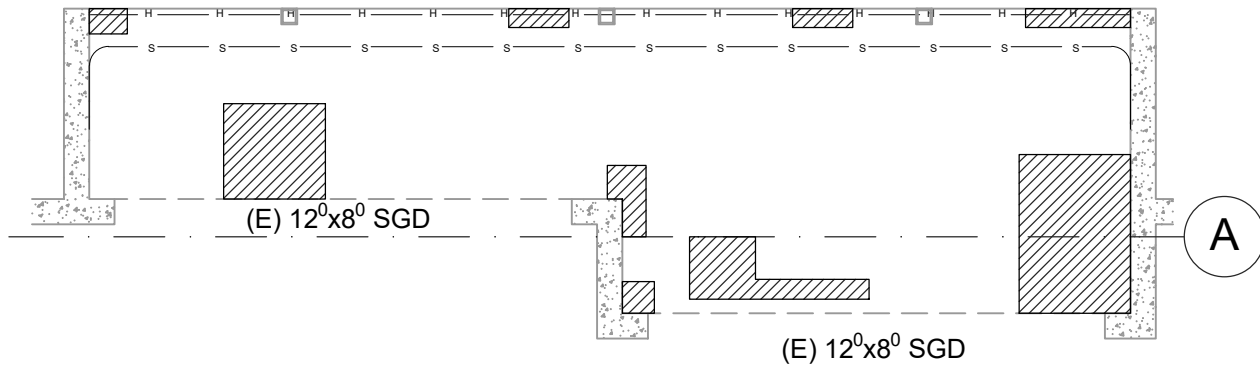
**UNIT 4304**

- **Unit 4304:**
  - Possible concrete spall located by the north interior corner in front of the living room. This area is directly aligned with the band group of tendons (N-S orientation) along column grid line A. Both banded tendons and uniform tendons (E-W orientation) may be impacted (and may require de-tensioning / re-tensioning to allow the slab concrete repairs) if located directly over the possible slab spalling/repair areas.
  - Identified several evident hollow sounding floor overlay / topping area locations. The existing floor finishes directly over the identified hollow sounding floor surfaces should be removed to further verify and rule out the possibility of being actual concrete slab spalling.
  - For more information see attached finding drawings.

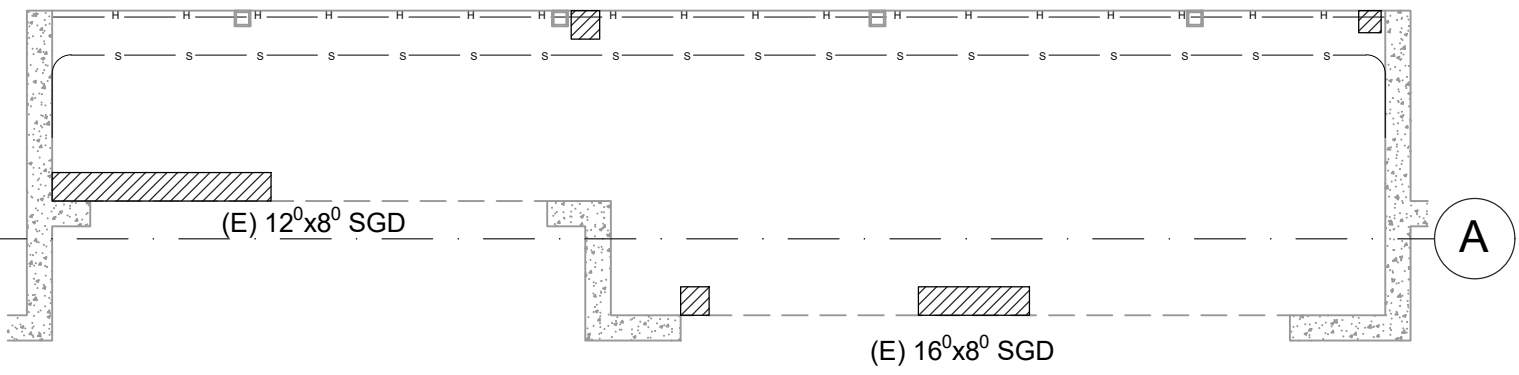
**UNIT 4305**

- **Unit 4305:**
  - Identified several evident hollow sounding floor overlay / topping area locations. The existing floor finishes directly over the identified hollow sounding floor surfaces should be removed to further verify and rule out the possibility of being actual concrete slab spalling.
  - For more information see attached finding drawings.

- SHUTTER PINS ARE DAMAGED.
- SHUTTERS TOP TRACK ABANDONED SCREWS.

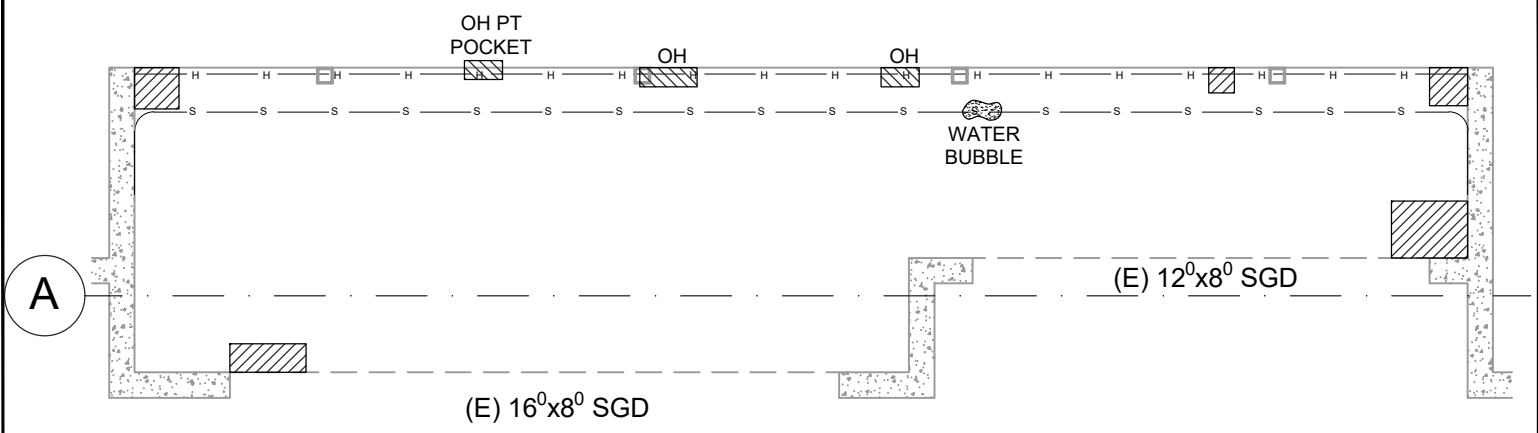
**UNIT 4402**

- **Unit 4402:**
  - Identified several evident hollow sounding floor overlay / topping area locations. The existing floor finishes directly over the identified hollow sounding floor surfaces should be removed to further verify and rule out the possibility of being actual concrete slab spalling.
  - Identified a couple locations of hollow sounding overhead ceiling plaster near the drip edge. Remove and install new stucco / plaster.
  - For more information see attached finding drawings.

- SOME MISSING SCREWS ON SHUTTERS (TOP TRACK).
- BOTTOM TRACKS RAISED W/ SHIMS.
- PAINT BLISTER OH ROOF EDGE

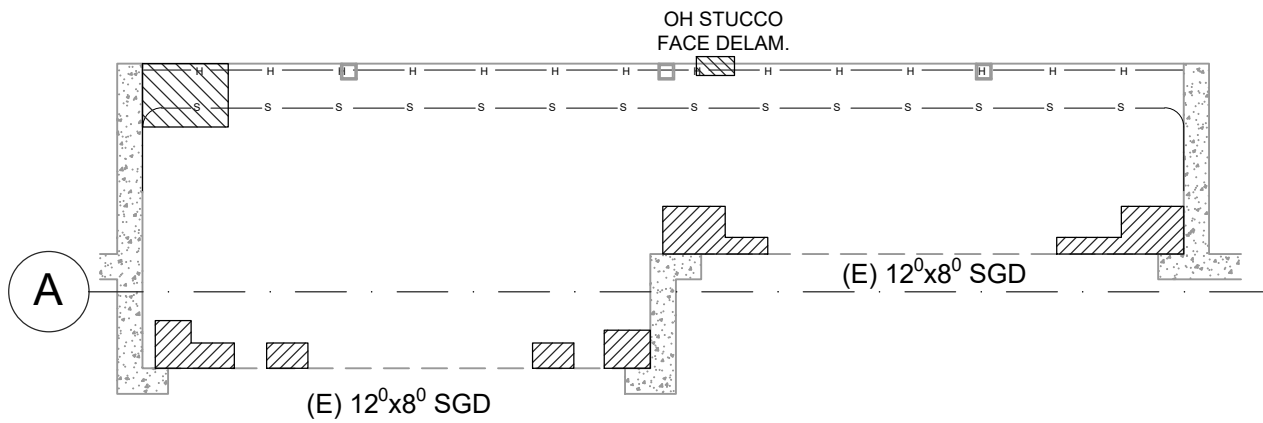
**UNIT 4403**

- **Unit 4403:**
  - Identified several evident hollow sounding floor overlay / topping area locations. The existing floor finishes directly over the identified hollow sounding floor surfaces should be removed to further verify and rule out the possibility of being actual concrete slab spalling.
  - Identified a location of hollow sounding overhead ceiling plaster near the drip edge. Remove and install new stucco / plaster.
  - For more information see attached finding drawings.

- SGD TOP TRACK CORRODED FASTENERS.
- MISSING SCREWS ON TOP TRACK.

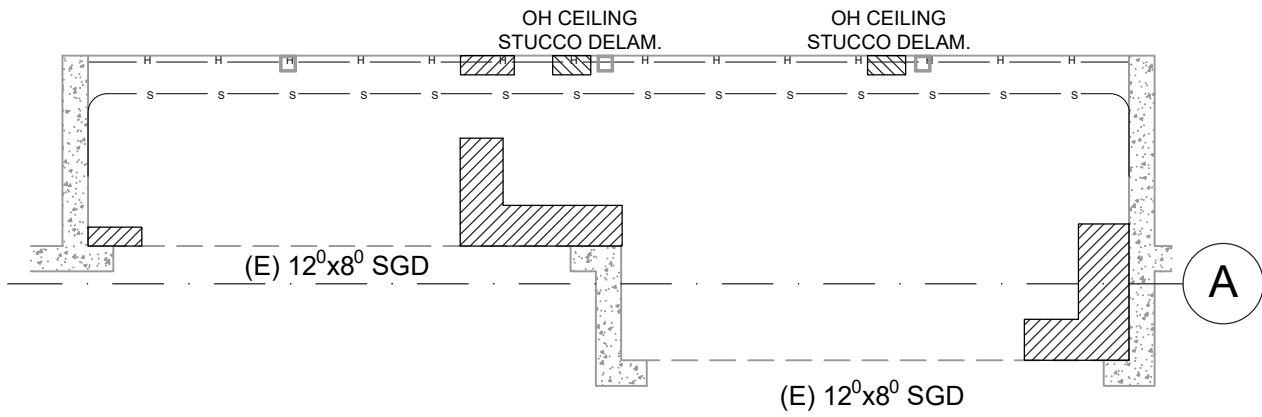
**UNIT 4404**

- **Unit 4404:**
  - Identified several evident hollow sounding floor overlay / topping area locations. The existing floor finishes directly over the identified hollow sounding floor surfaces should be removed to further verify and rule out the possibility of being actual concrete slab spalling.
  - Identified a couple locations of hollow sounding overhead ceiling plaster near the drip edge. Remove and install new stucco / plaster.
  - For more information see attached finding drawings.

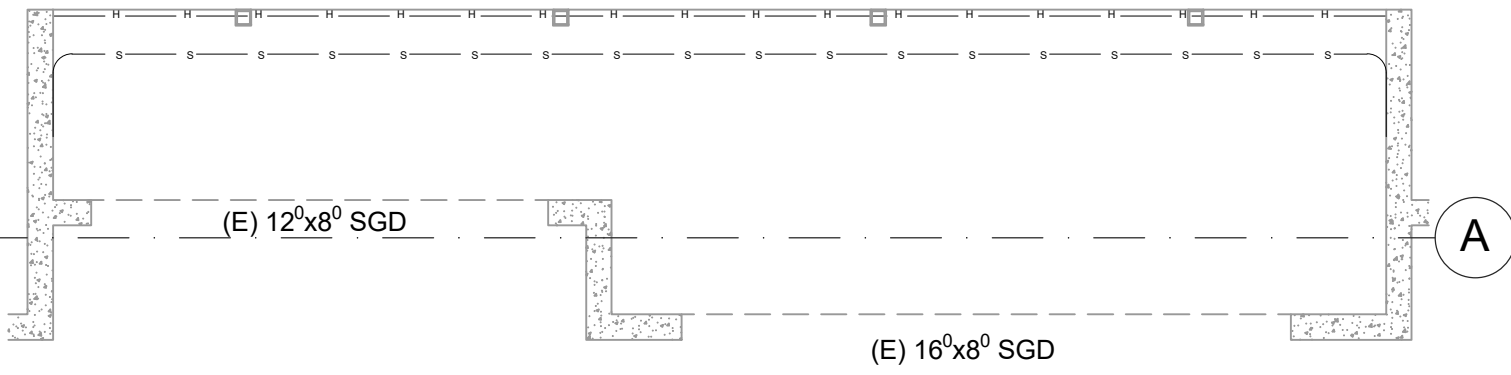
**UNIT 4405**

- **Unit 4405:**
  - The existing accordion shutters were closed at the time of the inspection. The edge of the slab was not accessible.
  - The interior floor and ceiling surfaces were checked and appear to be OK. No hollow sounding / delaminated surfaces observed.
  - For more information see attached finding drawings.

- PERIMETER SHUTTERS ARE CLOSED.
- PERIMETER SGD CAULKING MUST BE CHANGED.
