Long Term Balcony Protection

Long Term Balcony Protection Plan Blueprint 32 Outer and 64 Inner Lantana Units (Part 1)

January 26, 2022

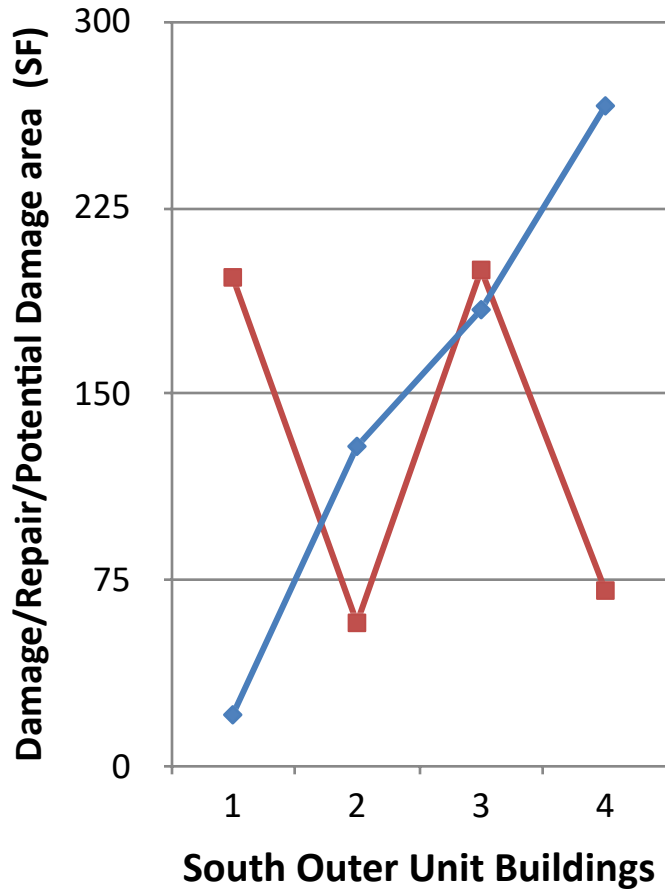
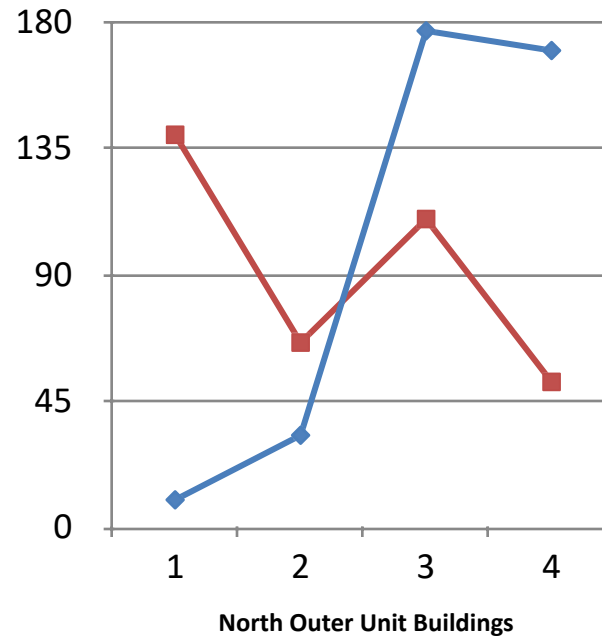
Figure 2. Comparison of Two Damage Assessments 2010 CRI (blue) and 2021 MBV (red) Damage Assessed in SF

- we will only know extent of real damage when we begin repairs in 2022
- Buildings having low damage repaired areas in 2010 had large potential damage sites in 2020; and buildings with large repaired damaged sites in 2010 had less potential problems in 2020 (Table 1 & Figure 2)

- 2010 CRI work clearly showed
 - buildings having no repair problems developed large potential problem areas in 2020
 - buildings with large repaired areas in 2010 had less potential damage areas in 2020/21 (Figure 2)

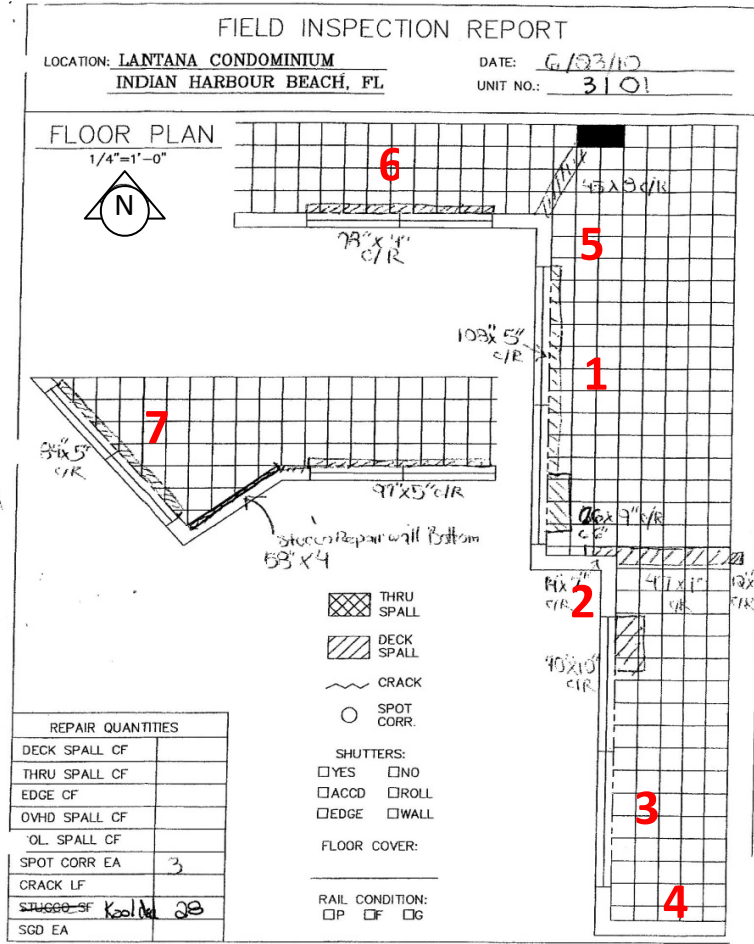
Figure 3. CRI Report

Damage/Repair Areas (SF) for Unit 3101 at Locations (1-7)

- 1 = 7.9
- 2 = 3.26
- 3 = 0.28
- 4 = 0
- 5 = 2.5
- 6 = 2.2
- 7 = 11.86
-
- Total 28. SF

- 1 - Large Slider (LS) PTC A
- 2 - Inside Corner (IC) PTC A
- 3 - Small Slider (SS)
- 4 - End Wall (EW)
- 5 - Outside Corner (OC) PTC A
- 6 - Outside Slider Facing North or South (OSN/S) PTC B
- 7 - Outside Angle Sliders (OAS)

- **A typical deck floor plan for an outer unit is shown in Figure 3**
 - based on CRI and MBV inspections, greatest stress was found at 7 critical locations noted in Figure 3

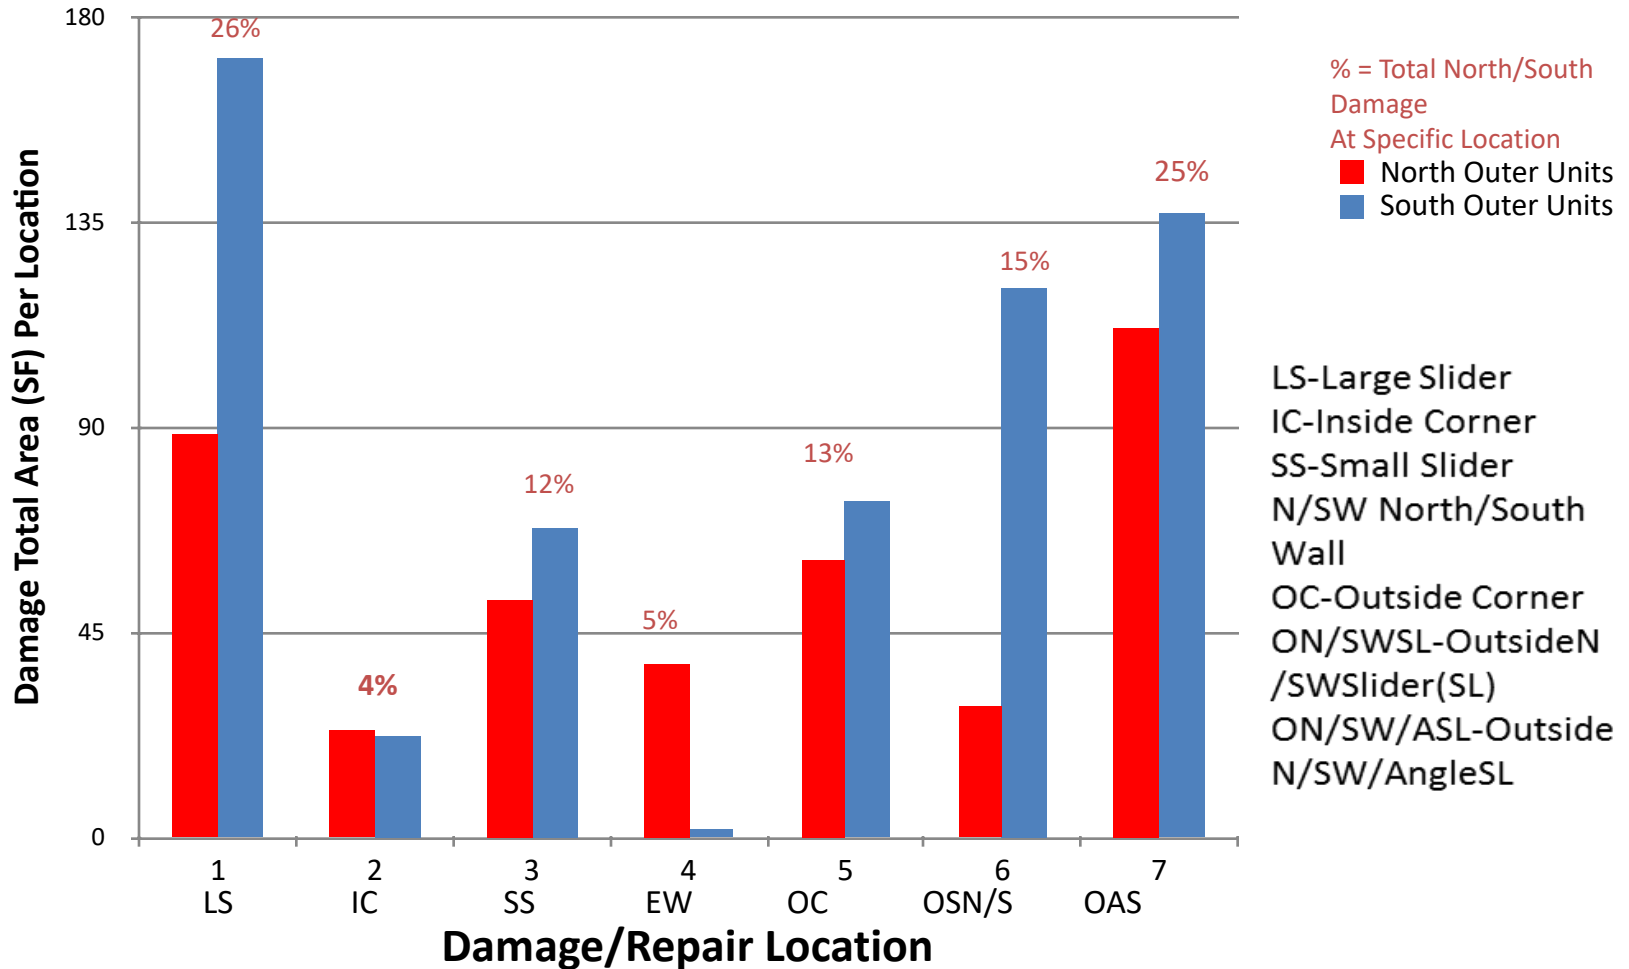
Figure 4. Outer Decks Analysis for 2010 CRI Data

- **Based on 2010 CRI damage/repair results, Figure 4 shows greatest damage occurred almost exclusively at these 7 critical locations**
 - statistically, South units had more damage than North units

- **Total damage for North and South outer units for all four building was 26% at location 1-LS (Large Glass Slider)**
 - total damages at locations 5-OC (outside Corner), 6-OSN/S (Outside Slider Facing North or South), & 7-OAS (Outside Angle Sliders) were 13%,15% and 25% respectively

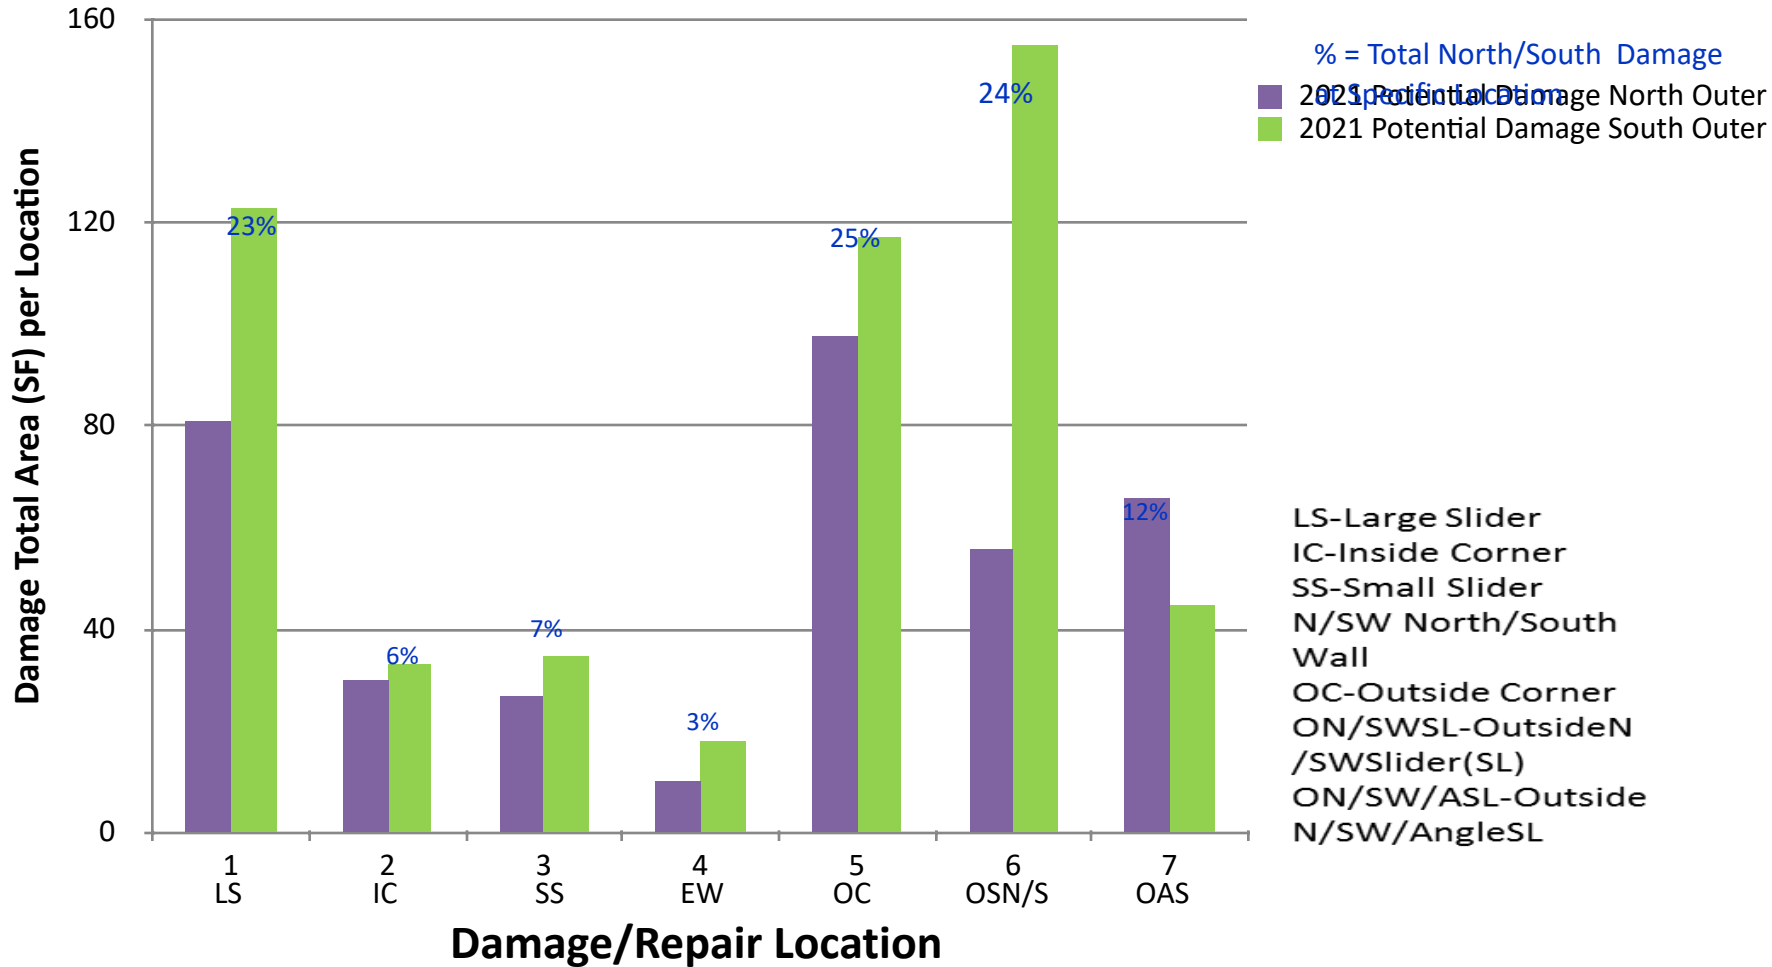
Figure 5. Outer Decks Analysis for 2021 MBV Data

- **In Figure 5 it is seen that greatest damage occurred at same locations for both South and North units, but with less damage in North units**
- **Total potential damage for all North/South units for all four buildings were 23% at Location 1-LS , 25% at Location 5-OC, 24% at Location 6-OSN/S and 13% at Location 7-OAS**

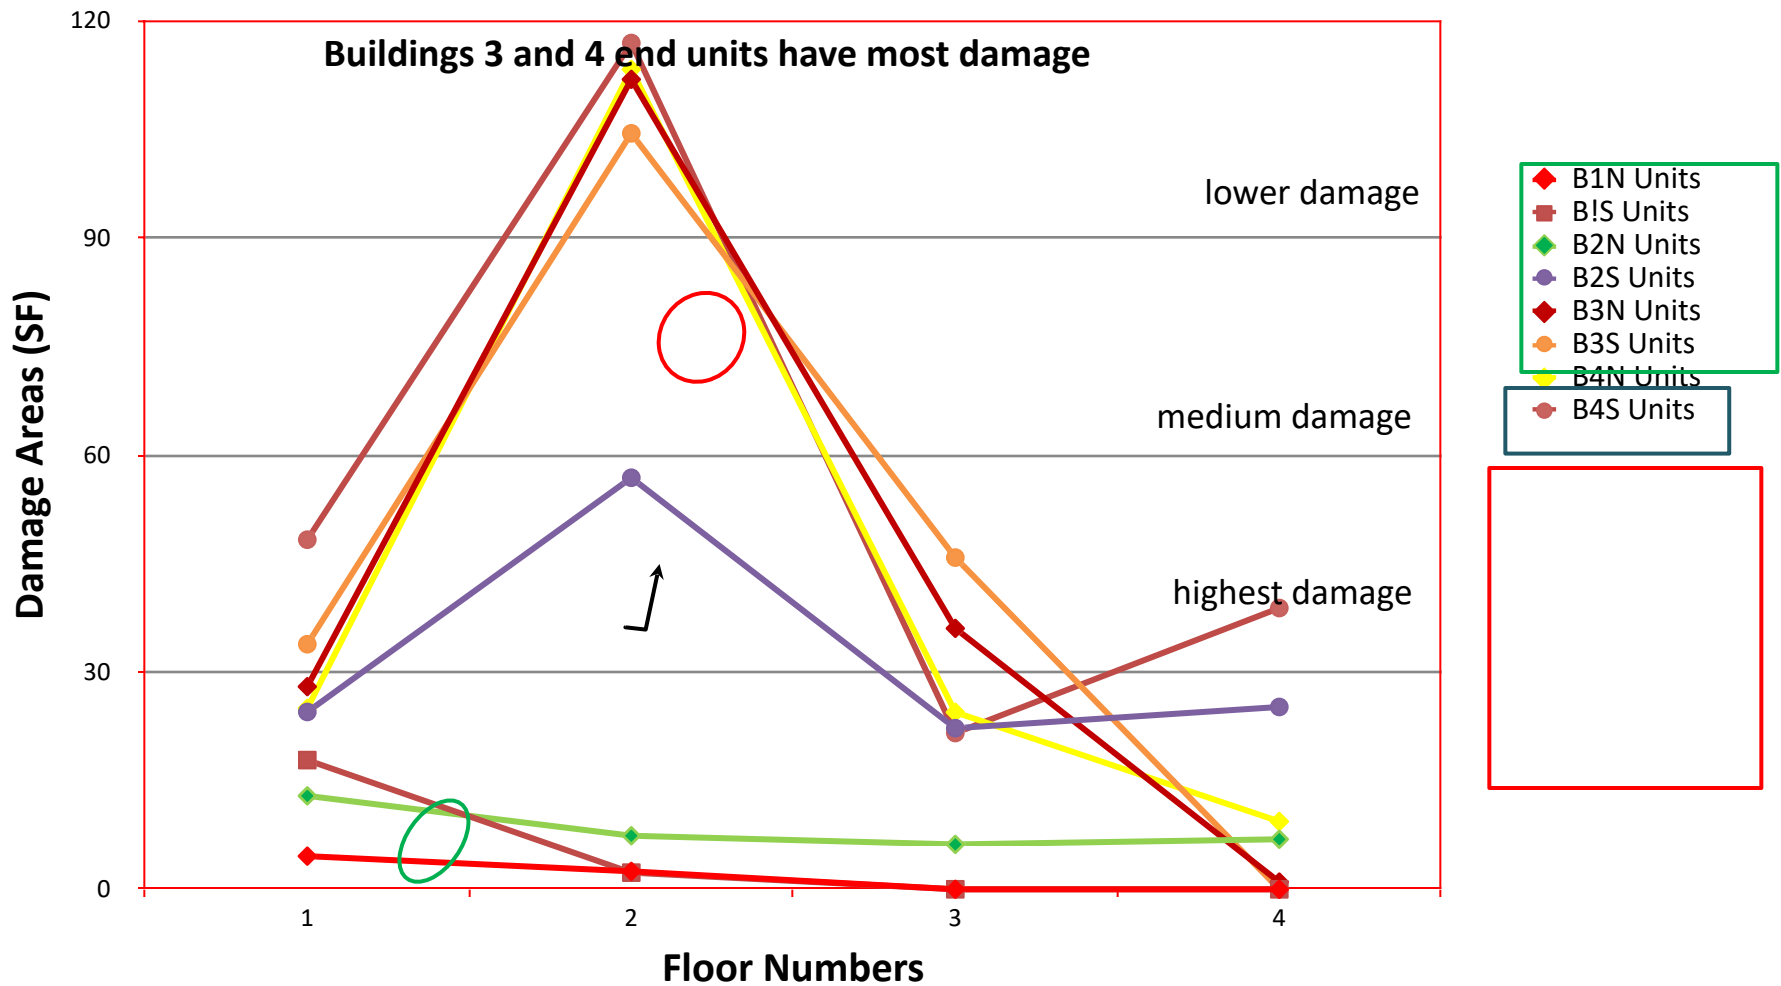
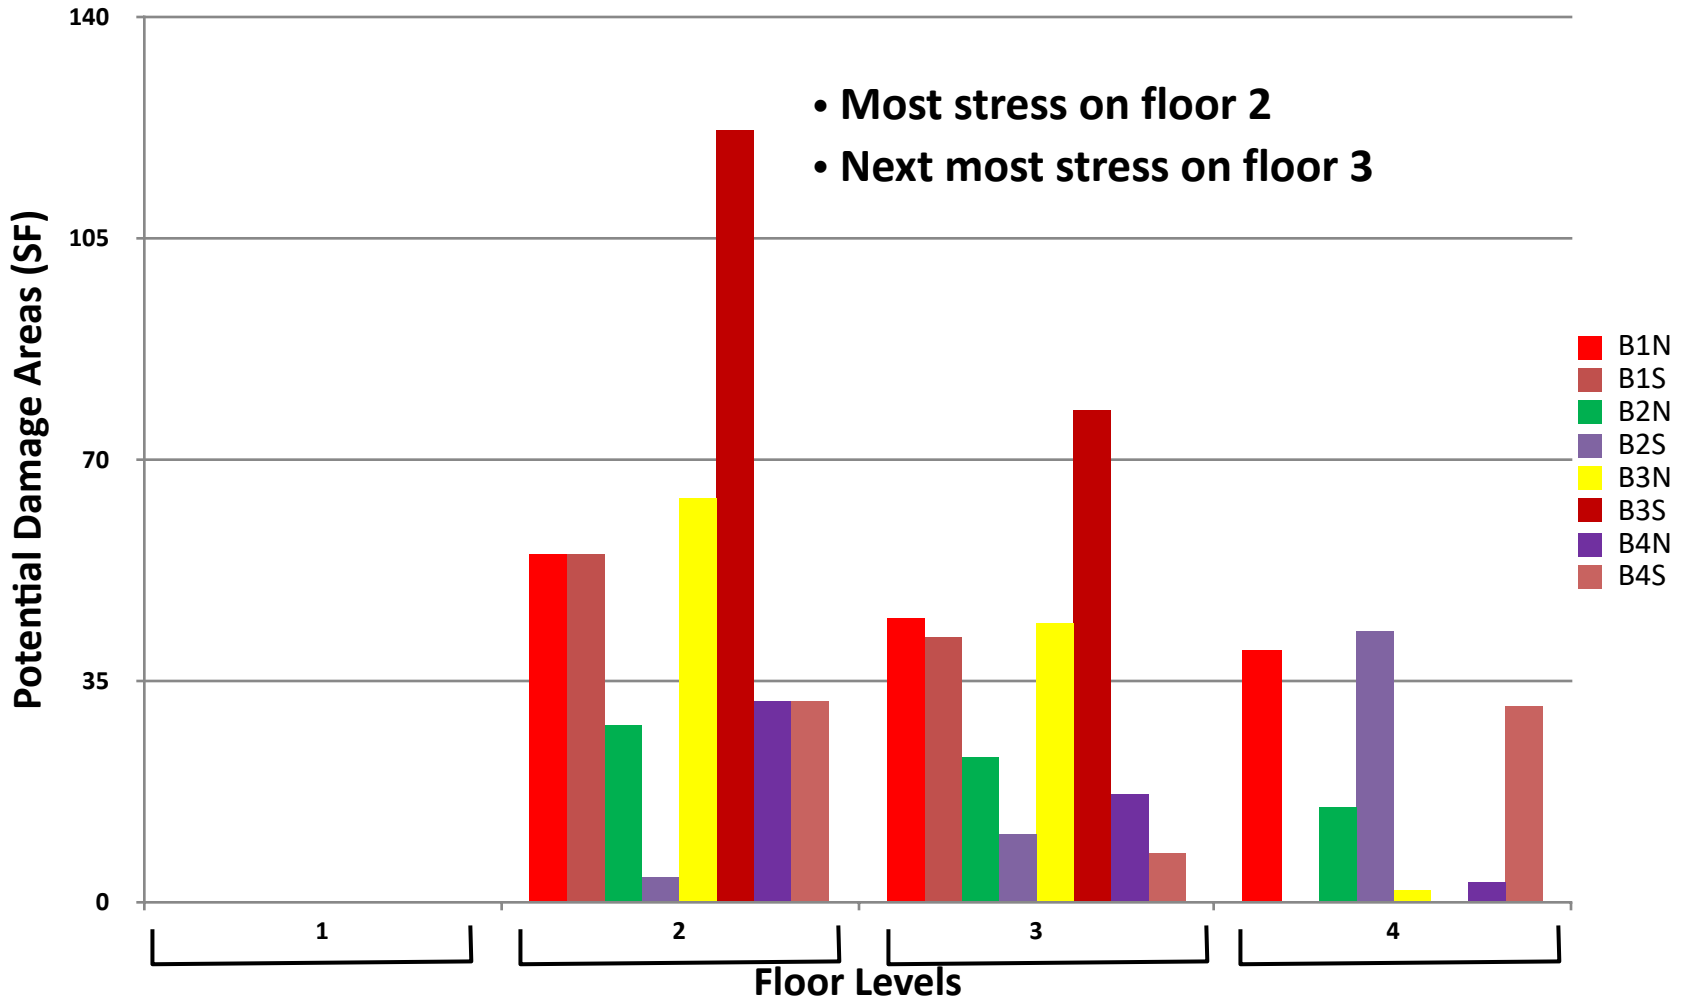
Figure 6. CRI 2010

- **Figures 6 (CRI) and 7 (MBV) confirm: greatest amount of damage or potential problems happen on second floors in all 4 buildings**

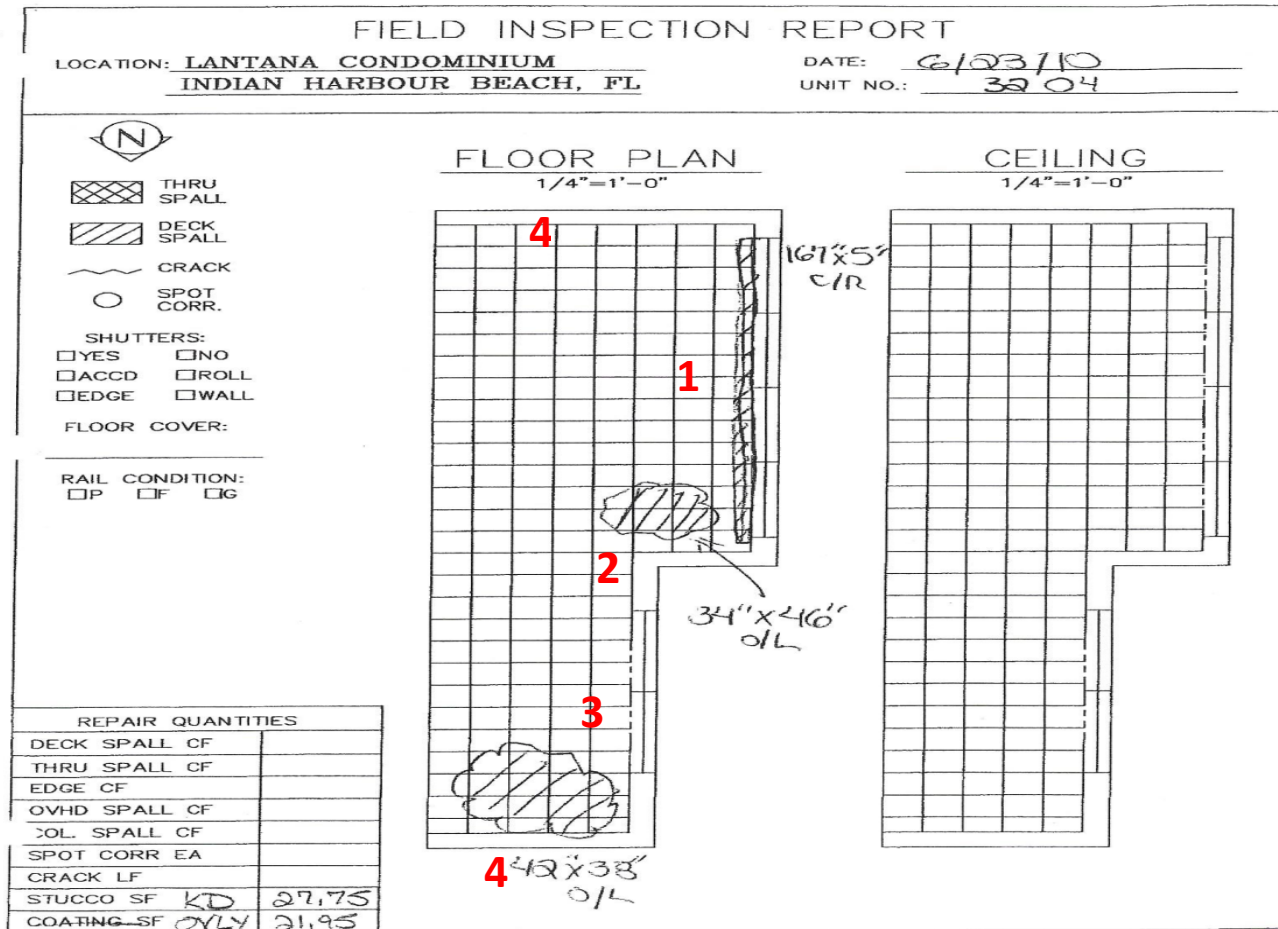
Figure 9. Inner Unit Damage/Repair Areas

Inner Unit 3204, Locations 1 - 4

- 1-Large Slider (LS)
PTC A
- 2- Inside Corner (IC)
PTC A
- 3-Small Slider (SS)
- 4-End Walls (EW)
PTC A
- East/West PTC Lines

- For unit 3204, specific damage area/location are:
 - (1) 7.90 (SF)
 - (2) 3.26 (SF)
 - (3) 0.28 (SF)
 - (4) 0.00 (SF)
 - (5) 2.50 (SF)
 - (6) 2.20 (SF)
 - (7) 11.86 (SF)

28. (SF) as reported
- All CRI damage/repair operations for inner units were identical to CRI outer unit operations
- Water penetration of paint into Kool Deck stucco caused cracks and debonding from concrete, and which required removal, new stucco and repainting
- This describes all problems which required attention

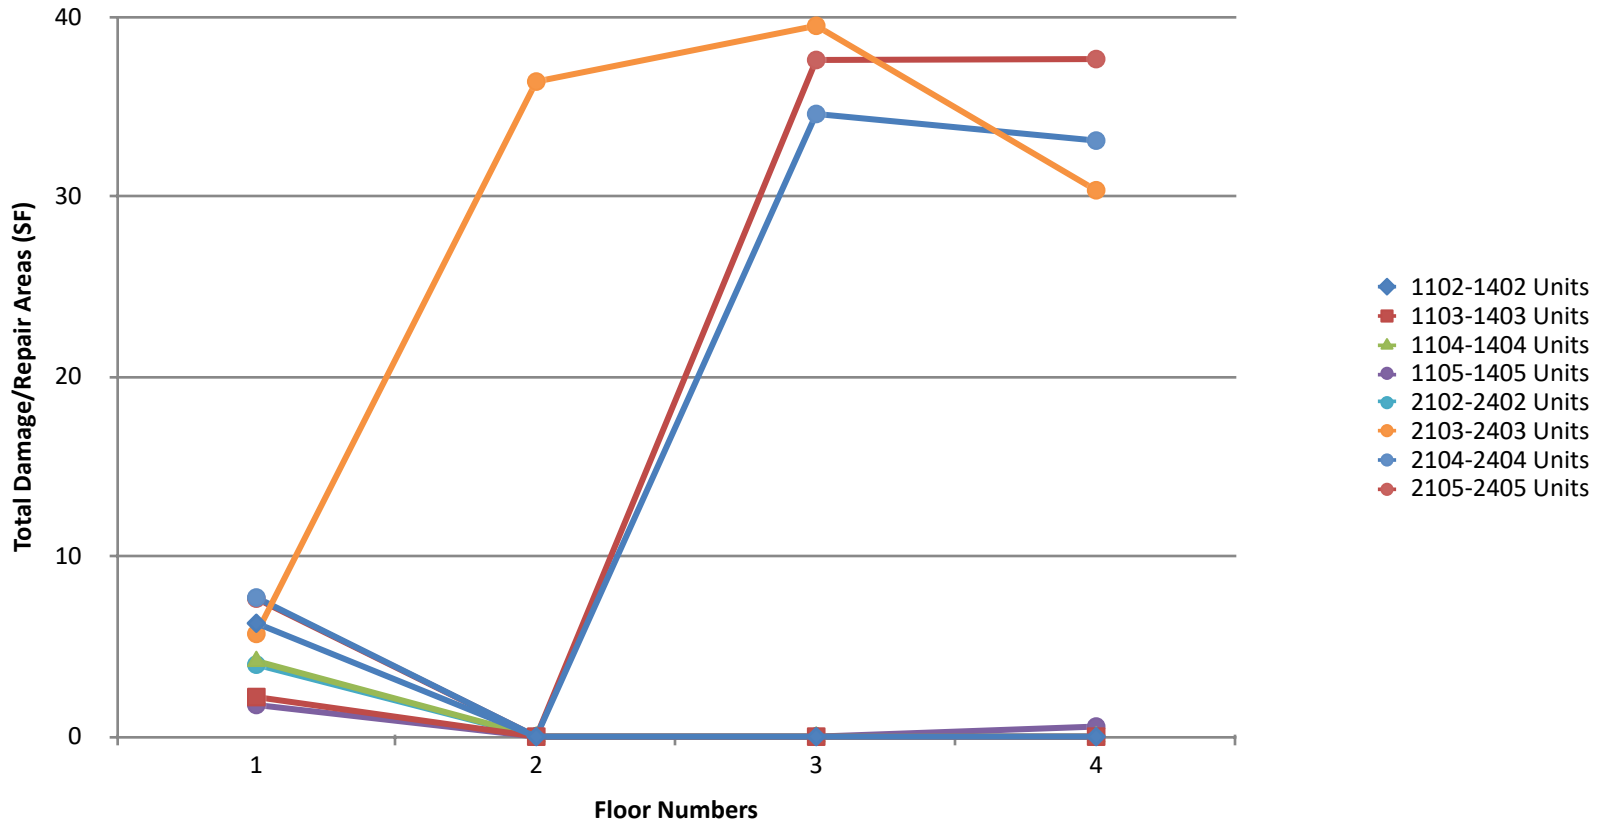
Figure 11.

Graphical Analysis of Total Damage/Repair Areas (SF) for Each Floor of 16 Inner Units of Buildings 1 and 2

- **Figure 11 is a graphical representation of Tables 11 - 14**
- **Figures 11 and 12 show amount of damage occurring on all floors for all inner units and buildings**
 - **Floors 2 and 3 had most damage**
- **B4 floor 2 - 179 SF, Floor 3- 120 SF, floor 1- 82 SF and floor 4- 67 SF**
- **B3 floor 2 - 154 SF, floor 3- 117 SF, floor 4- 91 SF and floor 1-67 SF**
- **B2 floor 3 - 112 SF, Floor 4- 104 SF, floor 2-35 SF, Floor 1-26 SF**
- **B1 floors 1- 46 SF**
- **Table 15 contain a direct comparison of same units damaged/repared by CRI and inspected by MBV (Table 15 is listed in Appendix B)**
 - **CRI problem areas had total a total value of 105 SF (locations 1, 2 and 3) while MBV total values were equal (105 SF) in locations 1, 3 and 4**

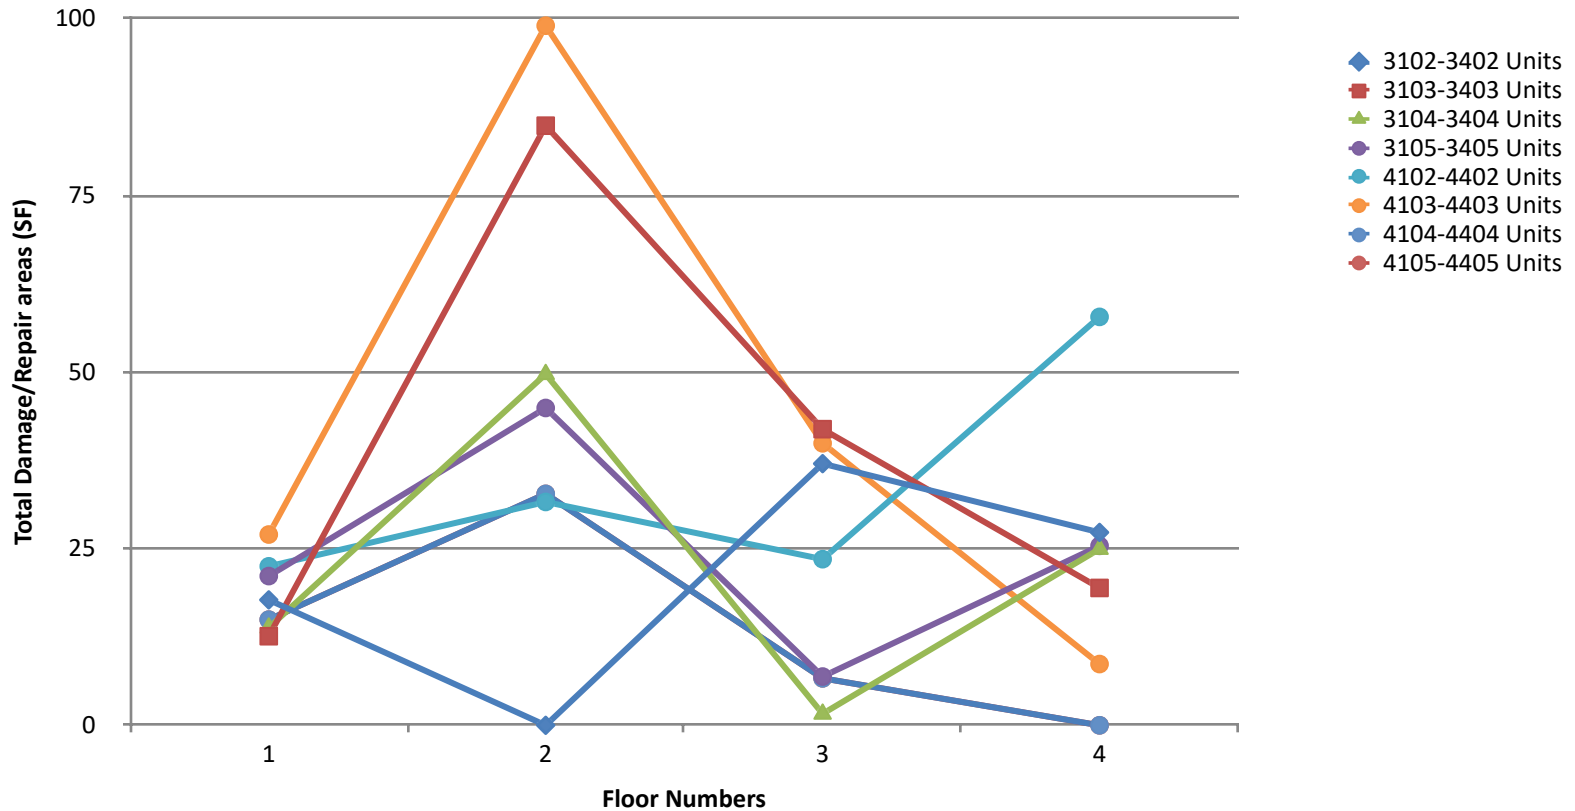
Figure 12.

Graphical Analysis of Total Damage/Repair Areas (SF) for Each Floor of 16 Inner Units of Buildings 3 and 4
