LANTANA
CONDOMINIUM
BALCONY INSPECTION
1791 A1A
INDIAN HARBOUR BEACH, FL

FINDINGS/REPAIRS

MBV
ENGINEERING, INC.
MOJA BOWLES VILLAMIZAR & ASSOCIATES
CONSULTING ENGINEERING CA #3728

JOB NO. 20-0374
DESIGNED JT
DRAWN AER
CHECKED RV
DATE NOV 2020
SHEET 1 OF 15

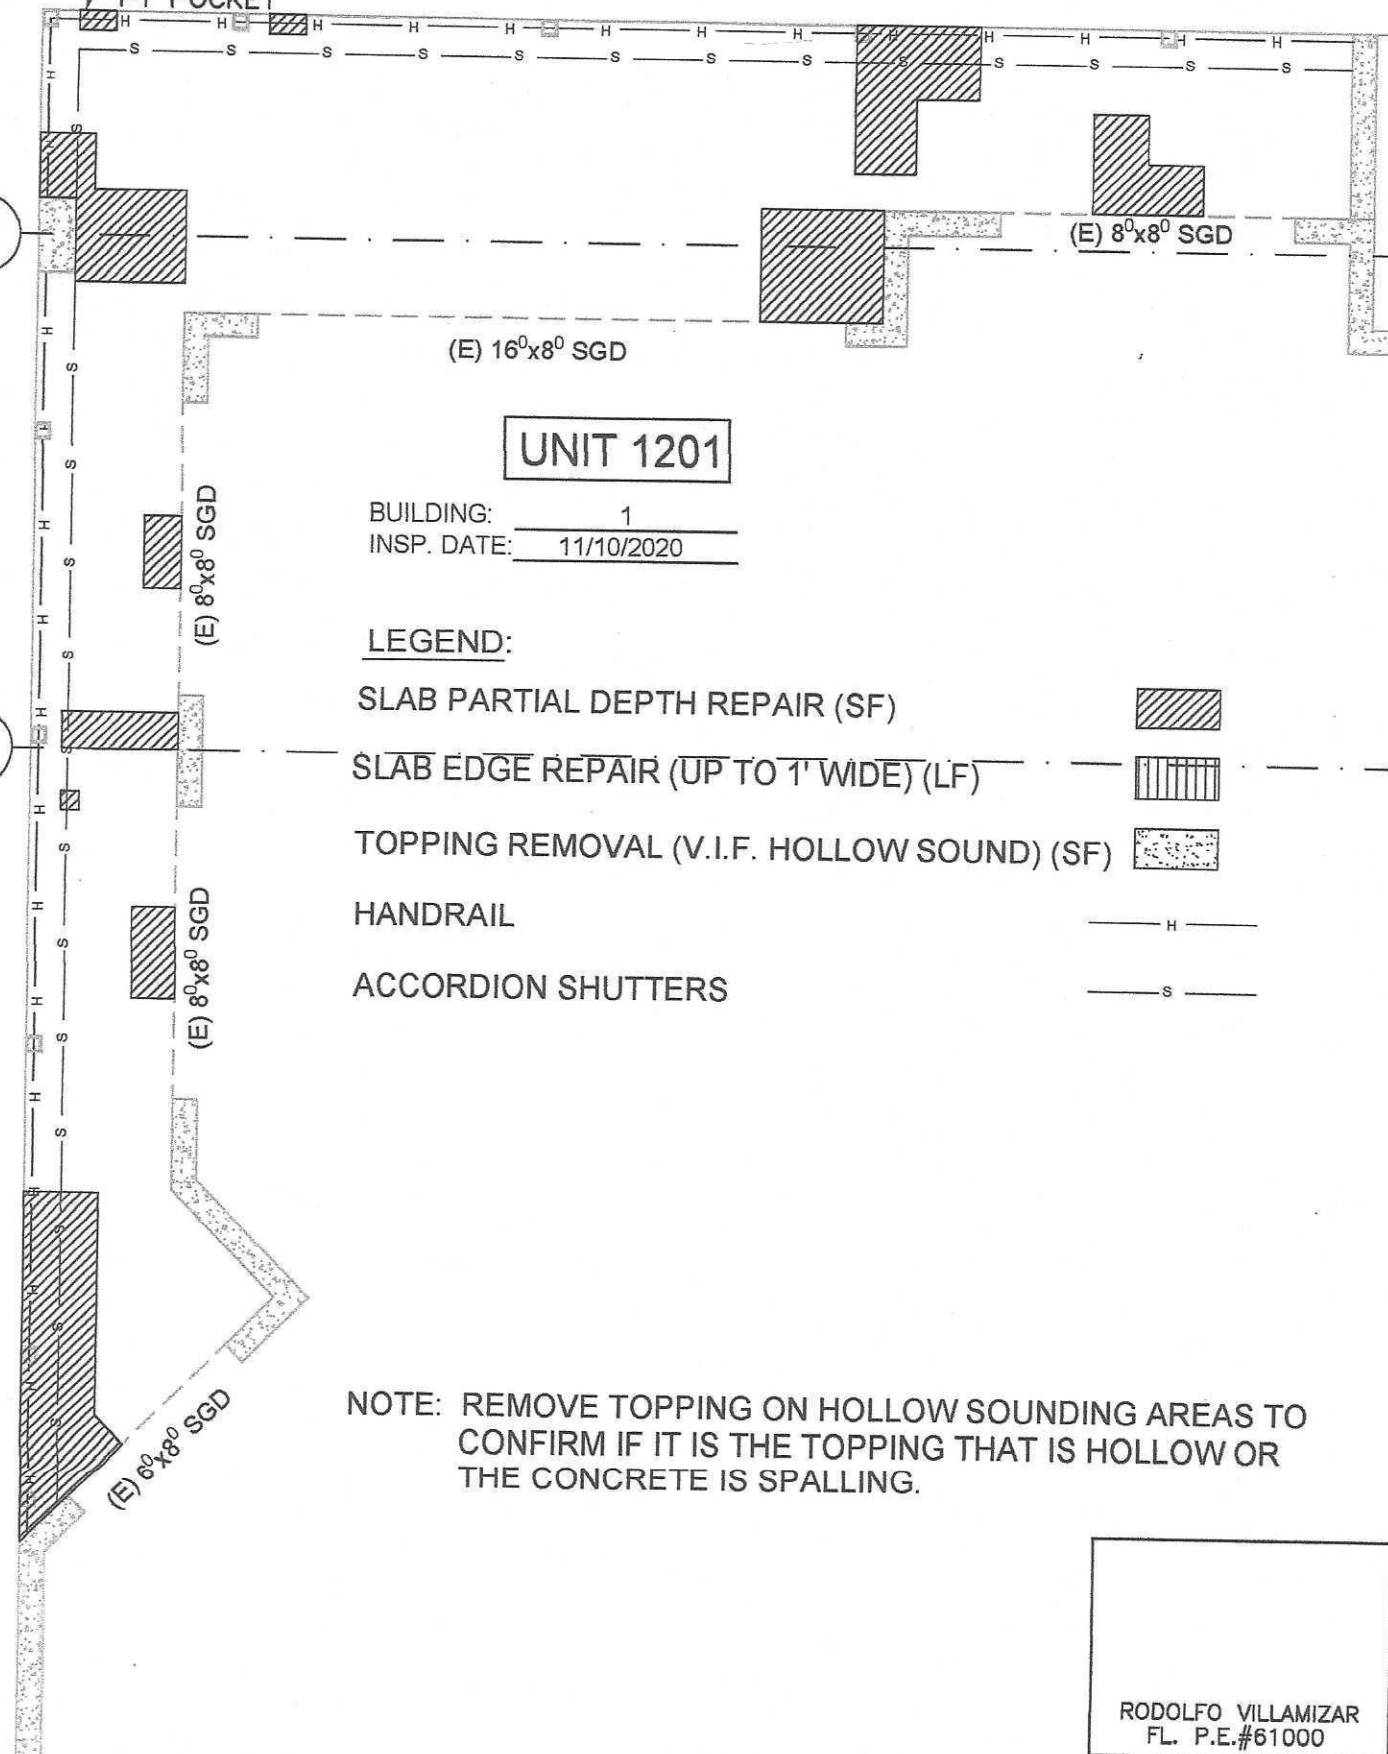
UNIT 1201

RS IN FACE
PT POCKET

A

B

NOTE: REMOVE TOPPING ON HOLLOW SOUNDING AREAS TO CONFIRM IF IT IS THE TOPPING THAT IS HOLLOW OR THE CONCRETE IS SPALLING.

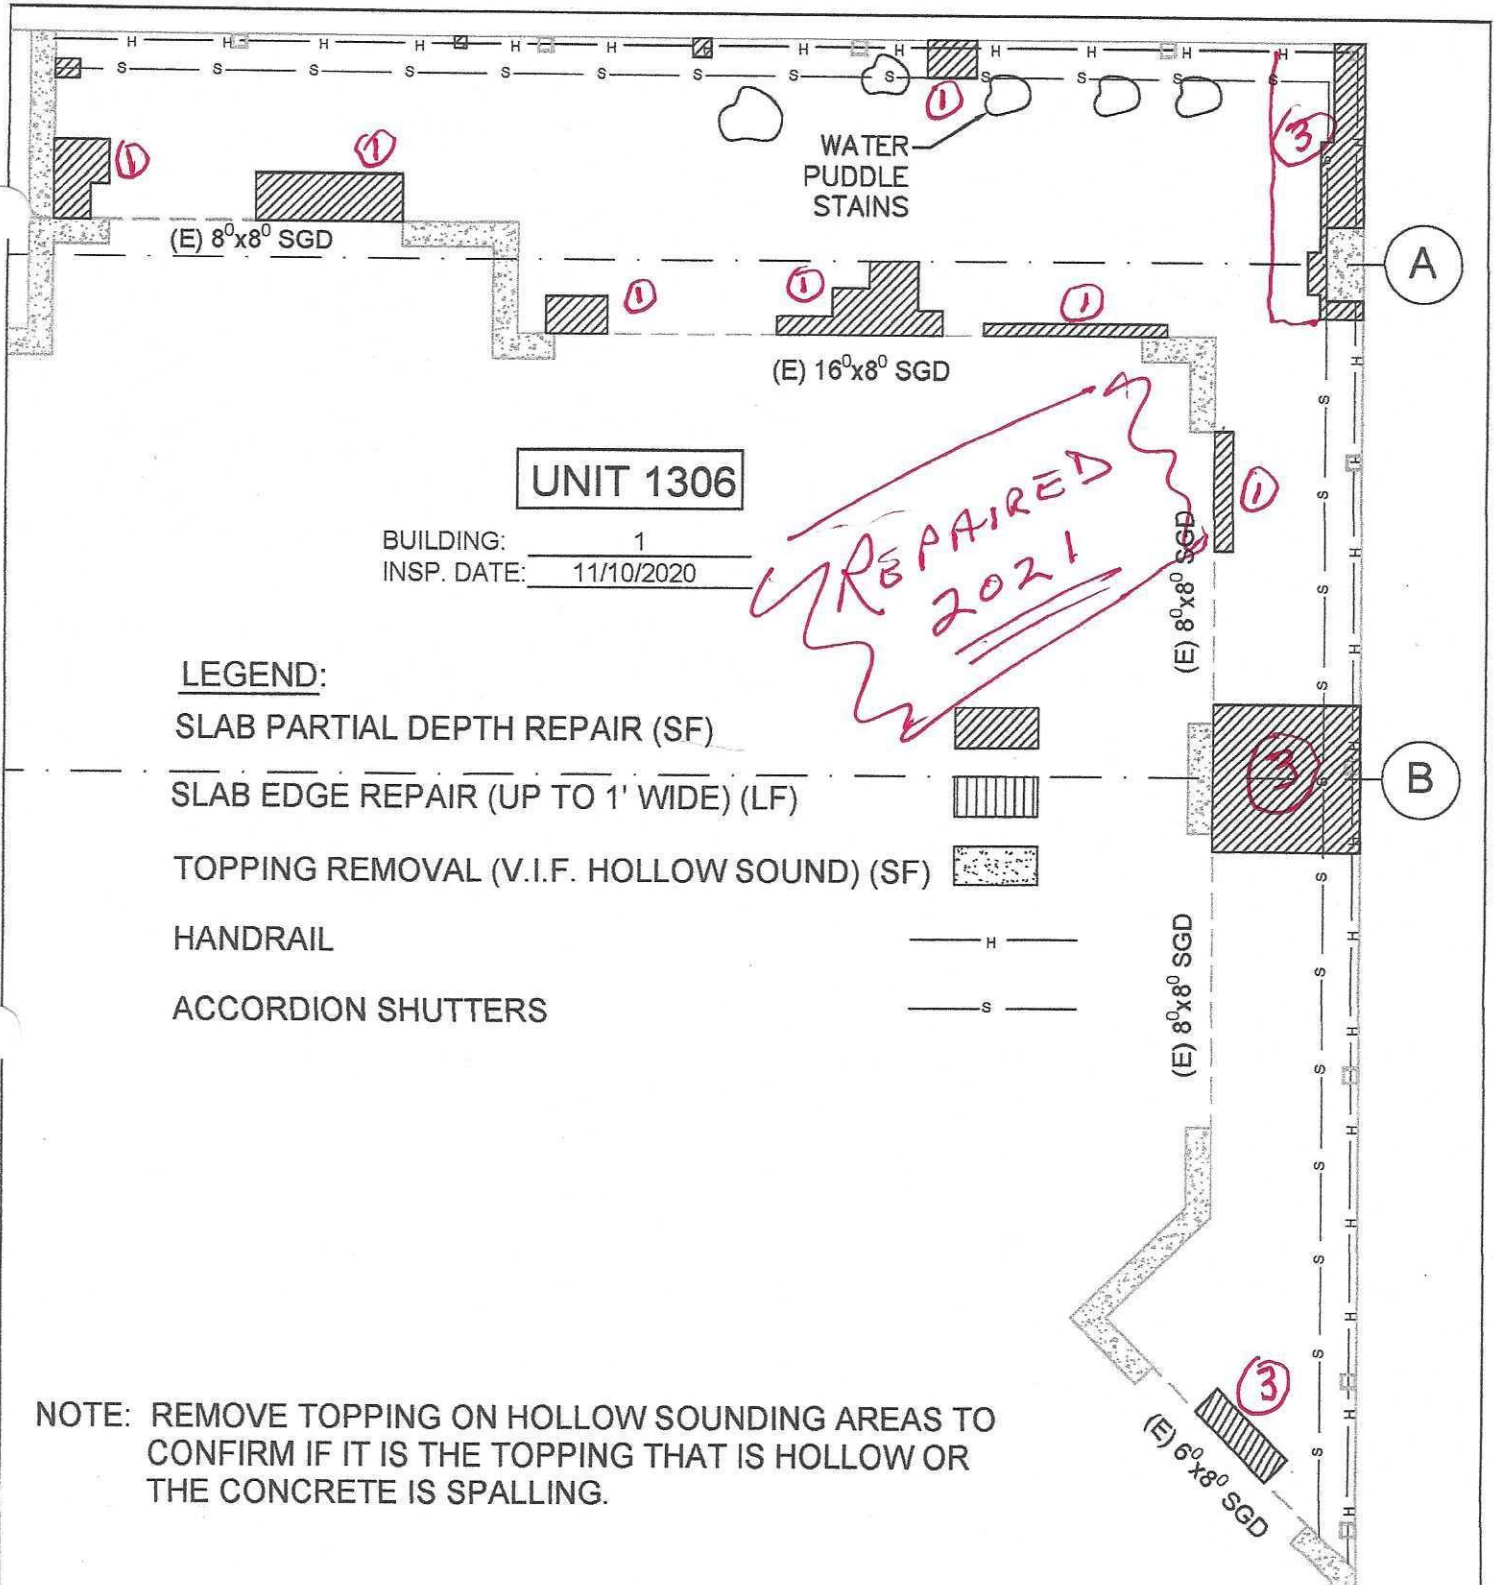
UNIT 1306

*REPAIRED
 2021*

NOTE: REMOVE TOPPING ON HOLLOW SOUNDING AREAS TO CONFIRM IF IT IS THE TOPPING THAT IS HOLLOW OR THE CONCRETE IS SPALLING.

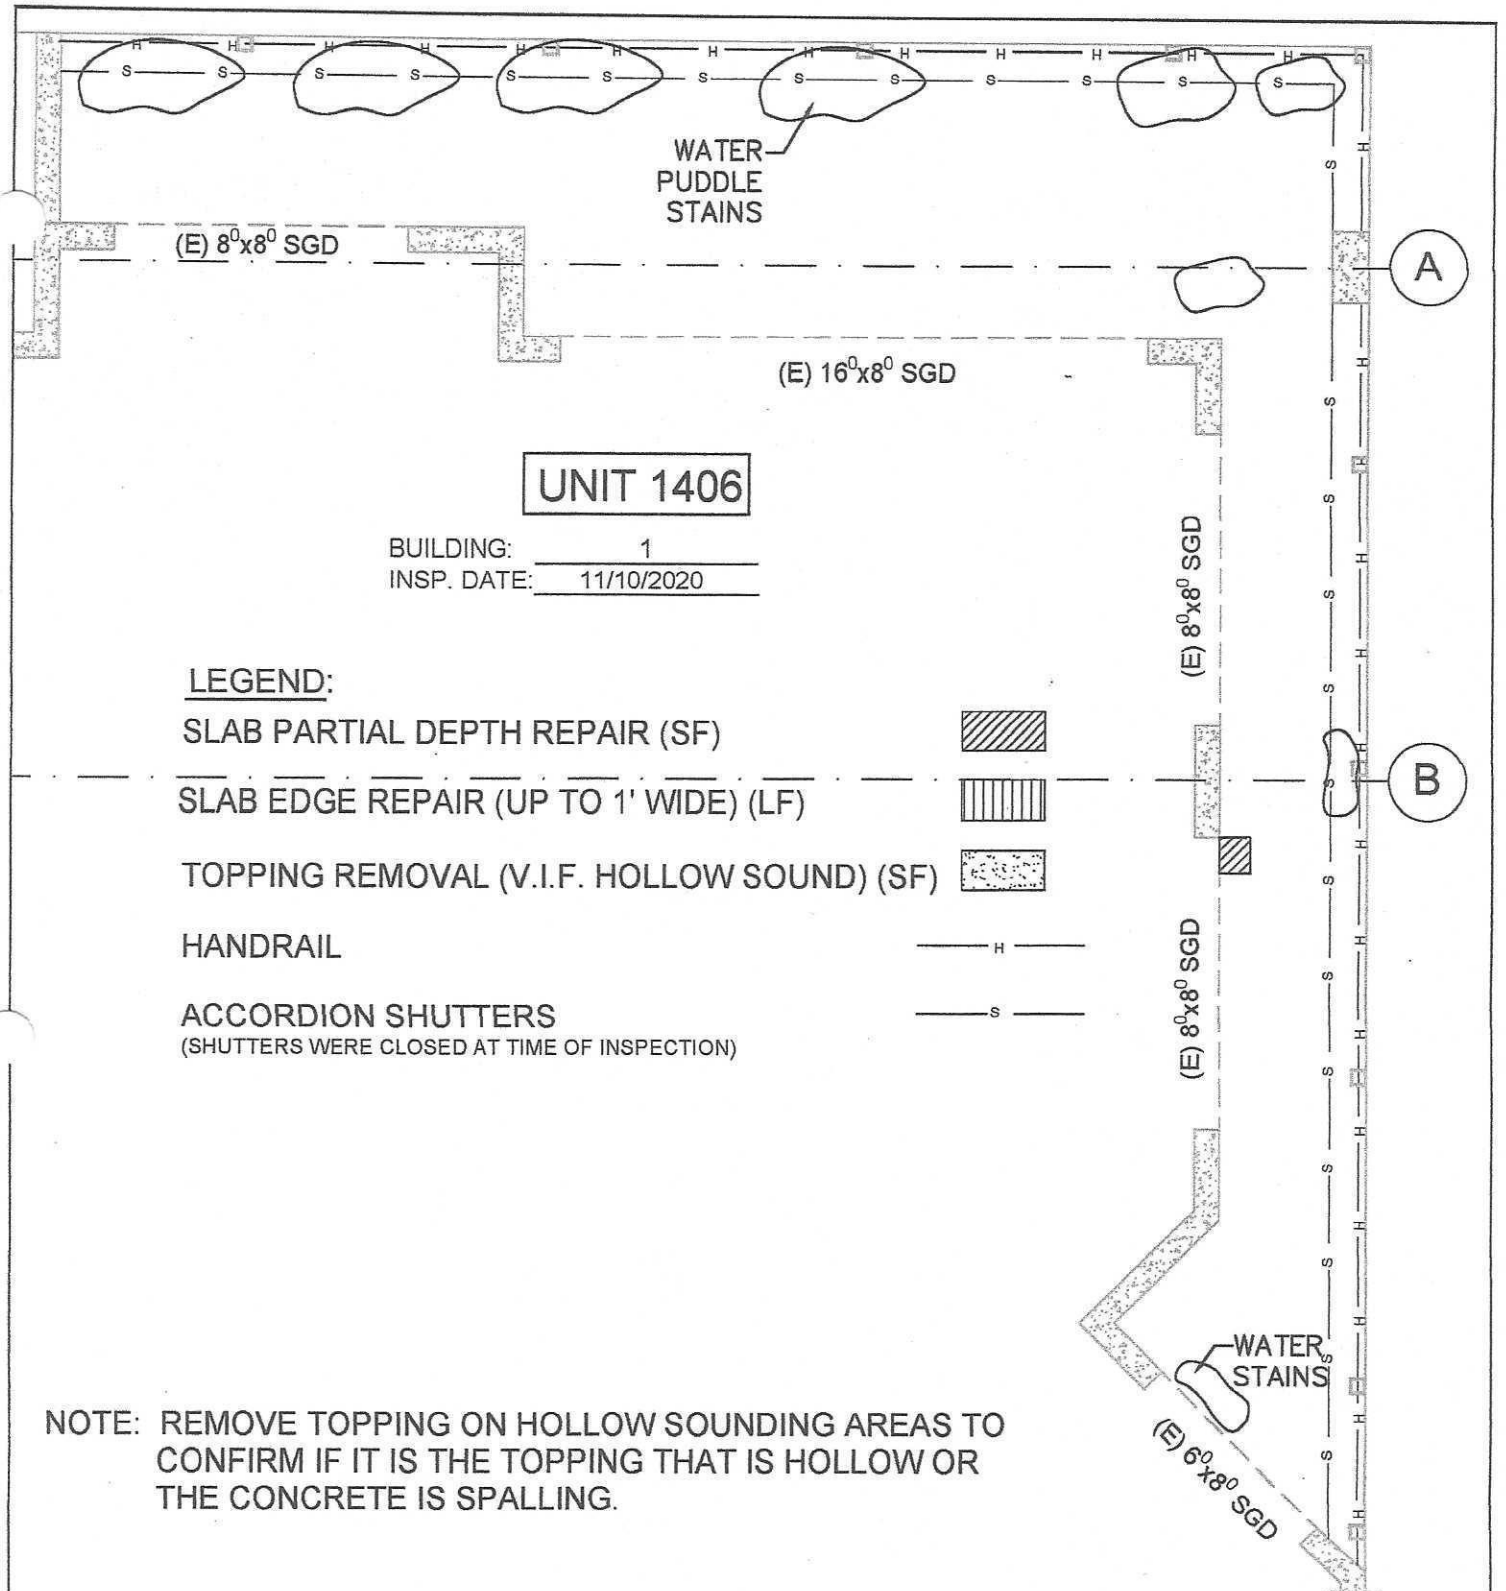
UNIT 1406

ACCORDION SHUTTERS
 (SHUTTERS WERE CLOSED AT TIME OF INSPECTION)

NOTE: REMOVE TOPPING ON HOLLOW SOUNDING AREAS TO CONFIRM IF IT IS THE TOPPING THAT IS HOLLOW OR THE CONCRETE IS SPALLING.
