LANTANA
 CONDOMINIUM
 BALCONY INSPECTION
 1811 A1A
 INDIAN HARBOUR BEACH, FL

FINDINGS/REPAIRS

JOB NO. 20-0374
DESIGNED JT
DRAWN AER
CHECKED RV
DATE NOV 2020
SHEET 1 OF 15

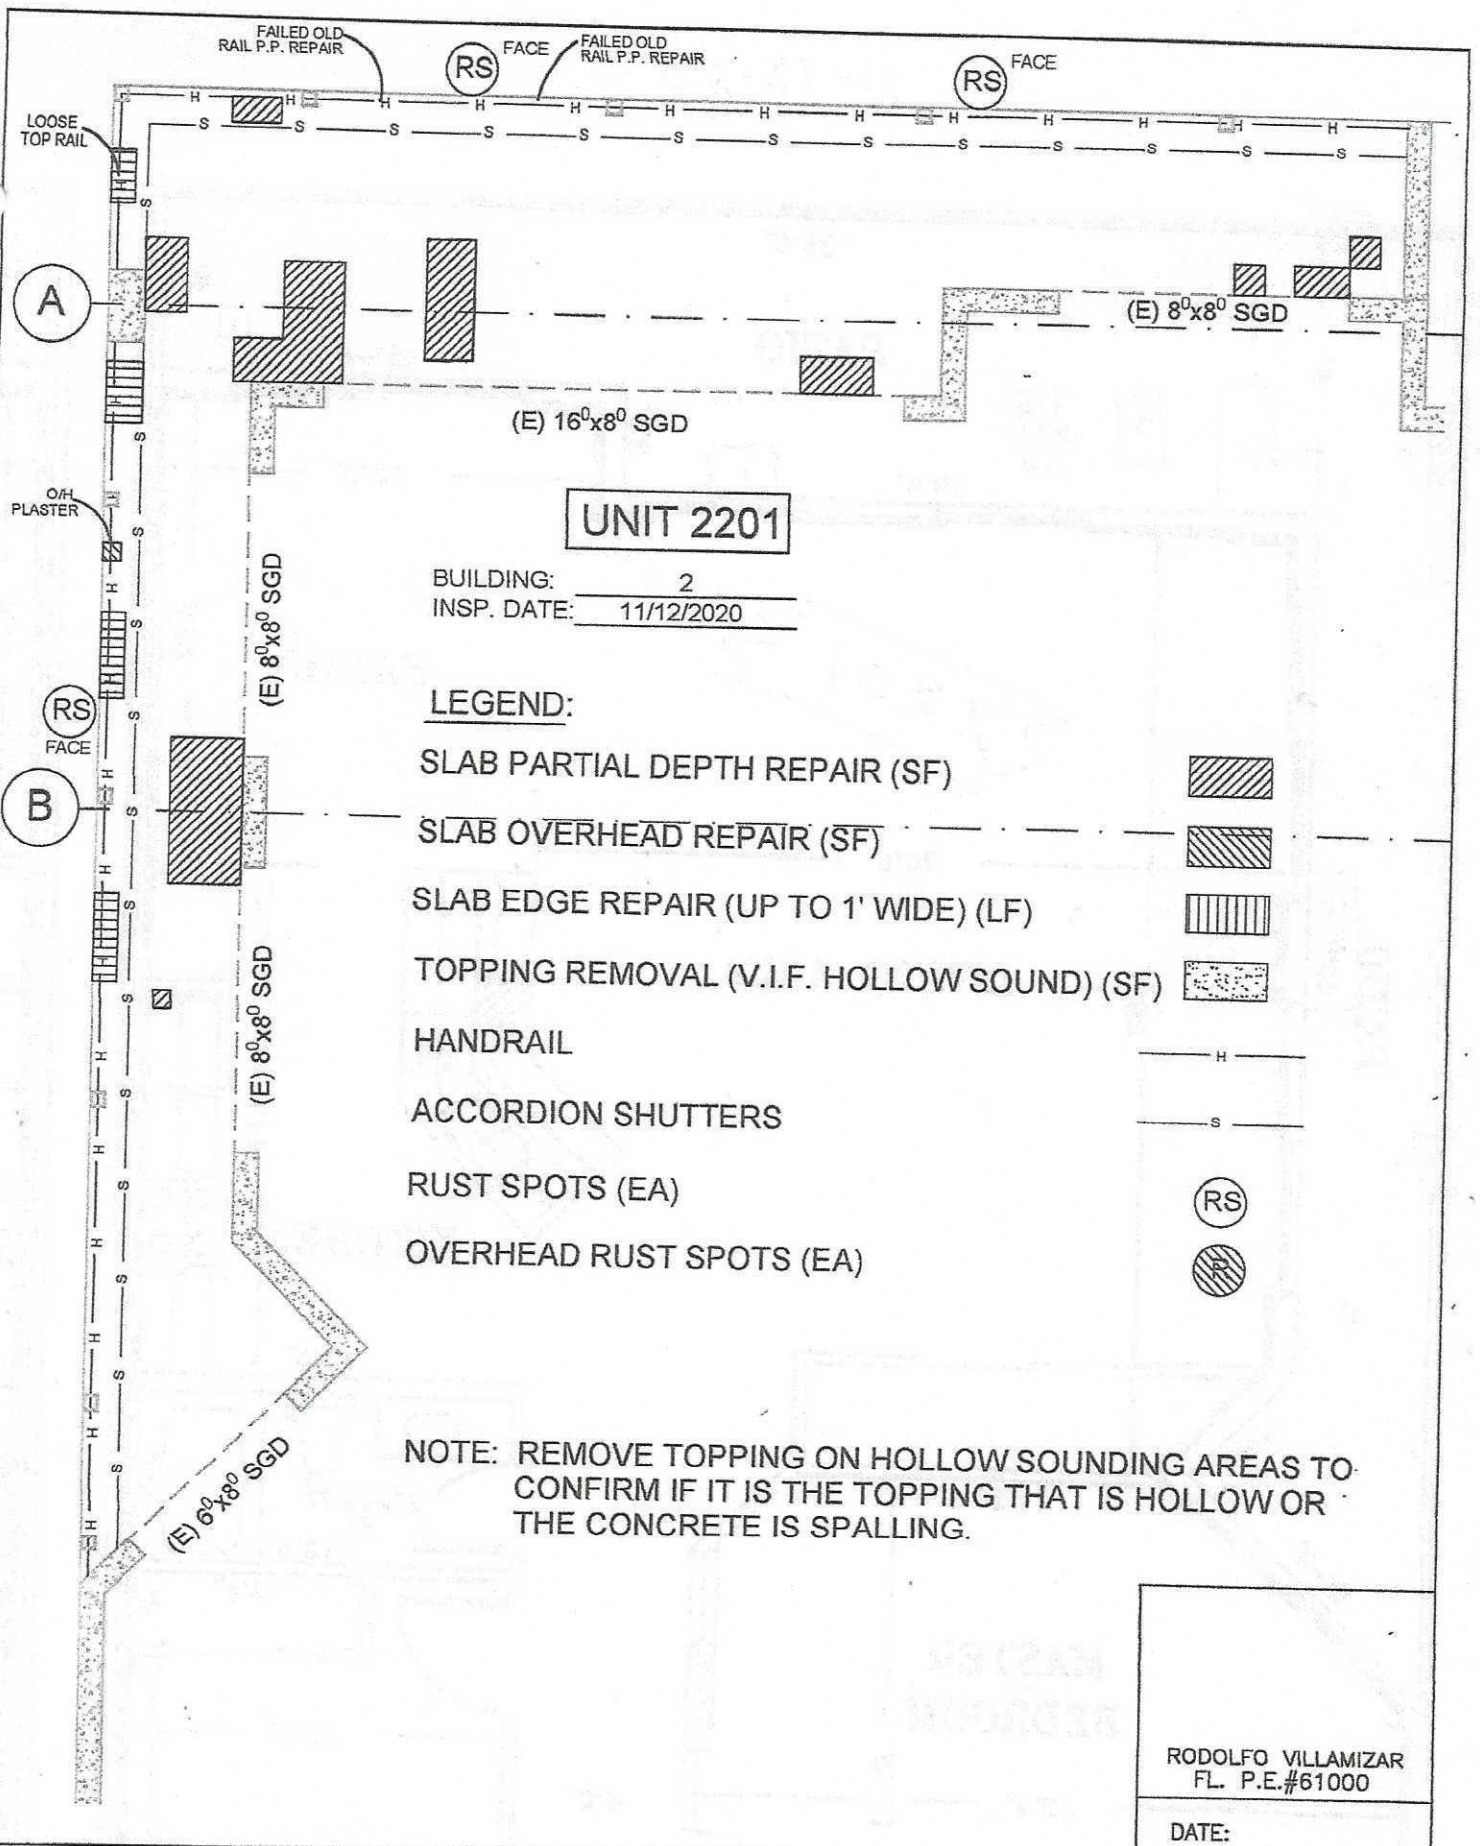
UNIT 2201

BUILDING: 2
 INSP. DATE: 11/12/2020

NOTE: REMOVE TOPPING ON HOLLOW SOUNDING AREAS TO CONFIRM IF IT IS THE TOPPING THAT IS HOLLOW OR THE CONCRETE IS SPALLING.

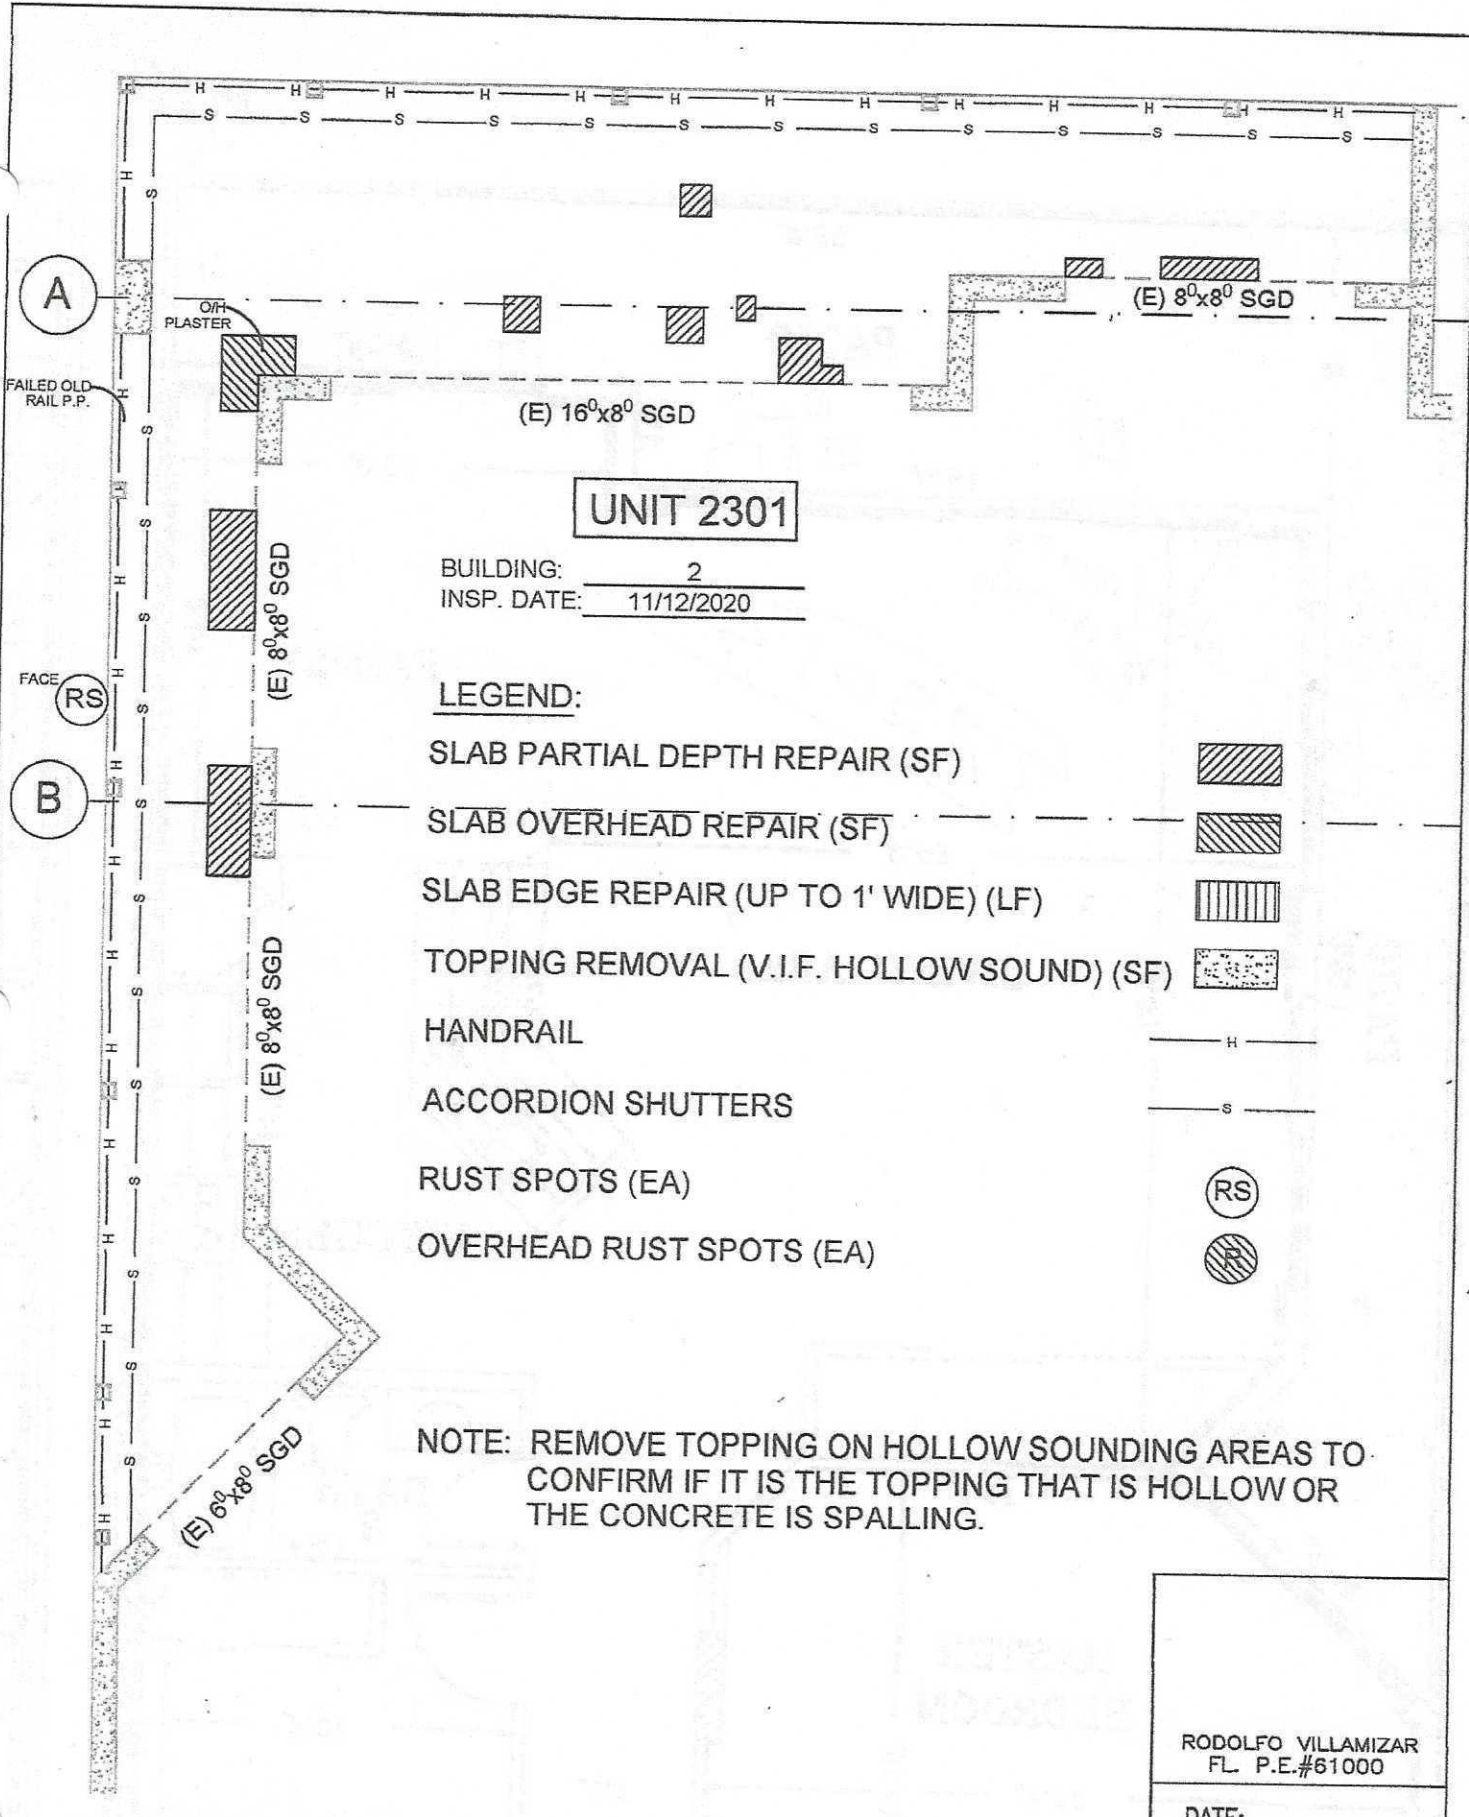
UNIT 2301

BUILDING: 2
 INSP. DATE: 11/12/2020

NOTE: REMOVE TOPPING ON HOLLOW SOUNDING AREAS TO CONFIRM IF IT IS THE TOPPING THAT IS HOLLOW OR THE CONCRETE IS SPALLING.

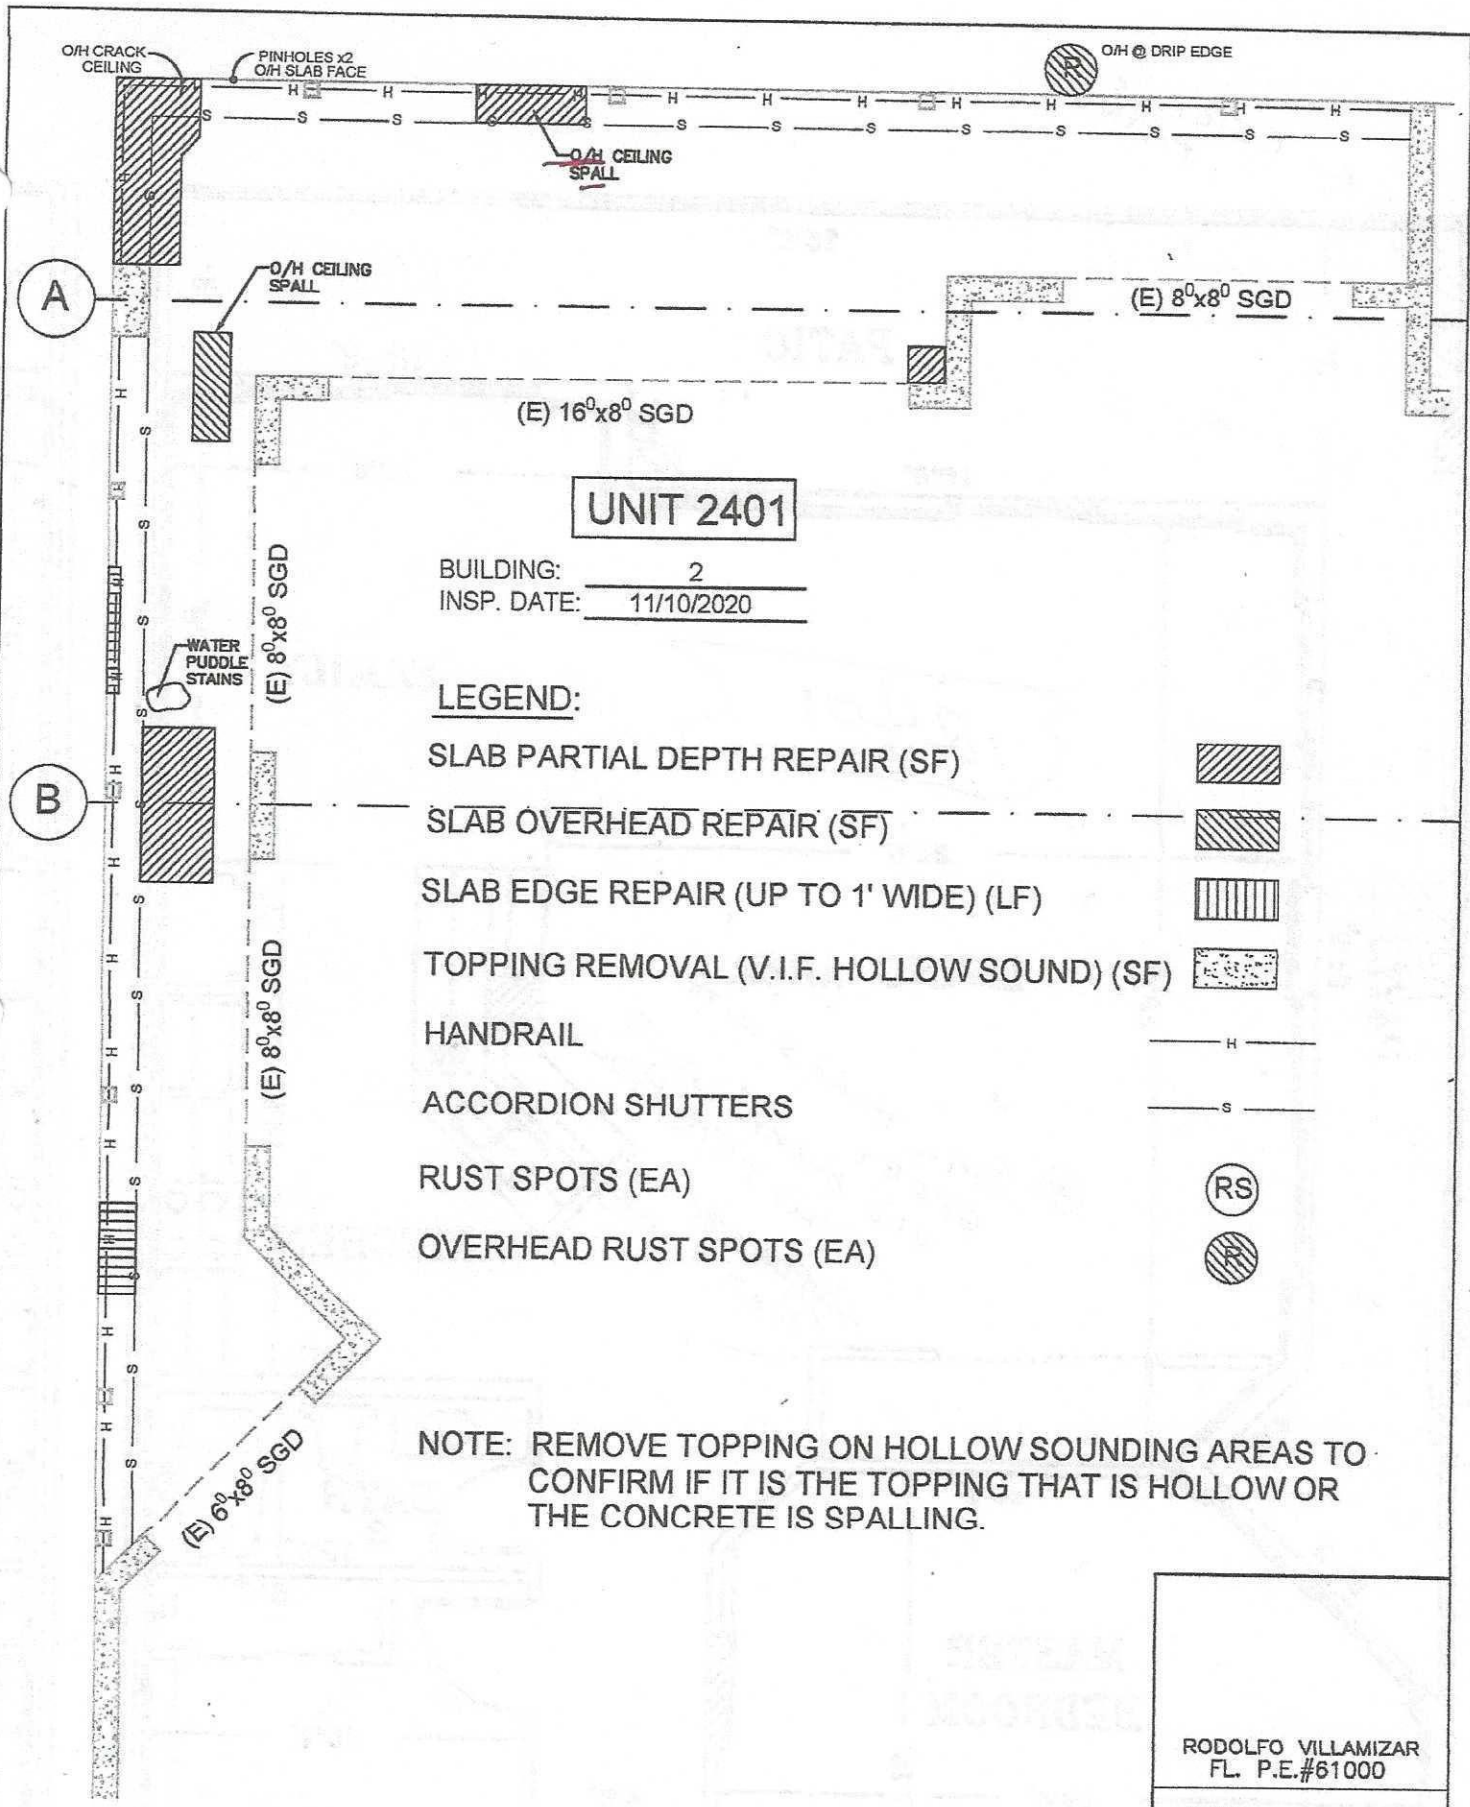
UNIT 2401

BUILDING: 2
 INSP. DATE: 11/10/2020

NOTE: REMOVE TOPPING ON HOLLOW SOUNDING AREAS TO CONFIRM IF IT IS THE TOPPING THAT IS HOLLOW OR THE CONCRETE IS SPALLING.

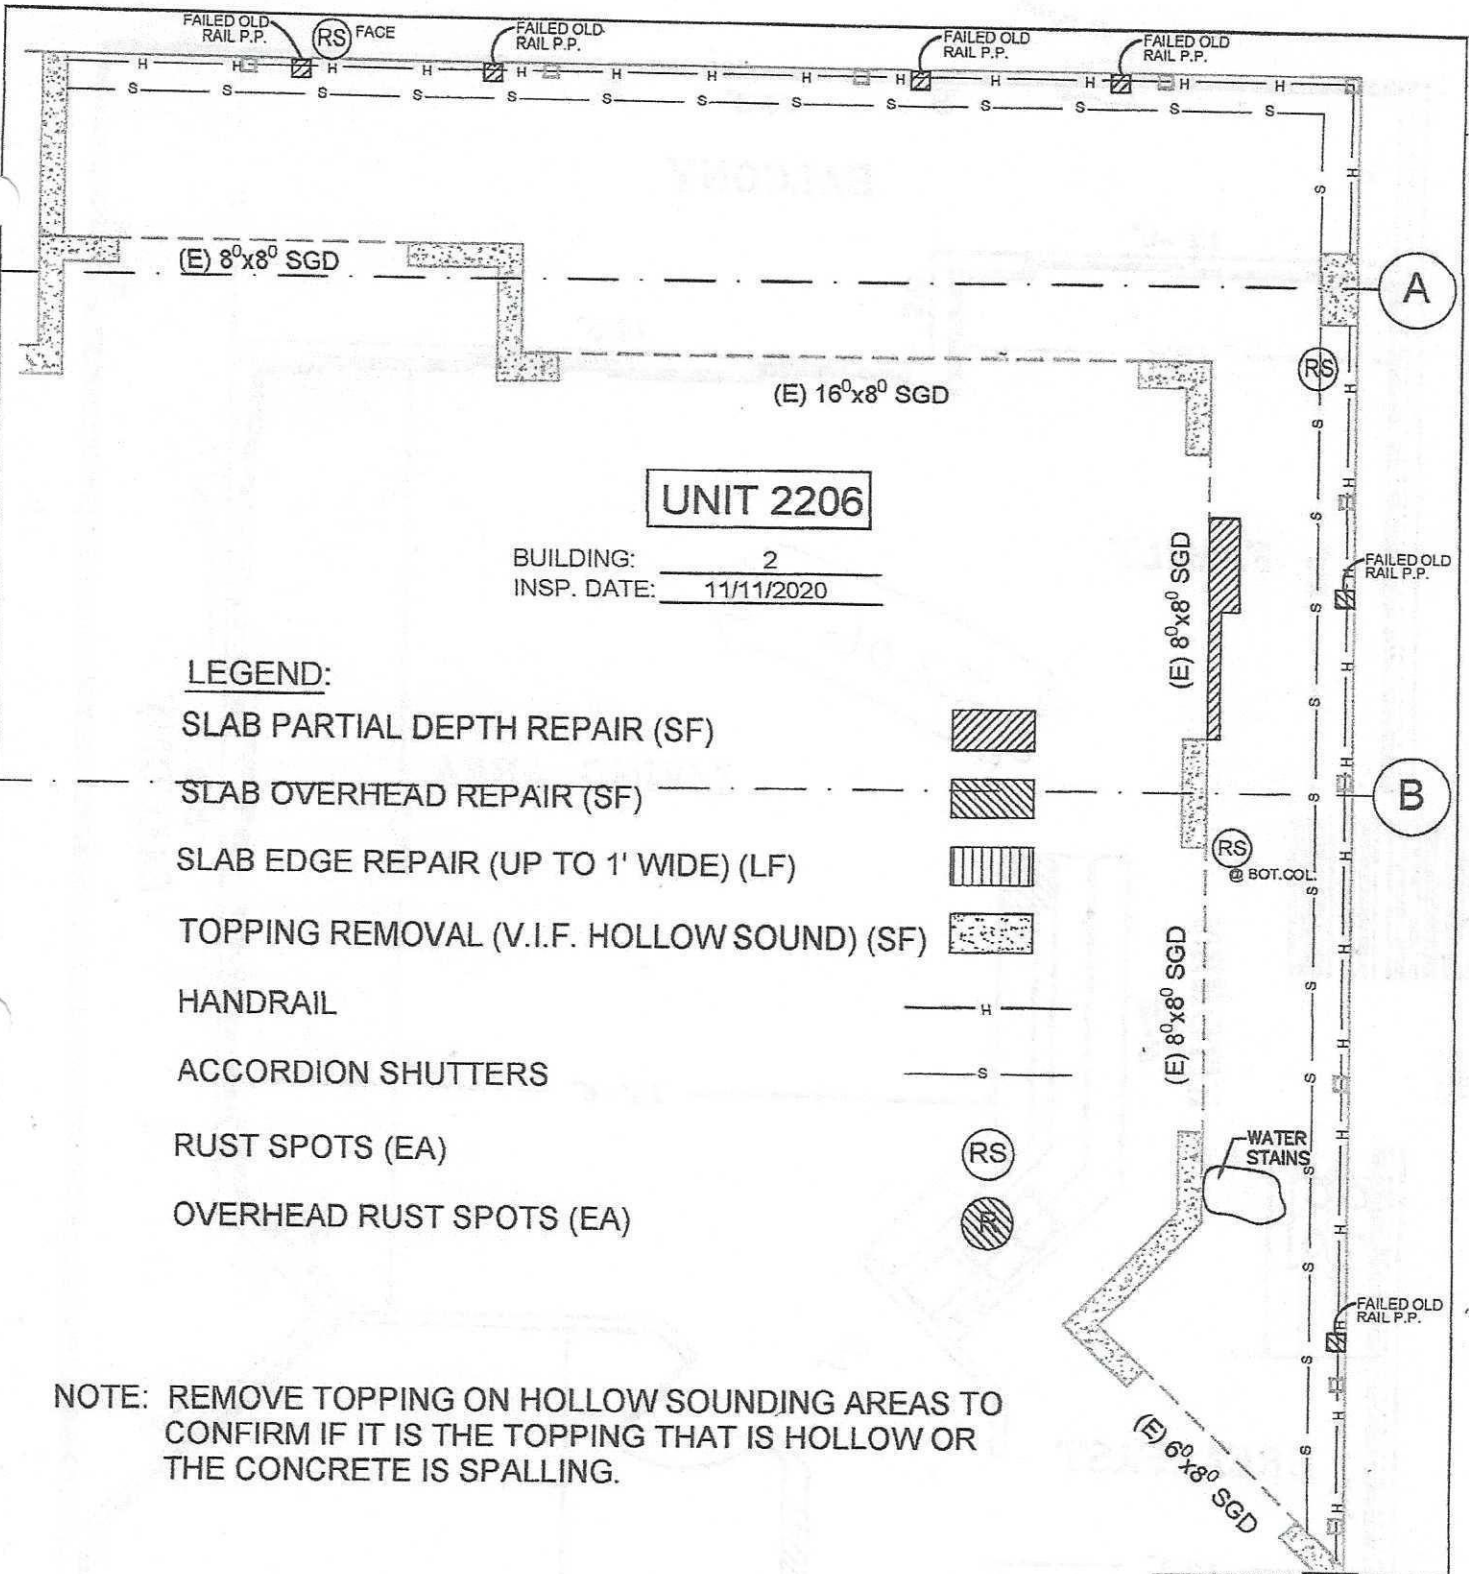
UNIT 2206

BUILDING: 2
 INSP. DATE: 11/11/2020

NOTE: REMOVE TOPPING ON HOLLOW SOUNDING AREAS TO CONFIRM IF IT IS THE TOPPING THAT IS HOLLOW OR THE CONCRETE IS SPALLING.

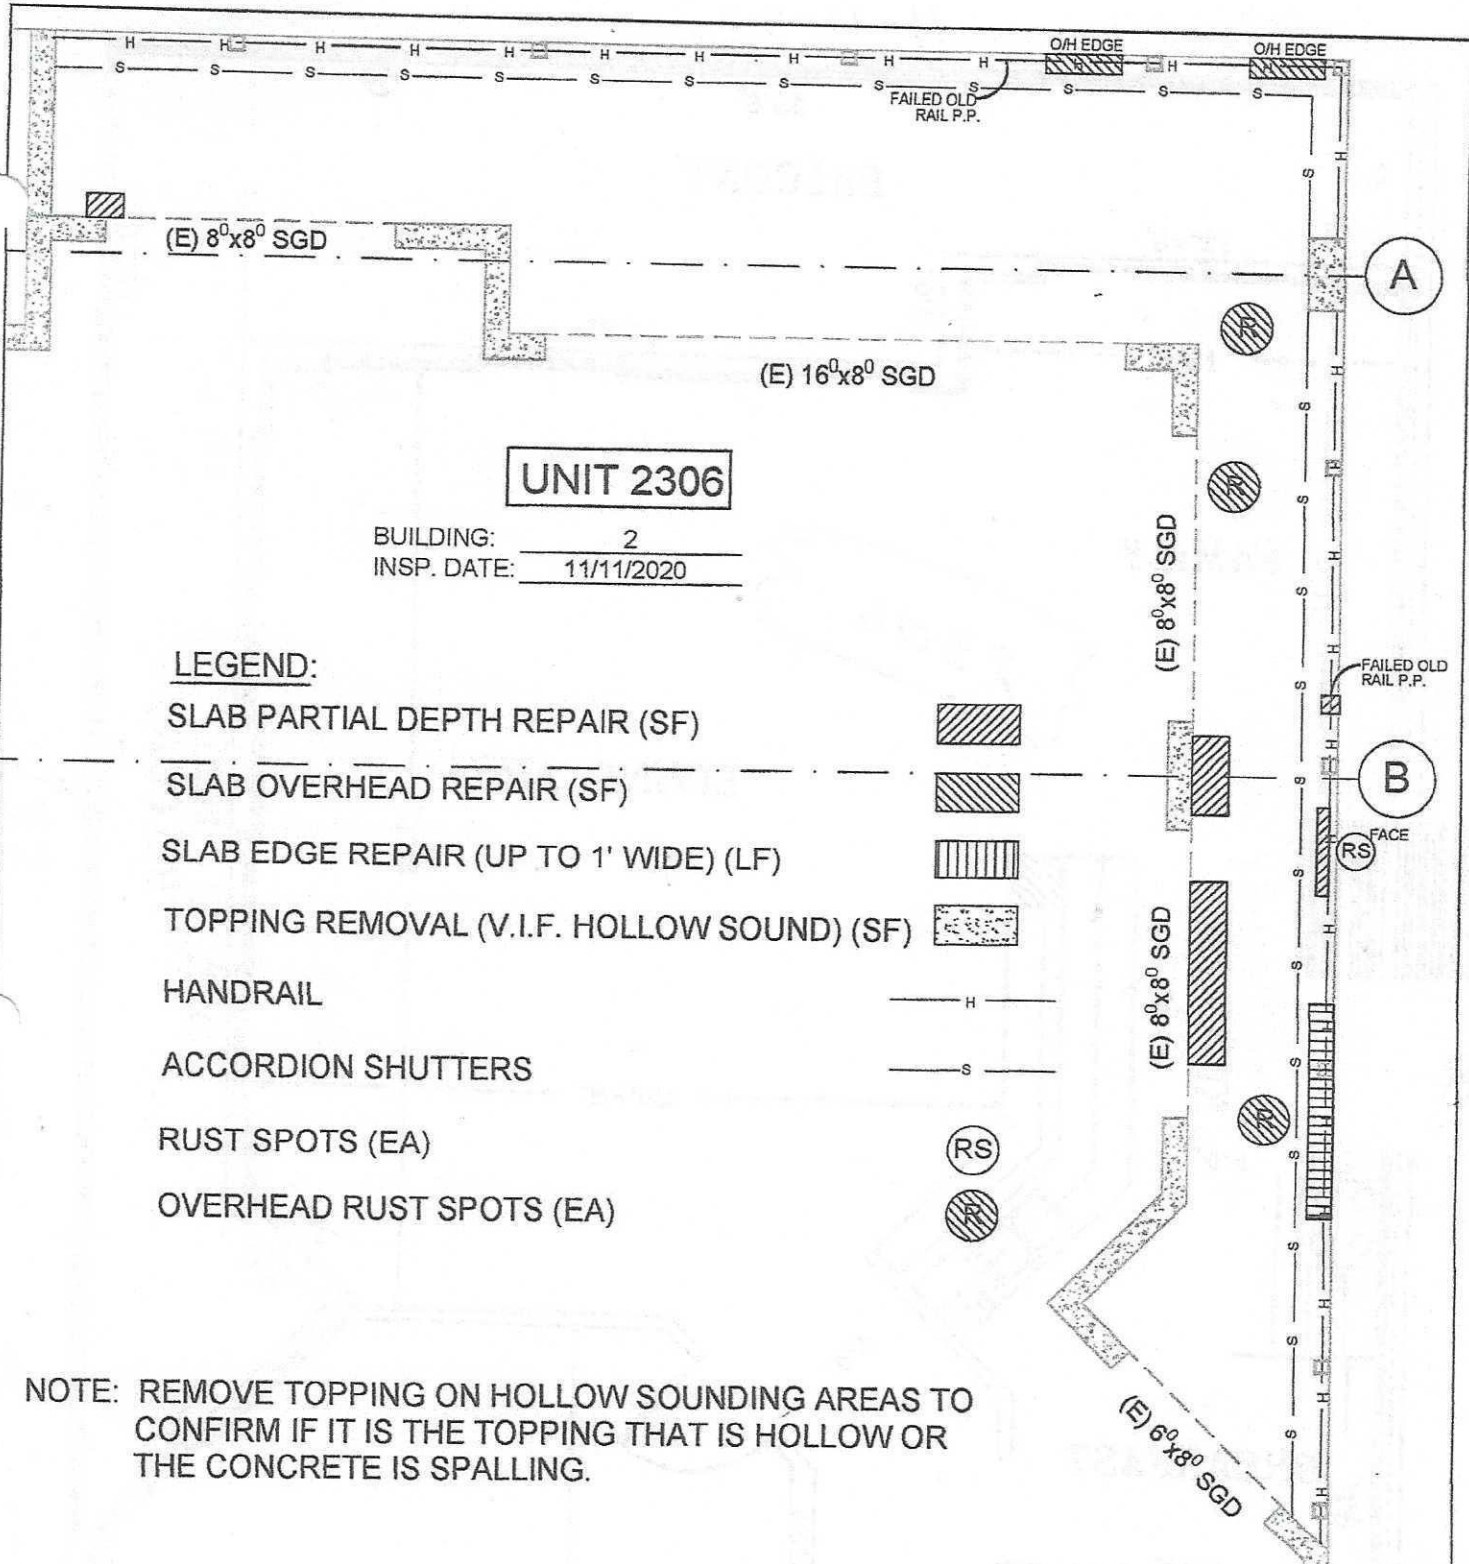
UNIT 2306

BUILDING: 2
 INSP. DATE: 11/11/2020

NOTE: REMOVE TOPPING ON HOLLOW SOUNDING AREAS TO CONFIRM IF IT IS THE TOPPING THAT IS HOLLOW OR THE CONCRETE IS SPALLING.

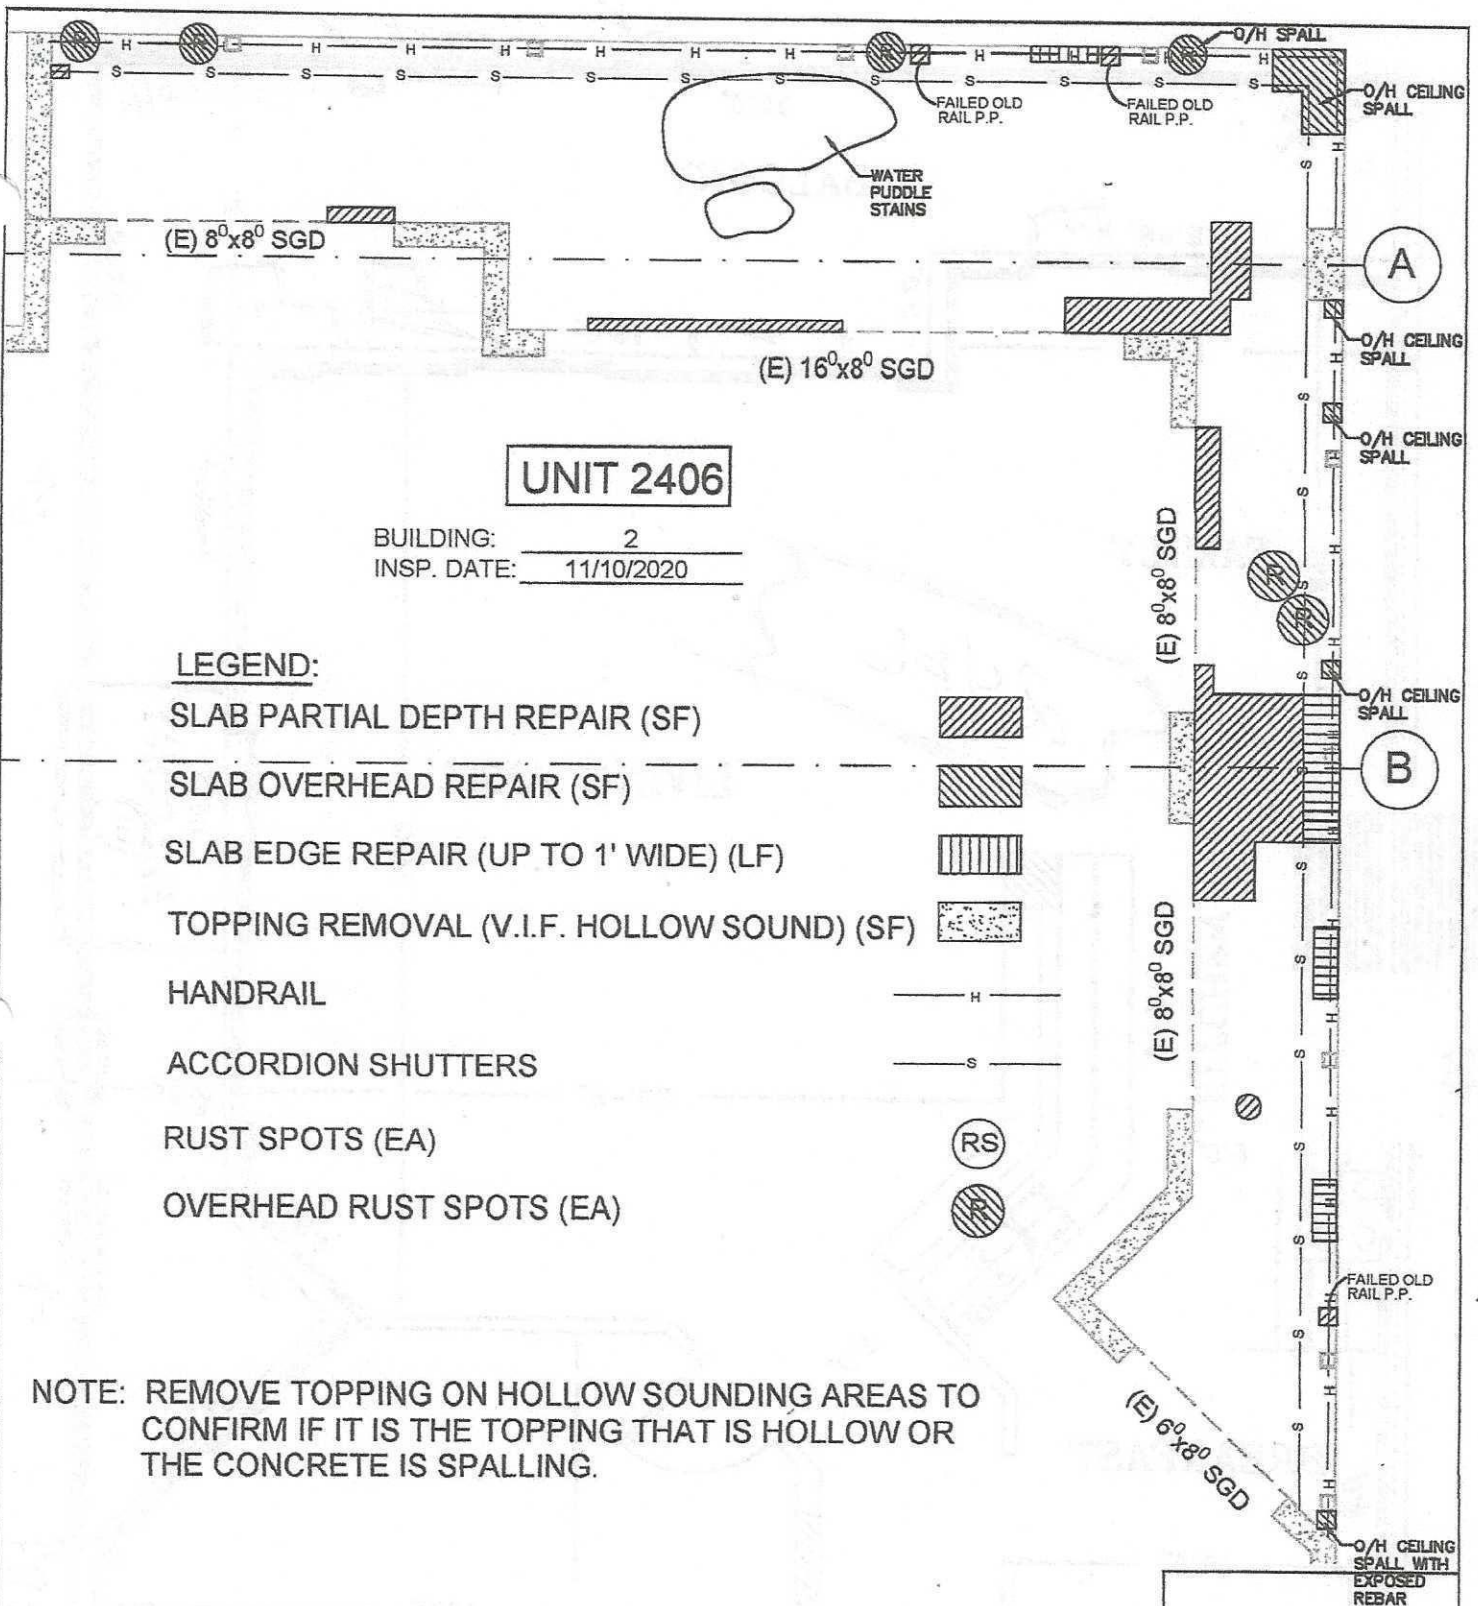
UNIT 2406

BUILDING: 2
 INSP. DATE: 11/10/2020

NOTE: REMOVE TOPPING ON HOLLOW SOUNDING AREAS TO CONFIRM IF IT IS THE TOPPING THAT IS HOLLOW OR THE CONCRETE IS SPALLING.
