Re: Property Address(es): Multiple - 1821 Highway A1A Indian Harbour Beach, FL 32937  
 Property County: Brevard  
 Policy/Account No: 33A0000013-000  
 Policy Inception Date: December 31, 2023  
 Deft Inspection Date(s): January 11, 2024  
 Report Type: Risk Management Report (Year 1)

Please accept this Year 1 Risk Management Report based on Deft’s recent physical inspection of Lantana Oceanfront, discussions with those interested in its insurability, and review of select documentation specific to said property.

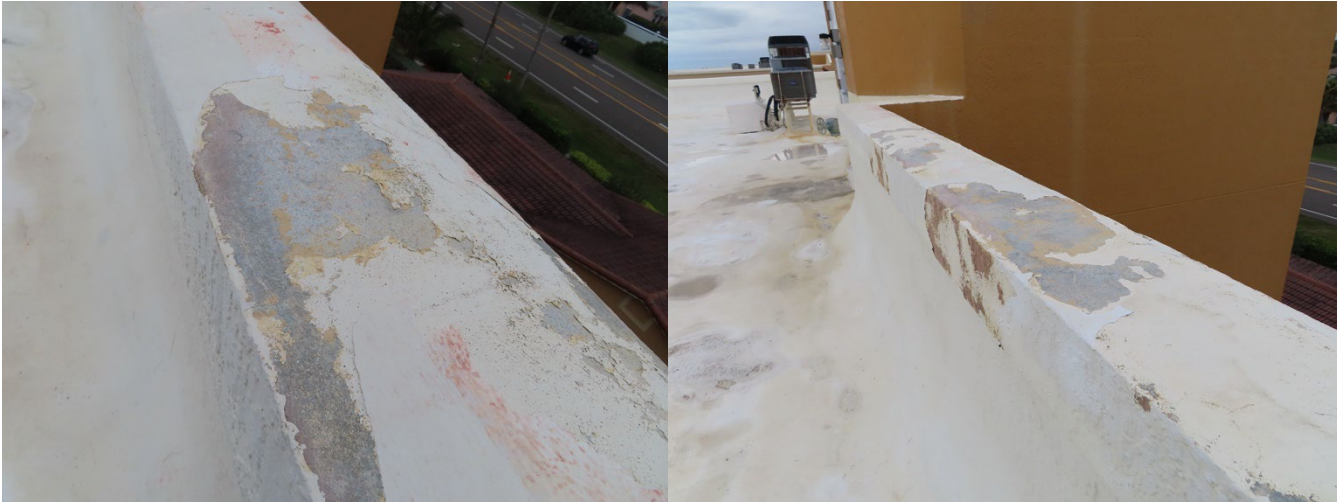
1. **Waterproofing repairs** – We noted wear/tear to the exterior painting and waterproofing, which is expected due to the age of the waterproofing and oceanfront location; however, we found that building 1 had significantly more wear. We noted missing painting/stucco on the parapet wall above where the tile roof section was replaced along with bubbling of paint on all elevations. With a full waterproofing project not projected for a year or two and we recommend addressing these areas/issues until a full waterproofing and painting project can be completed.

*Damage to parapet wall on Bldg 1. Note that this is from the recent replacement of the tiles roof section.*

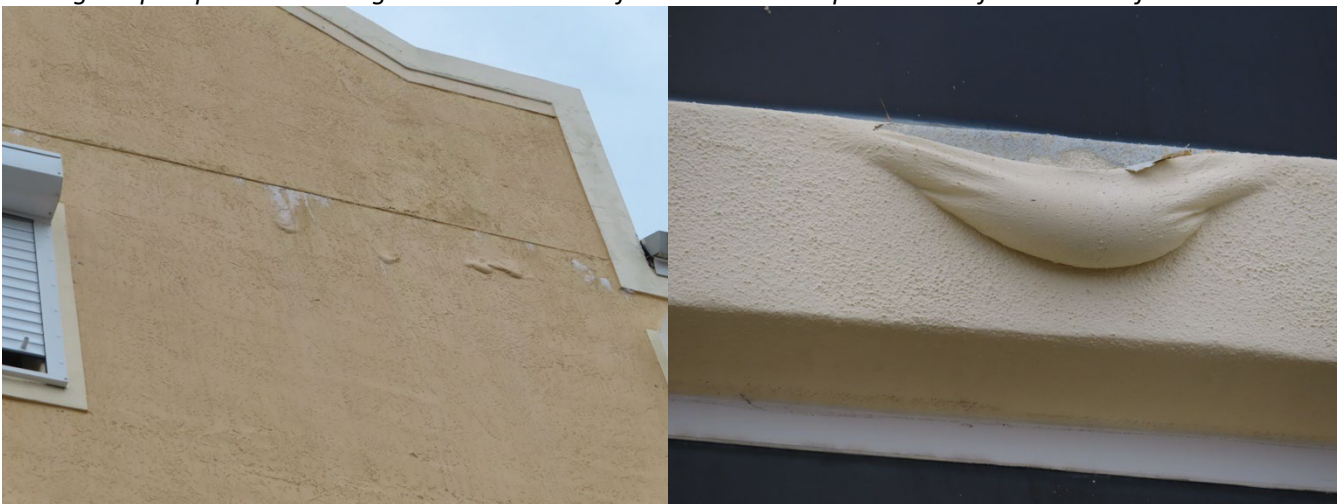
*Paint was found to be bubbling throughout the exterior of Bldg 1.*

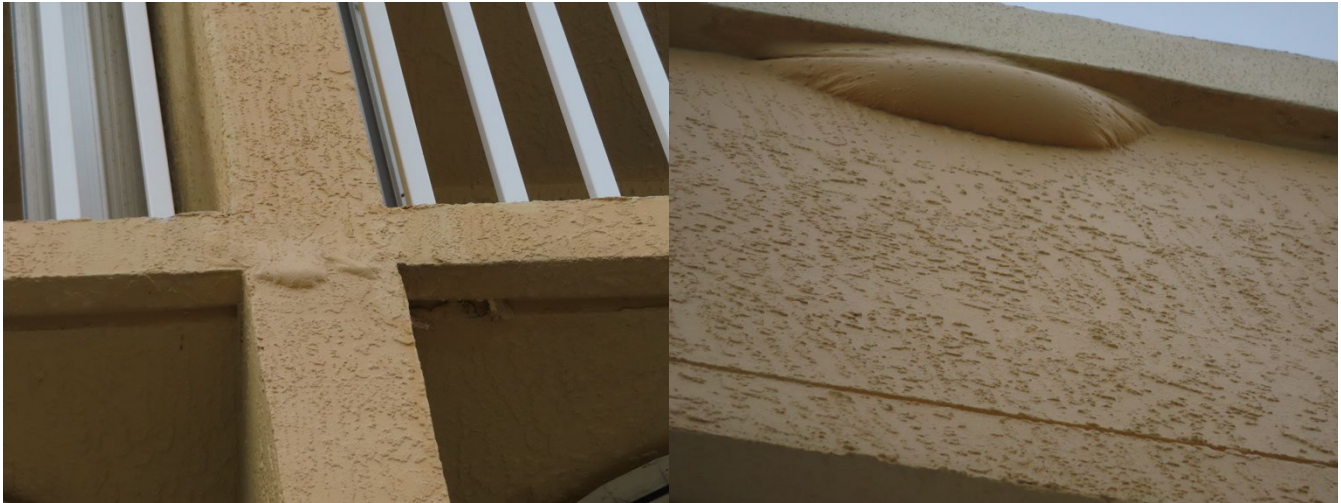
*Further examples of bubbling Bldg 1.*

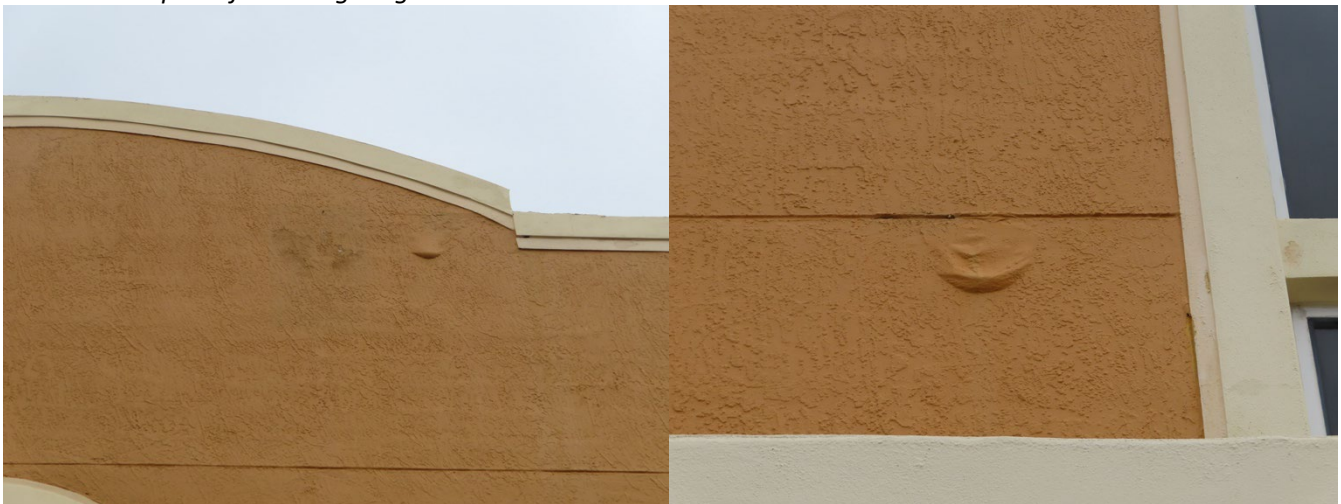
*While much less of a concern, several areas were noted on Bldg 3 where paint is bubbling.*

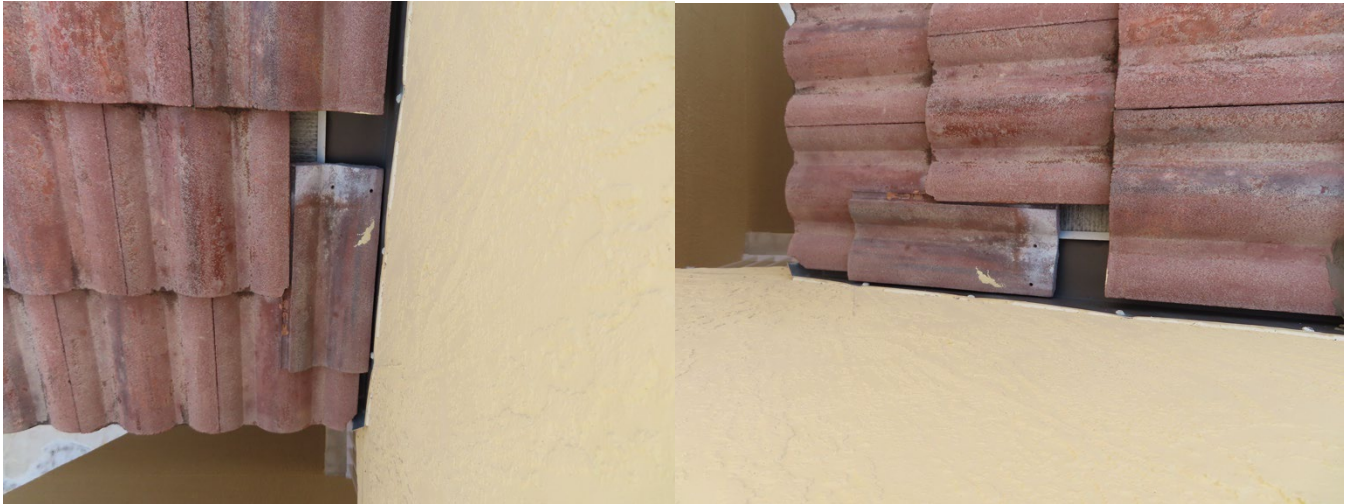
2. **Roof repair** – Building 3 has a loose concrete tile at the front slope. It is noted that this section of roof is scheduled for replacement in 2024. We recommend repairing this loose tile to prevent injury or further damage.

Bldg 3 loose tile

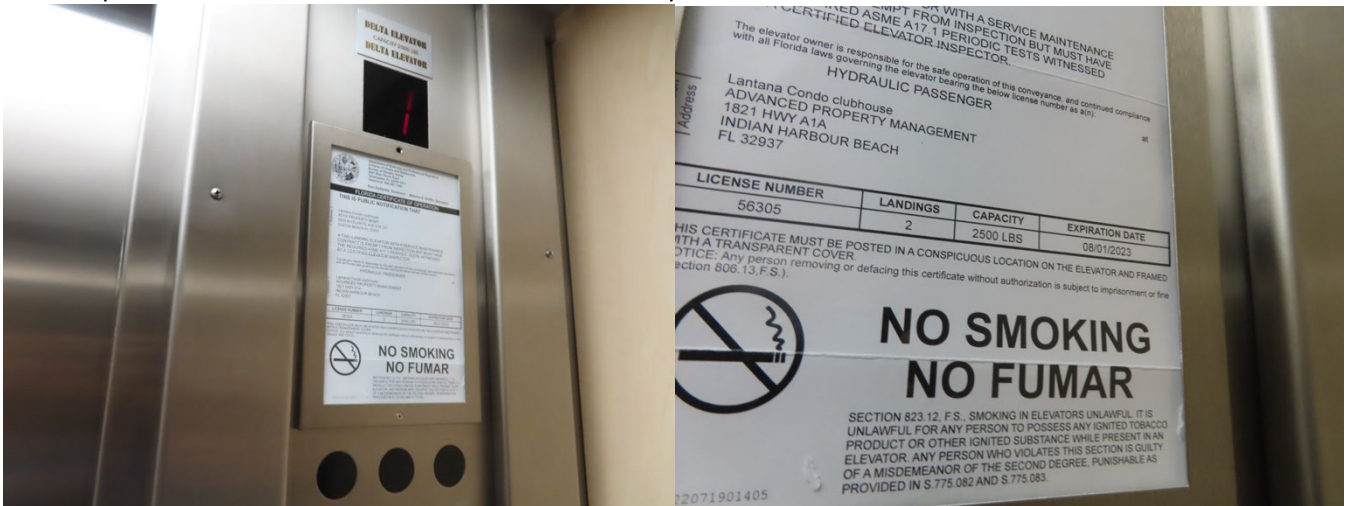
3. **Elevator inspection compliance** – Within the clubhouse, we noted the elevator inspection tag to be out of compliance. All others were found to be within compliance.

Certificate expired 8.1.2023.
