FINAL STRUCTURAL REPORT

Lantana Oceanfront Condominiums
Building 3 - 1811 Florida A1A
Indian Harbour Beach, Florida 32937

Engineer's Project # 20-0184
May 29, 2020

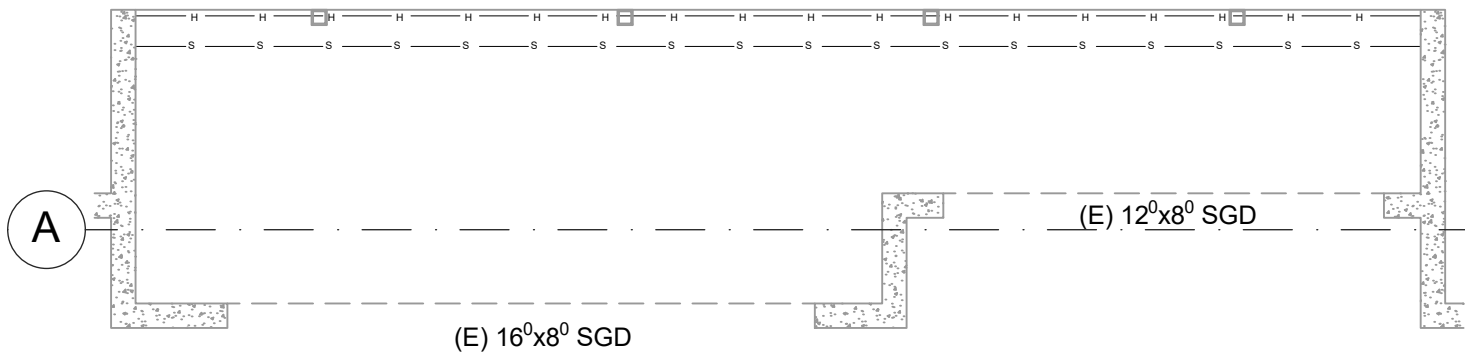
UNIT 3202

- 1 Column spall/damage location by grid lines B and 2.
 - For more information see attached finding drawings.
- **Unit 3202:**
 - None observed.
 - For more information see attached finding drawings.

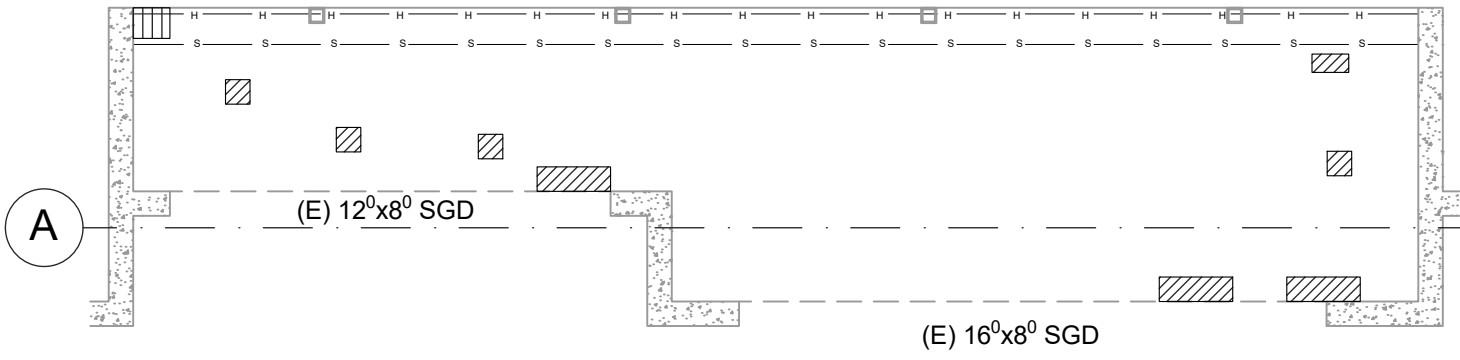
UNIT 3205

- **Unit 3205:**
 - Observed nine (9) slab hollow sounding locations. The majority of these areas are directly aligned with the banded group of tendons along column grid line A.

- A number of uniform tendons may be impacted (and will require de-tensioning / re-tensioning to allow the slab concrete repairs) if located directly over the possible slab spalling/repair areas. It is possible that some of these uniform direction tendons (E-W direction) will require their temporary lock-offs inside the units.

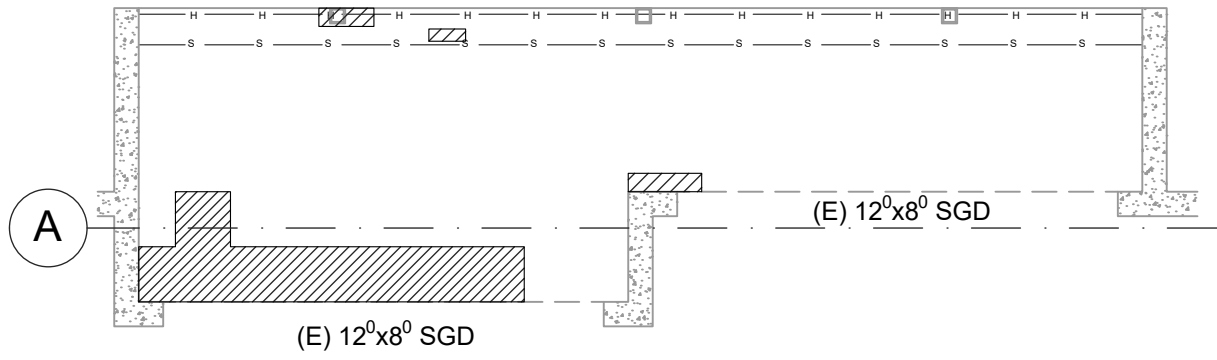
UNIT 3303

- **Unit 3303:**
 - 4 Slab Concrete spall locations. The majority of these areas are directly aligned with the banded group of tendons along column grid line A.
 - A number of uniform tendons may be impacted (and will require de-tensioning / re-tensioning to allow the slab concrete repairs) if located directly over the possible slab spalling/repair areas. It is possible that some of these uniform direction tendons (E-W direction) will require their temporary lock-offs inside the units.
 - For more information see attached finding drawings.

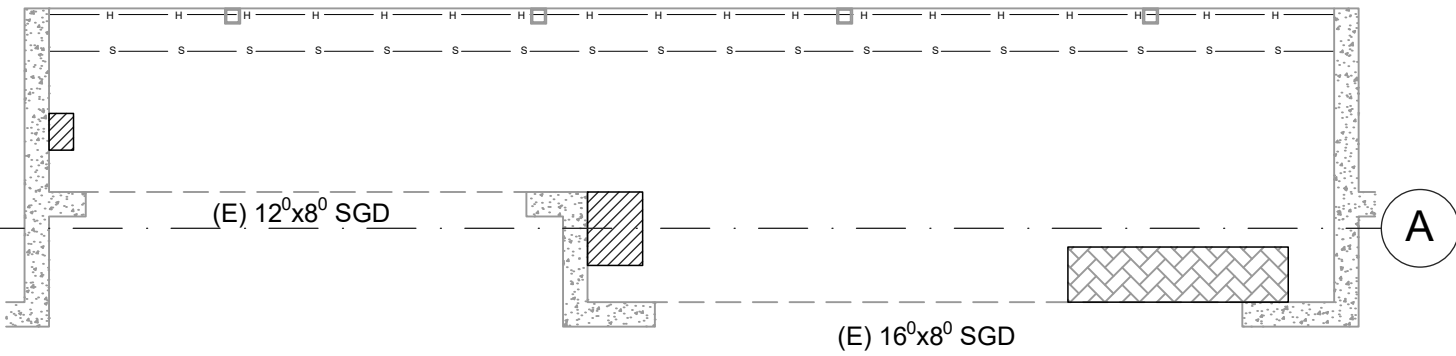
UNIT 3305

- **Unit 3305:**
 - 3 Concrete spall locations. The majority of these areas are directly aligned with the banded group of tendons along column grid line A.
 - A number of uniform tendons may be impacted (and will require de-tensioning / re-tensioning to allow the slab concrete repairs) if located directly over the possible slab spalling/repair areas. It is possible that some of these uniform direction tendons (E-W direction) will require their temporary lock-offs inside the units.
 - For more information see attached finding drawings.

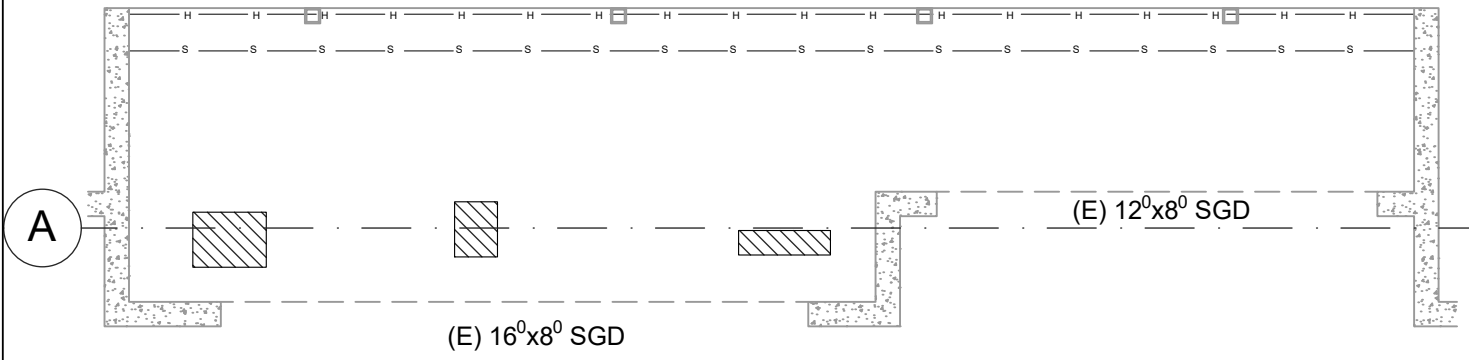
UNIT 3402

- **Unit 3402:**
 - (3) small hollow sounding slab/topping areas near the north SGD. It should be verified if these are actual concrete slab spalling.
 - For more information see attached finding drawings.
