## **LANTANA CONDOMINIUMS INDIAN HARBOUR BEACH, FLORIDA POST-TENSIONING TESTING**

VCS Project Number – F20028FL

June 5, 2020

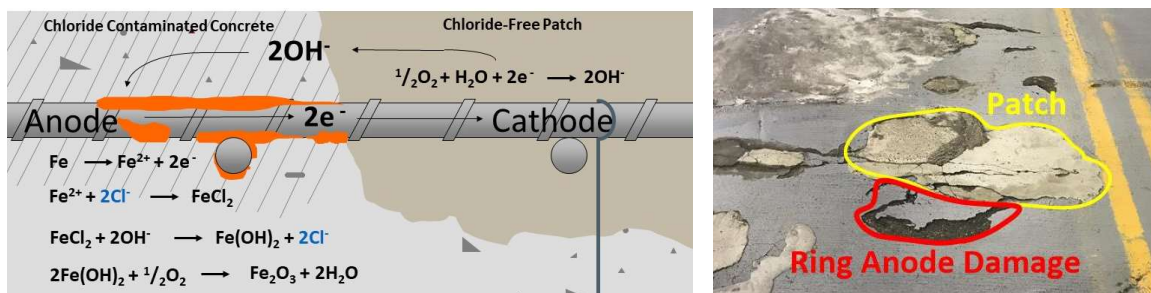
Figure 7: Ring Anode Effect

When the localized concrete repairs are completed, chloride-contaminated concrete is left in place adjacent to the repair. The reinforcing steel crosses the interface between the original contaminated concrete and the completed steel concrete repairs which are chloride-free and alkaline. This incompatibility can accelerate corrosion around the repairs in the adjacent chloride-contaminated concrete; this phenomenon is referred to as the ring anode effect (Figure 7). A common method to mitigate the effects of ring anode corrosion is the use of embedded galvanic anodes within the repair area. Embedded galvanic anodes consist of zinc as a sacrificial metal encased in an activating mortar. When connected to the reinforcing steel within the completed concrete repairs, a small level of protective current is generated to mitigate the formation of new corrosion sites in the surrounding concrete. Embedded galvanic anodes are available in a range of sizes and shapes and are spaced along the steel surface area based on the risk for corrosion. A good ACI reference for the use of embedded galvanic anodes is *Repair Application Procedure Bulletin #8 – Installation of Embedded Galvanic Anodes*. For this application VCS recommends Type 1A anodes (standard concrete repairs, alkali activated). Installation of Type 1A will have an additional cost of approximately \$15-25 per ft<sup>2</sup> of patch repair area.

For the Basic Repair option, the currently spalled and delaminated areas will need to be repaired. In addition to the patch repair recommendations provided by MBV, VCS recommends installation of galvanic anodes around the perimeter of the patch repairs.
