# STRUCTURAL REPORT

## Lantana Oceanfront Condominiums Building 2 - 1811 Florida A1A Indian Harbour Beach, Florida 32937

Engineer's Project # 21-0530  
January 26, 2022

### 1. Executive Summary

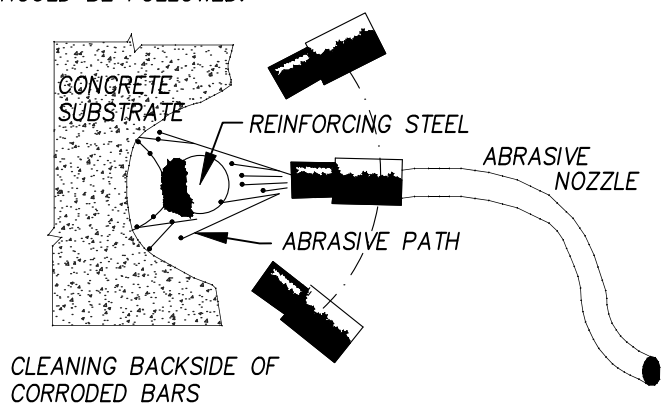
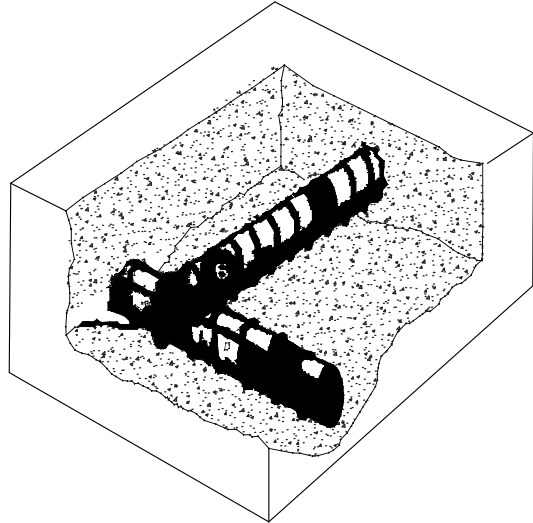
## REPAIR OF REINFORCING STEEL DUE TO LOSS OF SECTION

IF REINFORCING STEEL HAS LOST SIGNIFICANT CROSS SECTION, A STRUCTURAL ENGINEER SHOULD BE CONSULTED. IF REPAIRS ARE REQUIRED TO THE REINFORCING STEEL, ONE OF THE FOLLOWING REPAIR METHODS SHOULD BE USED:

- \* COMPLETE BAR REPLACEMENT, OR
- \* ADDITION OF SUPPLEMENTAL BAR OVER AFFECTED SECTION.

NEW BARS MAY BE MECHANICALLY SPLICED TO OLD BARS OR PLACED PARALLEL TO AND APPROXIMATELY  $\frac{3}{4}$  IN. (19 MM) FROM EXISTING BARS. LAP LENGTHS SHALL BE DETERMINED IN ACCORDANCE WITH ACI 318; ALSO REFER TO CRSI AND AASHTO MANUAL.

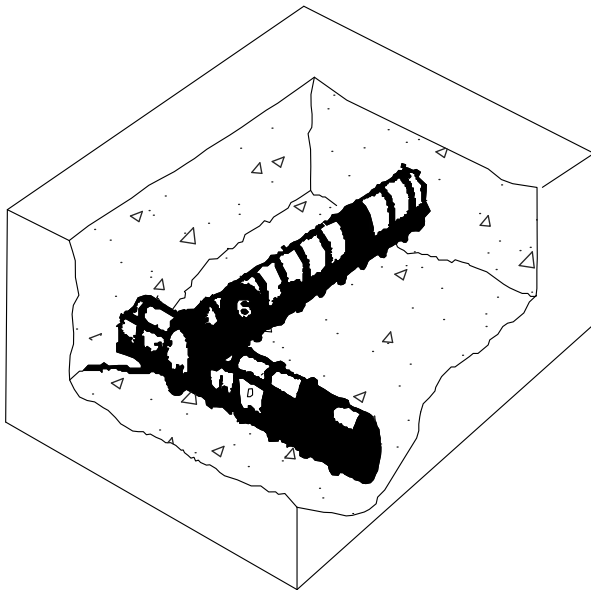
BOUNDARY OF LOOSE AND DELAMINATED CONCRETE

RECOMMENDED LAYOUT

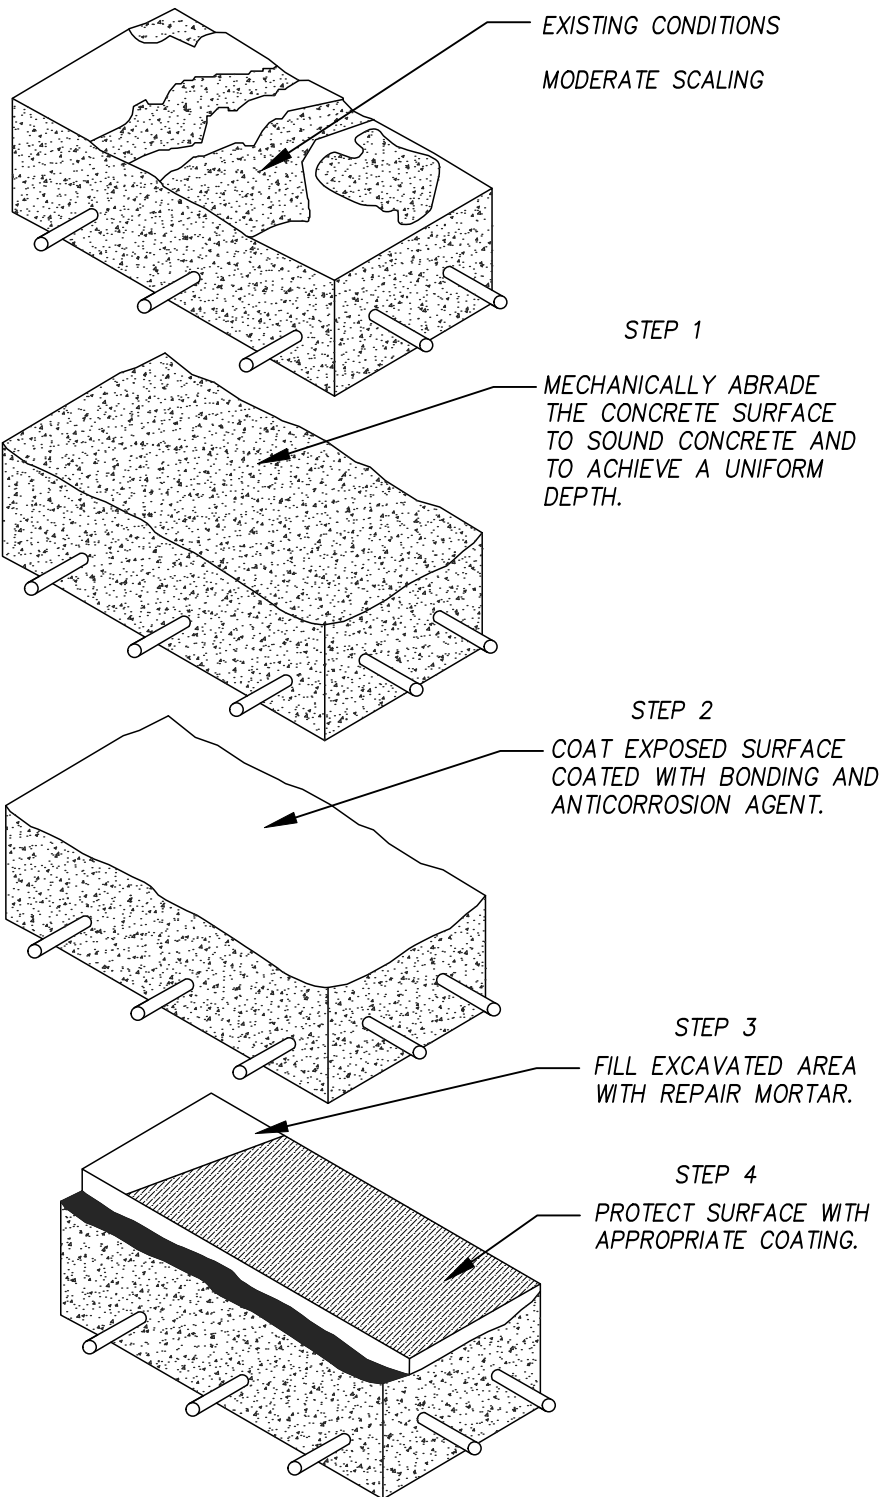
# DECK OVERLAY SCALING / SLAB PITCH CORRECTION

1. SPALL/SCALING UP TO 1/4" (7mm) IN DEPTH WITH MINOR AGGREGATE LOOSE, BUT NO EXPOSURE TO REBARS.
2. AN EXPOSED AGGREGATE PROFILE OF +/- 1/8"(3mm) IS REQUIRED IN ORDER TO OBTAIN A GOOD MECHANICAL BOND TO THE SUBSTRATE. PRESSURE WASH AFTER EXCAVATION TO REMOVE DUST, LAITANCE AND OTHER BOND INHIBITING MATERIALS, SSD SUBSTRATE.
3. APPLY A 20 MIL. COATING OF BONDING AND ANTI-CORROSION AGENT ONTO THE SSD SURFACE TO INSURE PROPER BOND OF REPAIR MATERIAL.
4. FILL AND SCREED EXCAVATED AREA WITH THE APPROPRIATE REPAIR MORTAR, CONSOLIDATE, FINISH AND CURE AS REQUIRED.
