Long Term Balcony Protection

Long Term Balcony Protection Plan Blueprint 32 Outer and 64 Inner Lantana Units (Part 1)

January 26, 2022

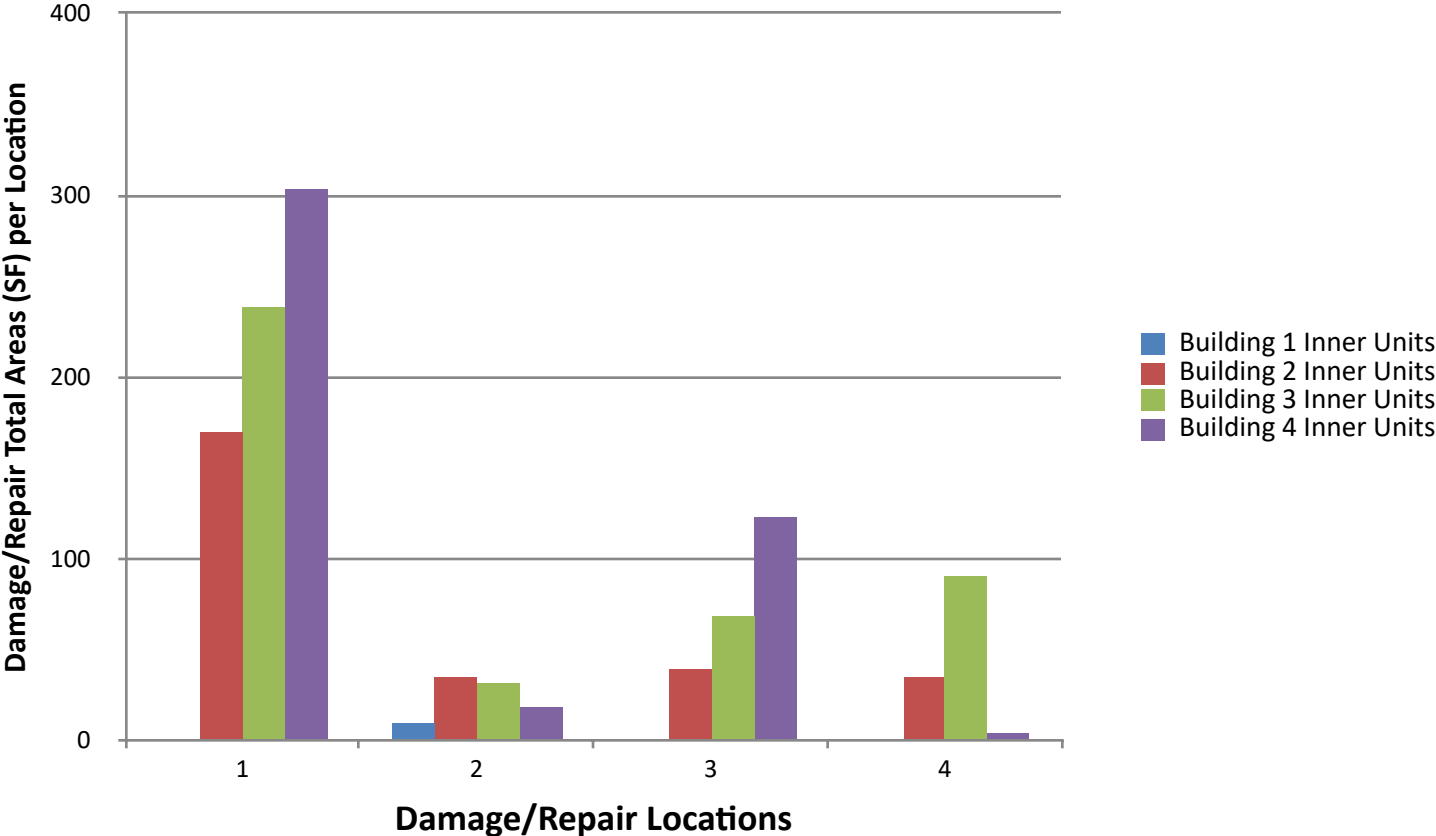
Figure 11.

- **Figure 11 is a graphical representation of Tables 11 - 14**
- **Figures 11 and 12 show amount of damage occurring on all floors for all inner units and buildings**
 - **Floors 2 and 3 had most damage**
- **B4 floor 2 - 179 SF, Floor 3- 120 SF, floor 1- 82 SF and floor 4- 67 SF**
- **B3 floor 2 - 154 SF, floor 3- 117 SF, floor 4- 91 SF and floor 1-67 SF**
- **B2 floor 3 - 112 SF, Floor 4- 104 SF, floor 2-35 SF, Floor 1-26 SF**
- **B1 floors 1- 46 SF**
- **Table 15 contain a direct comparison of same units damaged/repared by CRI and inspected by MBV (Table 15 is listed in Appendix B)**
 - **CRI problem areas had total a total value of 105 SF (locations 1, 2 and 3) while MBV total values were equal (105 SF) in locations 1, 3 and 4**
